ARKANSAS
Department of Environmental Quality

WATER DIVISION COMPLAINT REPORT

AFIN: 51-00164	PERMIT #: ARG590001
COUNTY: 51 Newton	PDS #: 019610
GPS LOCATION: LAT: 35.923155 LONG: -93.073633	
<input type="checkbox"/> Discharge Site / <input type="checkbox"/> General Area / <input checked="" type="checkbox"/> Entrance

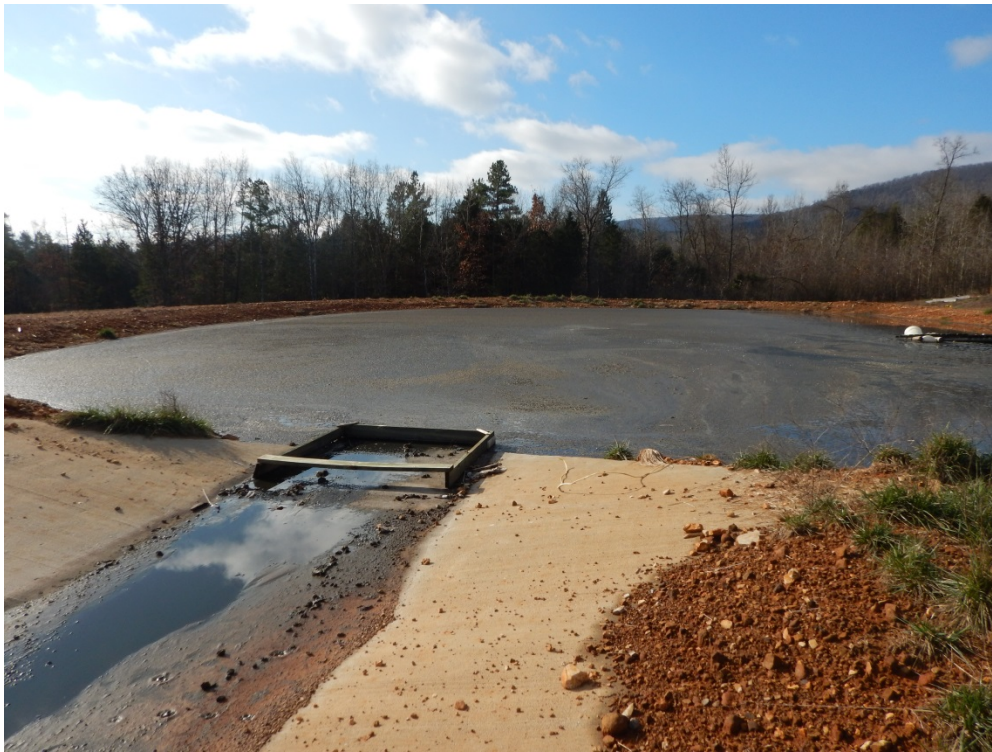
A site visit was conducted on December 30, 2015 at approximately 9:20 A.M. Wastewater from Waste Storage Pond (WPS) #1 is designed to flow over a spillway (Photograph 1) into WPS #2 once wastewater from WPS #1 reaches a certain level; however, at the time of the visit it was not discharging into WPS #2. WPS #2 pond depth was approximately 1 foot below the facilities Must Pump Down level (Photograph 2). There was no evidence indicating either pond had overflowed. The permittee has been conducting daily inspections of both ponds. Stormwater runoff from the facility is diverted around the ponds so any additional water that enters the ponds that is not wastewater should only be precipitation. The ponds are approximately 100 to 150 feet higher in elevation than Big Creek. It did appear from the debris remaining on the County Road 54 bridge (Photograph 3) that crosses Big Creek, that water levels within Big Creek were higher than the day of the investigation but the rising levels did not impact the farm or the ponds. The water quality of the unnamed tributary on County Road 41 directly below the farm was clear (Photographs 4 and 5).

Location:	C&H Hog Farms		
Photographer:	Jason Bolenbaugh	Date:	12/30/2015
Witness:	Keith Waters	Time:	
		Photo #:	1
Description:	Standing between WPS #1 and #2 looking toward WPS #1. Wastewater was not flowing from WPS #1 into WPS #2 at the time of the inspection.

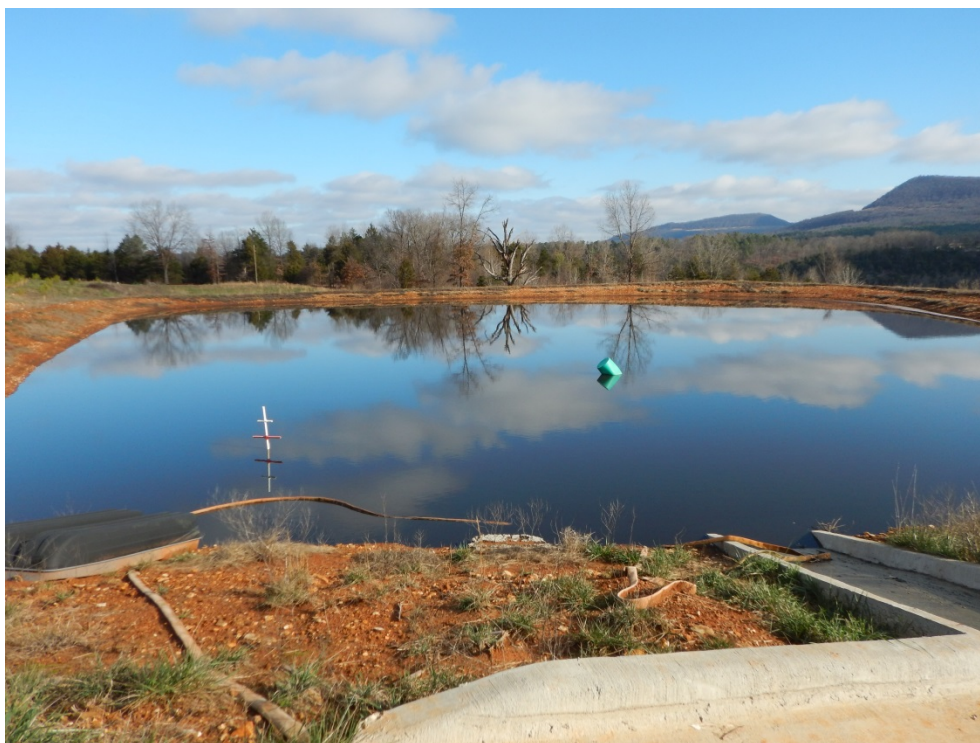
Photographer:	Jason Bolenbaugh	Date:	12/30/2015
Witness:	Keith Waters	Time:	
		Photo #:	2
Description:	WPS #2 showing adequate amount of freeboard and the depth gauge which marks (red line) the Must Pump Down level.

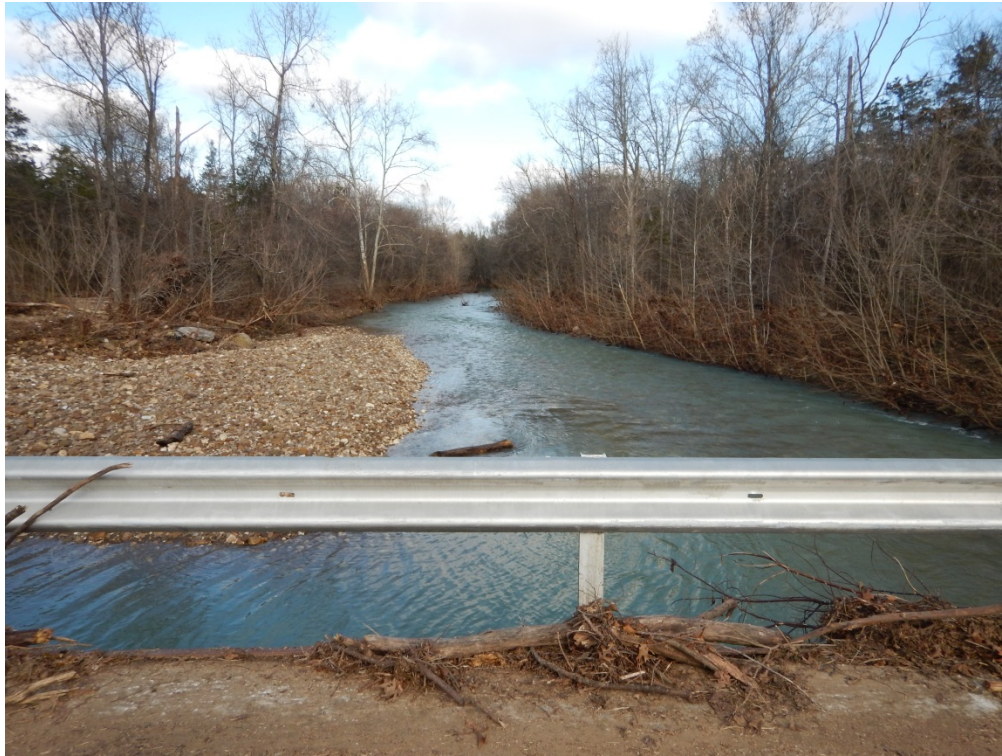
Location:	C&H Hog Farms				
Photographer:	Jason Bolenbaugh	Date:	12/30/2015	Time:	
Witness:	Keith Waters	Photo #:	3		
Description:	Big Creek at the County Road 54 bridge.

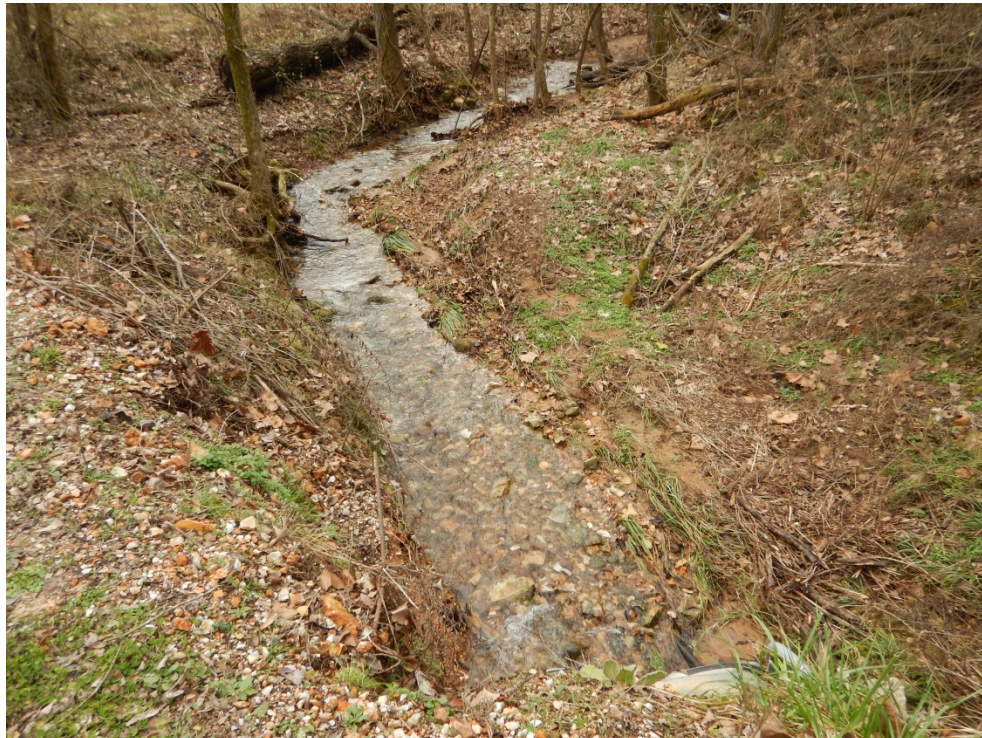
Photographer:	Jason Bolenbaugh	Date:	12/30/2015	Time:	
Witness:	Keith Waters	Photo #:	4		
Description:	Unnamed tributary directly below C&H Hog Farm.

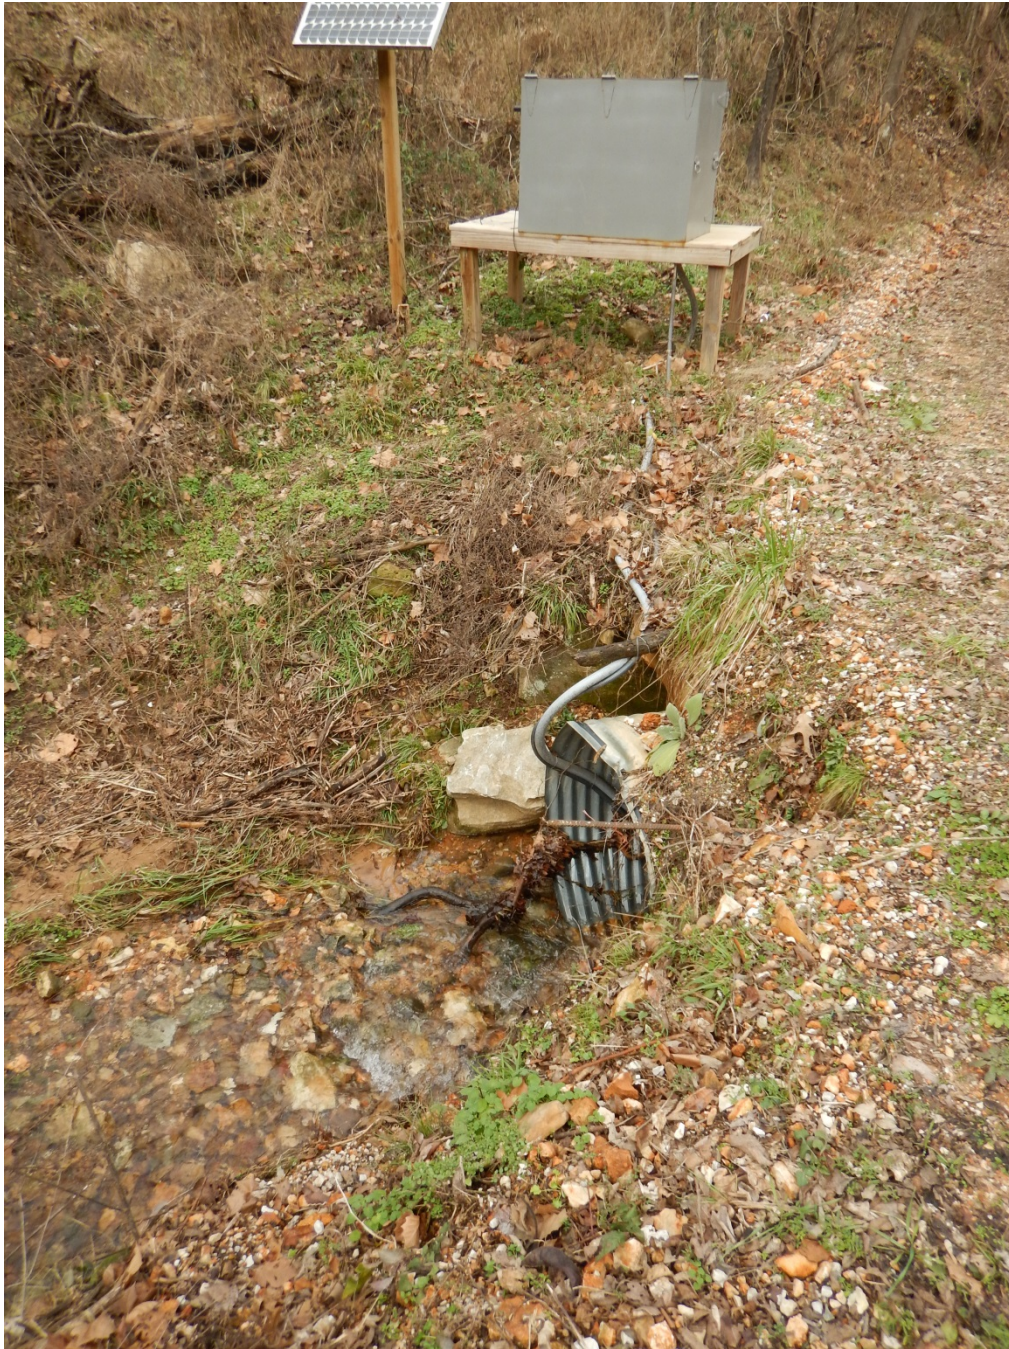
Location:	C&H Hog Farms				
Photographer:	Jason Bolenbaugh	Date:	12/30/2015	Time:	
Witness:	Keith Waters	Photo #:	5		
Description:	Water quality monitoring station in the unnamed tributary below C&H Hog Farm as pictured in Photograph 4 above.
