Big Creek Research and Extension Team
University of Arkansas System Division of Agriculture
Quarterly Report – April 1 to June 30, 2014

**MONITORING THE
SUSTAINABLE
MANAGEMENT OF
NUTRIENTS ON C&H FARM
IN BIG CREEK WATERSHED**

Ground Penetrating Radar (GPR) Survey Report

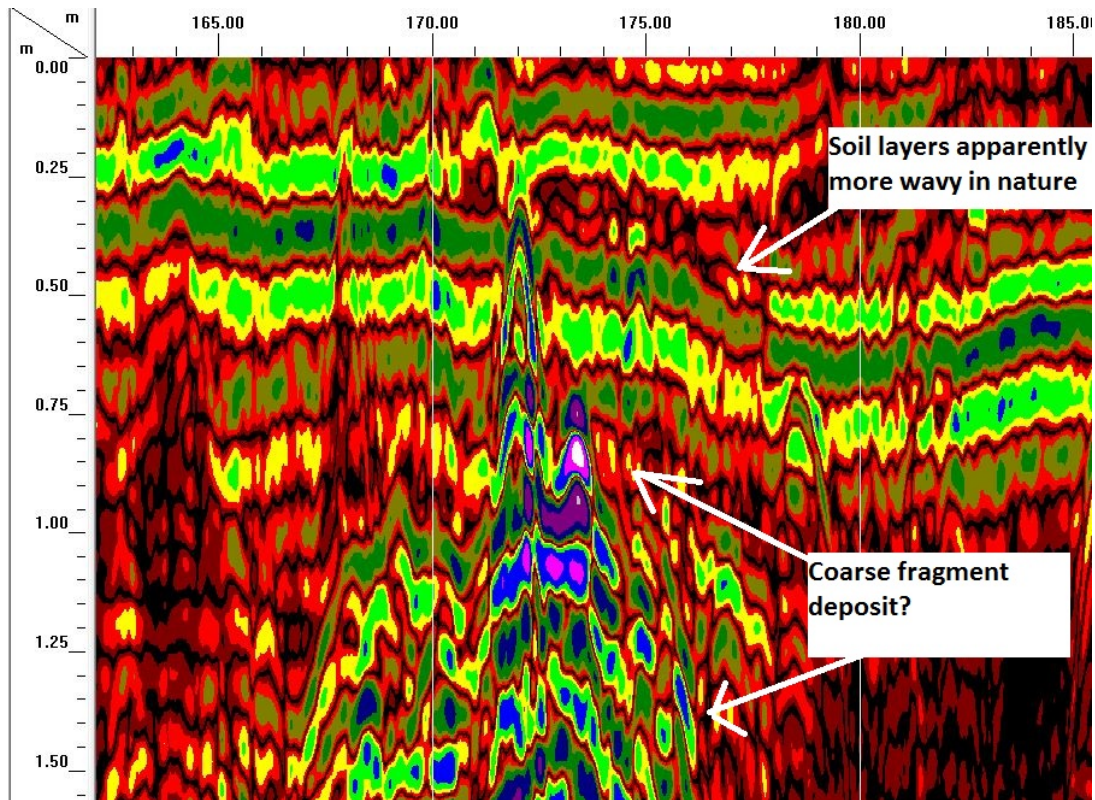
Figure 3. Along Transect 3, possible gravel layers were noted as the survey approaches Big Creek.

9. At around the 170-m mark (figure 3), the soil horizons become more wavy in nature. This change could be related to more recent scouring and deposition from Big Creek.

10. An anomaly at the 170-m mark, at around 1-m deep, could be a pocket of coarse fragments deposited by Big Creek (figure 3).
11. An anomaly was noted on the radar record at the end of survey 3 upon data collection (figure 4). It resembled possible coarse fragment deposits from the previous field visit. A test whole was augered at around the 225-m mark. The upper soil horizons (0-55-cm) were more sandy in nature than observations further from the creek along this transect. Subsurface textures were sandy loam. At 55-cm, augering was not possible due to coarse fragment content. Coarse fragment content was estimated at 35-45%.

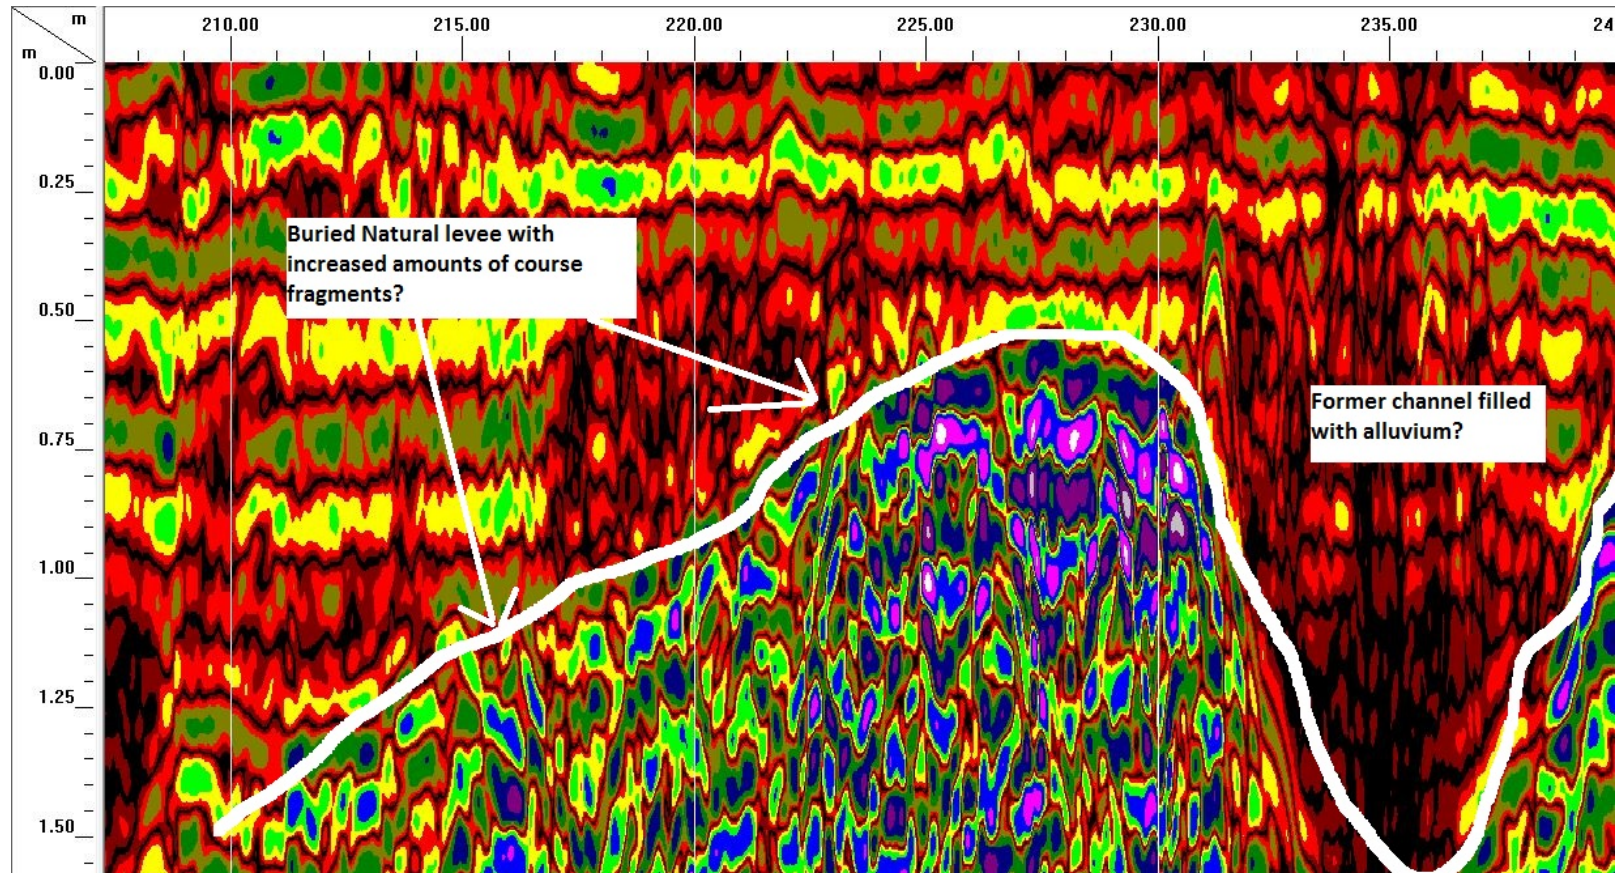
Figure 4. This anomaly at the end of Survey 3 may be a gravel bar deposited by Big Creek.

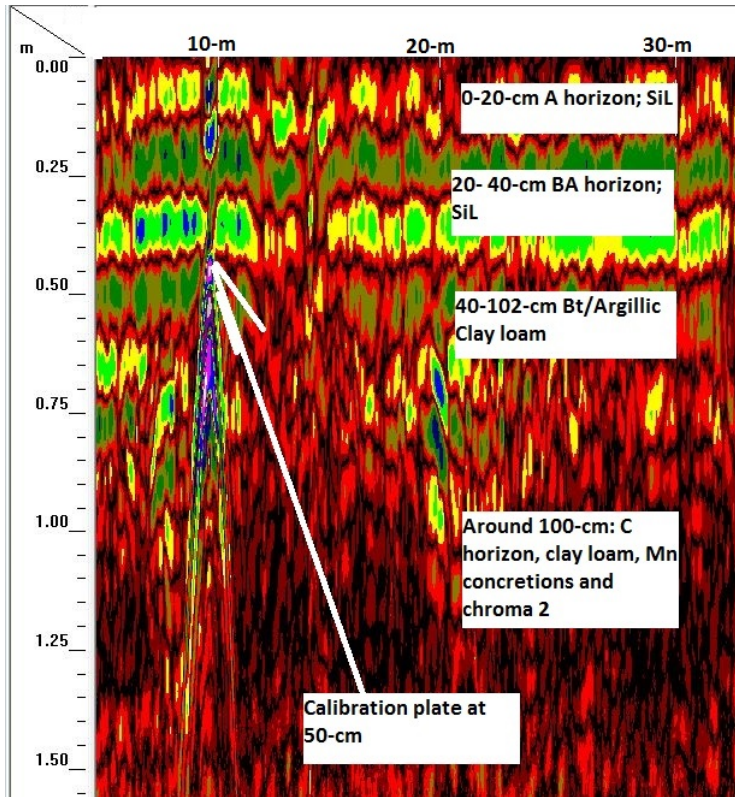
Figure 5. The first 30-m of survey number 4.

- The soils along this transect appear to be uniformly stratified for about the first 120-m of the survey (Figure 5).
- Test holes observed generally followed the Spadra series concept, except for one where gravels were observed in the subsoil

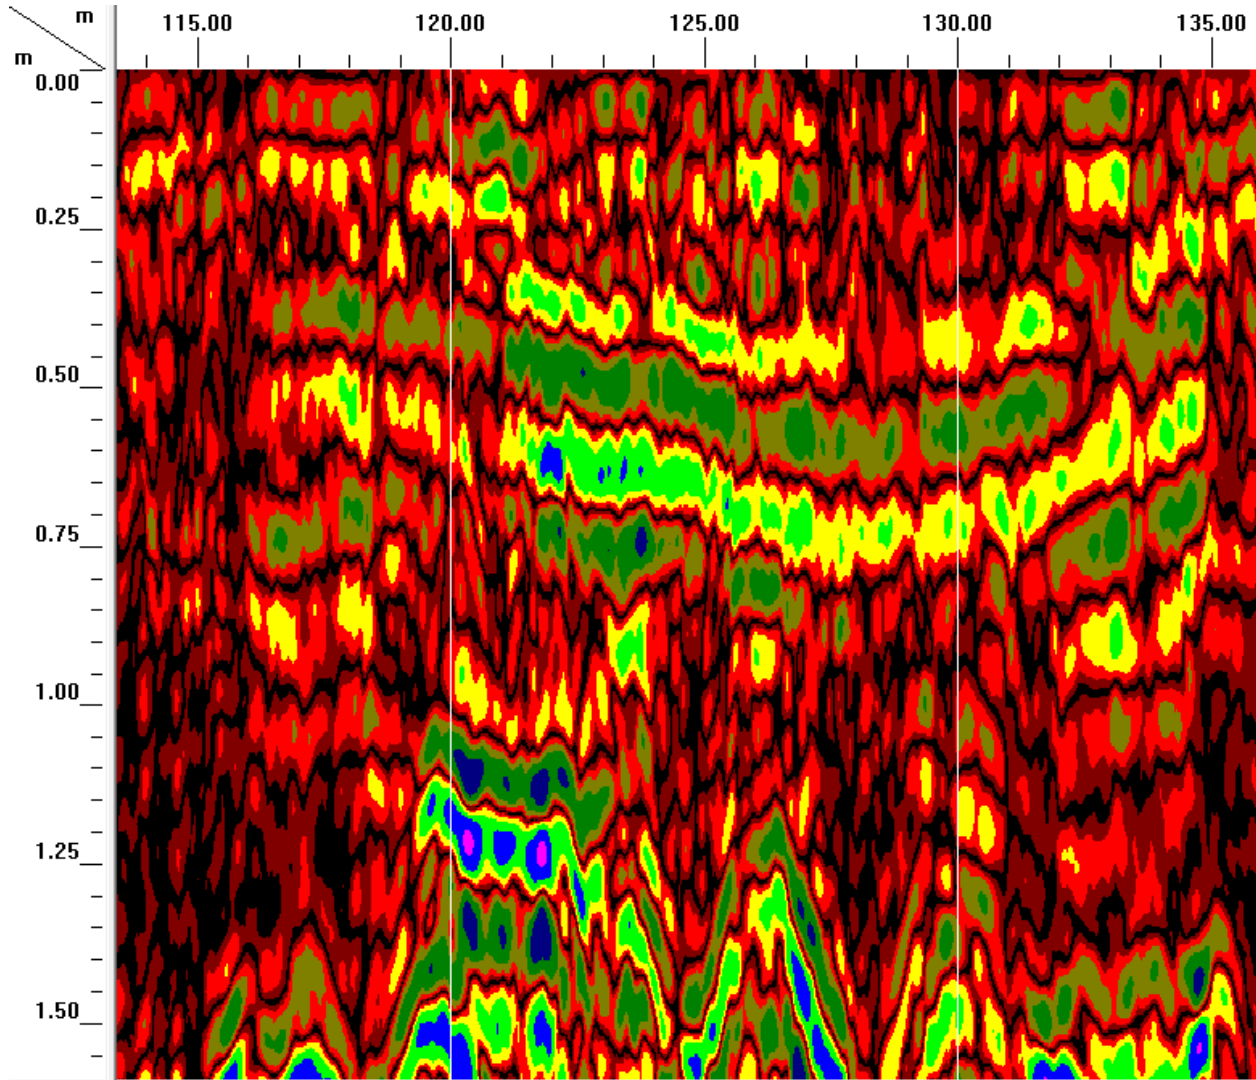
Figure 6. Features at bottom may be gravel deposits along survey number 4.

- Based on the radar record, soil horizons apparently become more wavy in nature between 120 and 130-m along the transect (Figure 6). This area is also underlain by radar signature that was found to be indicative of gravel deposits in previous test holes.

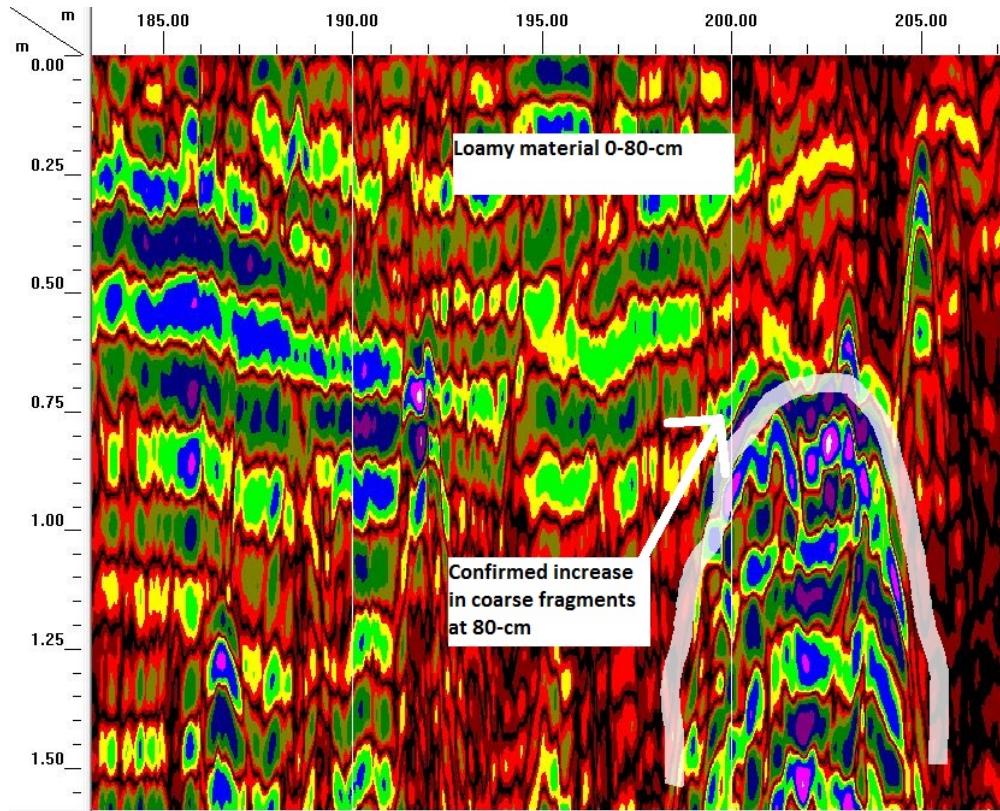
Figure 7. A subsurface horizon with increased fragment content was suspected and confirmed in the field along survey # 4.

- A test hole was augured at the 200-m mark on transect 4, as summarized below. A suspected area of gravel deposition was confirmed to be present (Figure 7). The upper 80-cm was covered with loamy alluvium.

A: 0-25-cm; Fine sandy loam

Bt1: 25-50-cm; Sandy clay loam

Bt2: 50-80-cm Sandy clay loam (marked clay increase)

BC: 80-120-cm Very gravelly Sandy loam 35% fragments

C: 120-cm plus; Very gravelly (or cobbly) Sandy loam >40% fragments

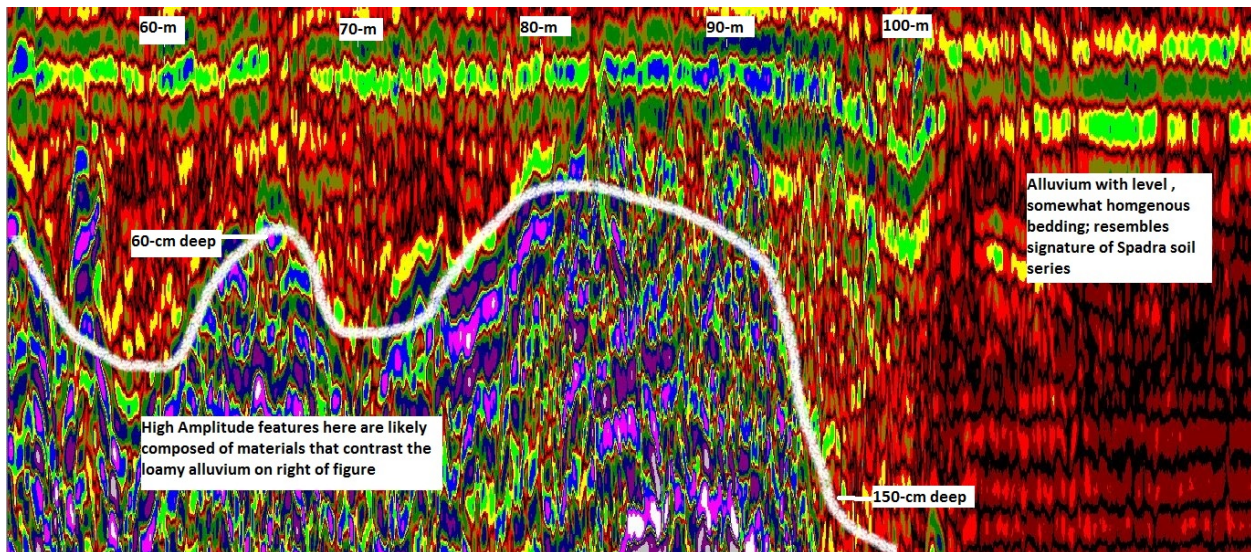
Figure 9. Contrasting materials below loamy alluvium disappear at the 100-m mark on transect #6.

- No points were ground-truthed along this radar survey
- The data indicates that most of this soil is uniformly layered, with a radar record resembling surveys # 3 and # 4. The survey indicates that the argillic layer usually starts around 25-cm.
- There were highly contrasting materials noted at a depth of 60-cm from around the 40-m mark of this transect until around the 90-m mark (figure 9). Speculatively, this could be layers that greatly increase in clay content, or an increase in coarse fragments that are alluvial in nature.

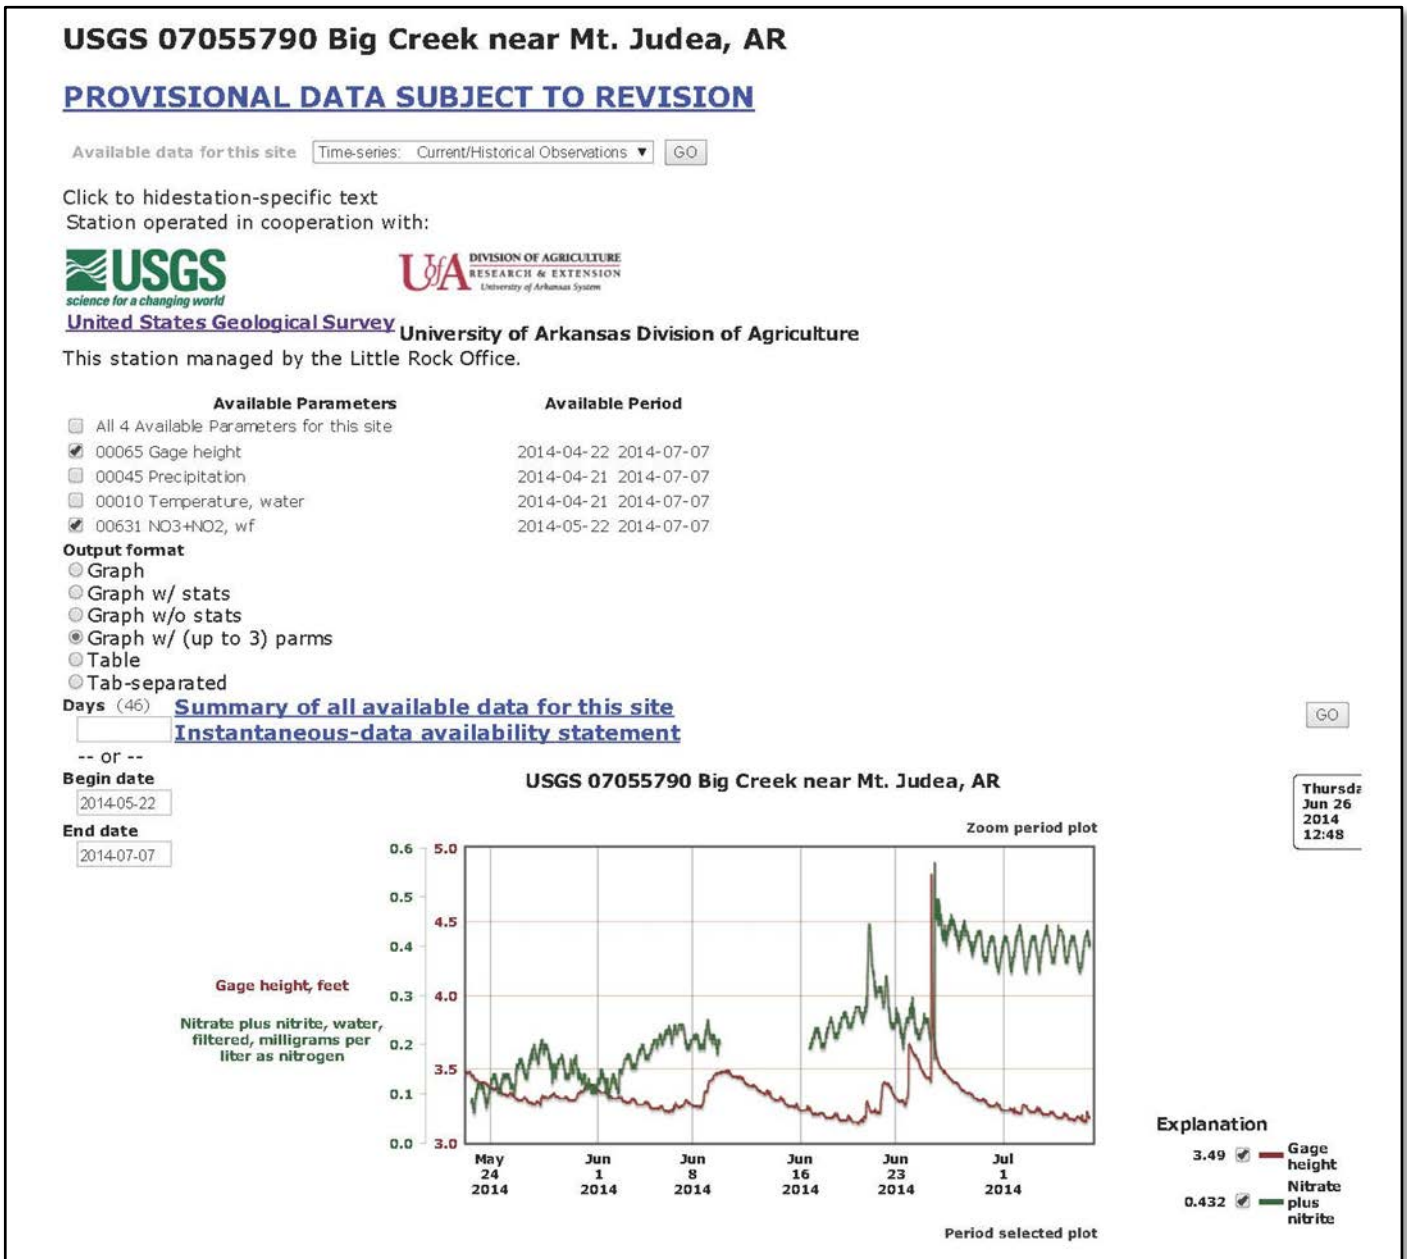
Figure 12. Display of USGS gaging site on Big Creek, downstream of the C&H Farm showing continuous flow and nitrate plus nitrite concentrations since the equipment became active in May, 2014.

Collaborating with USGS, Big Creek at the downstream site of prior water sample collection was instrumented with continuous flow gaging equipment, along with a nitrate sensor, which provided real-time flow, water temperature, water nitrate and precipitation. These data are available on-line at the following sites.

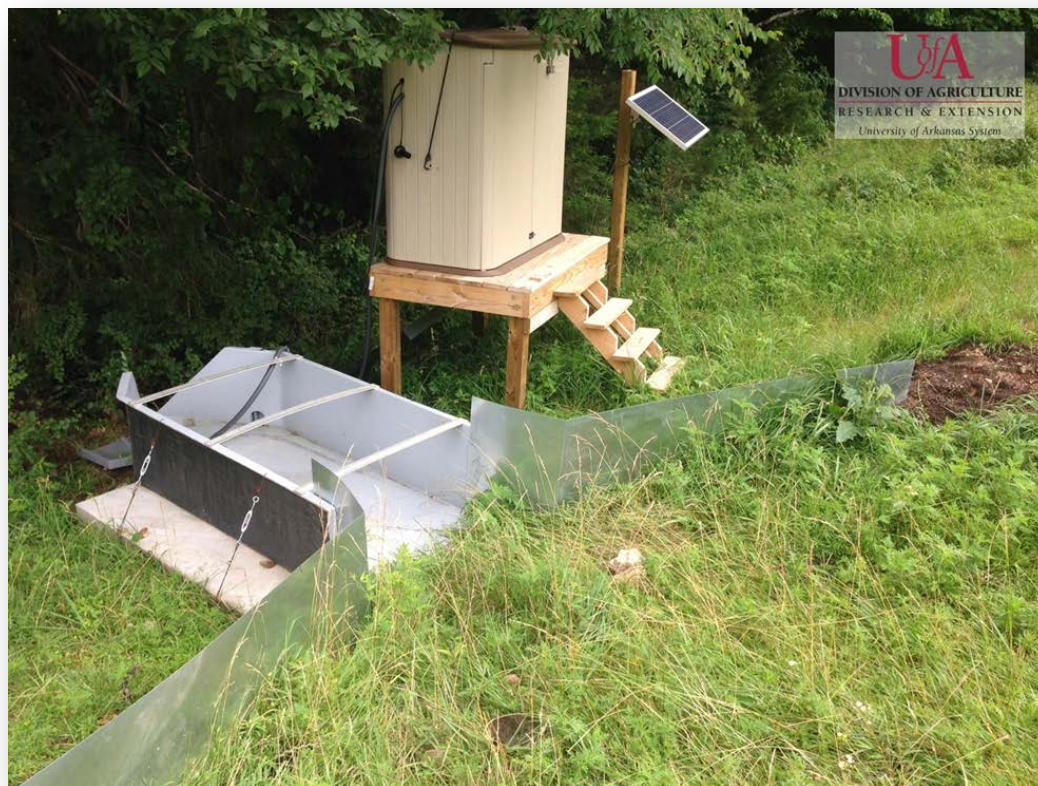
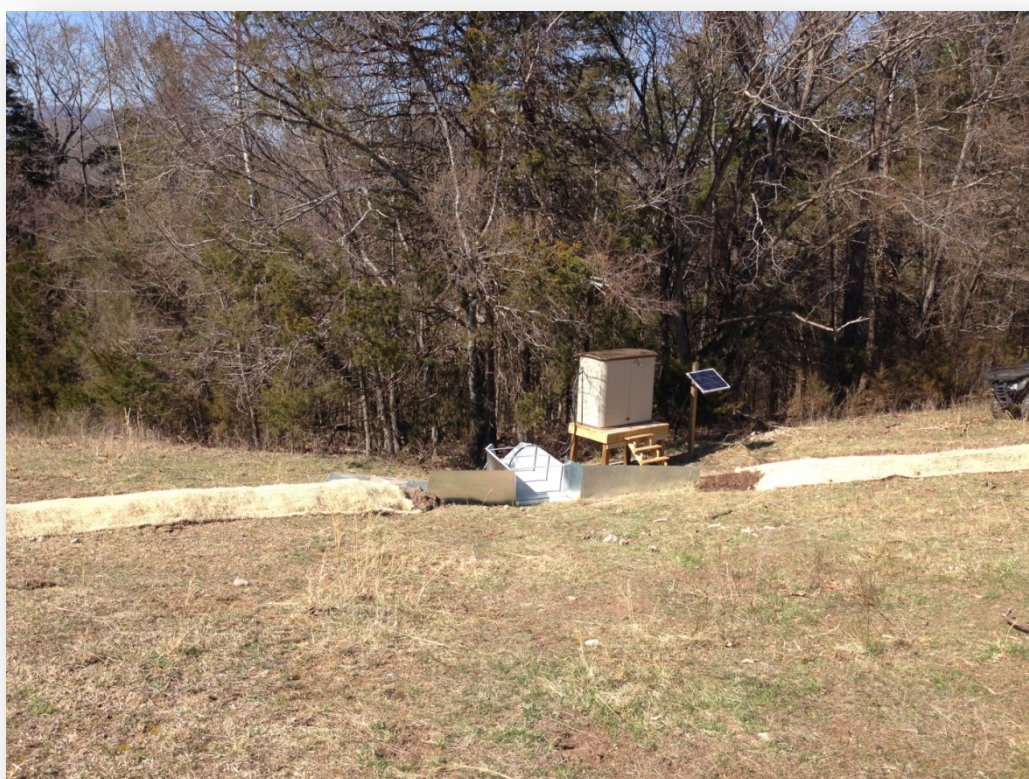
Figure 15. Edge-of-field surface runoff flume on Field 1 on the C&H Farm.

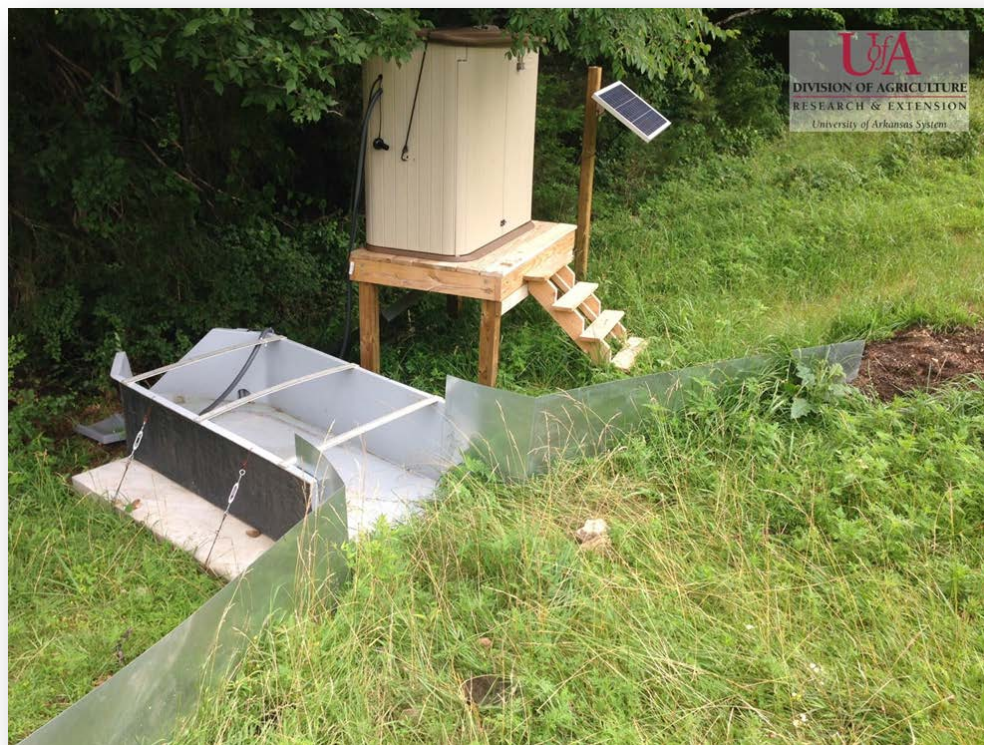
Figure 17. Edge-of-field surface runoff flume on Field 5a on the C&H Farm.

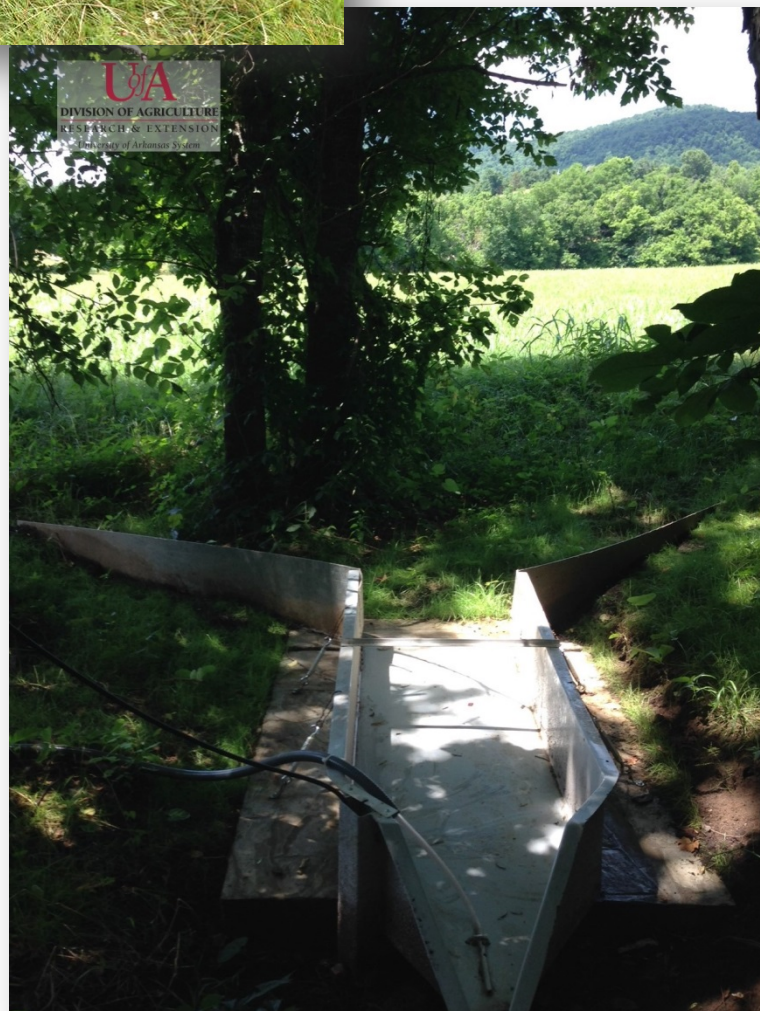
Figure 18. Surface and subsurface flow monitoring on Field 12 on the C&H Farm.

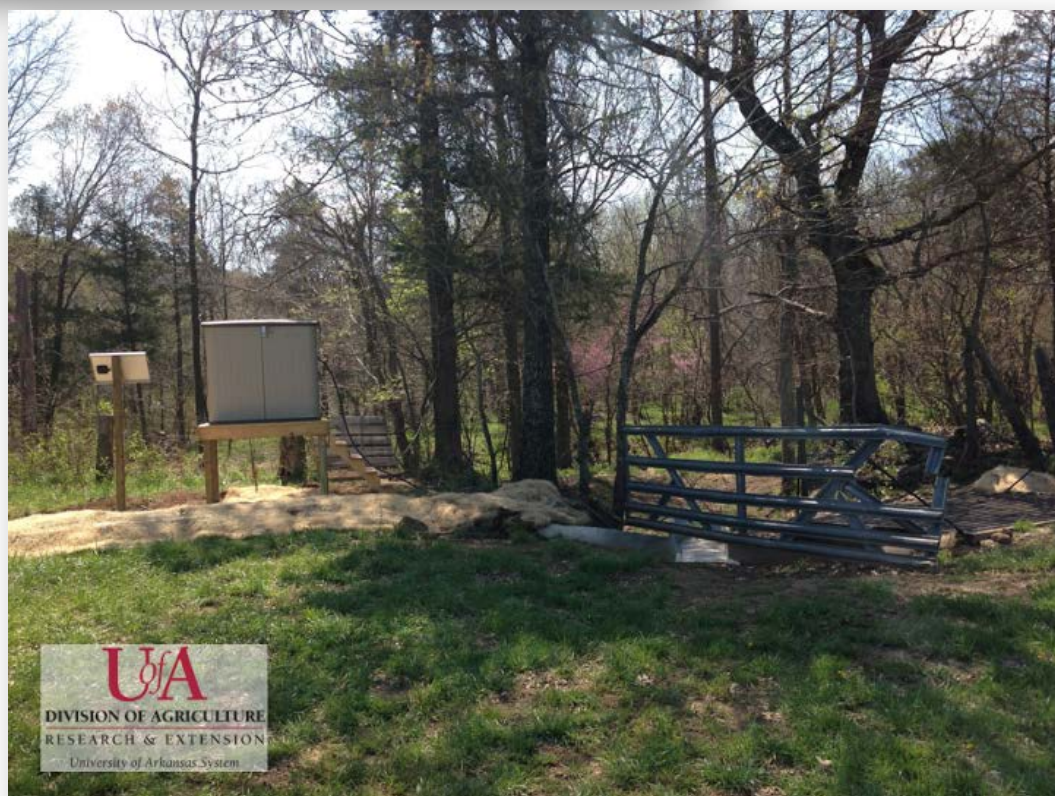
Figure 19. Edge-of-field surface runoff flume on Field 12 on the C&H Farm.

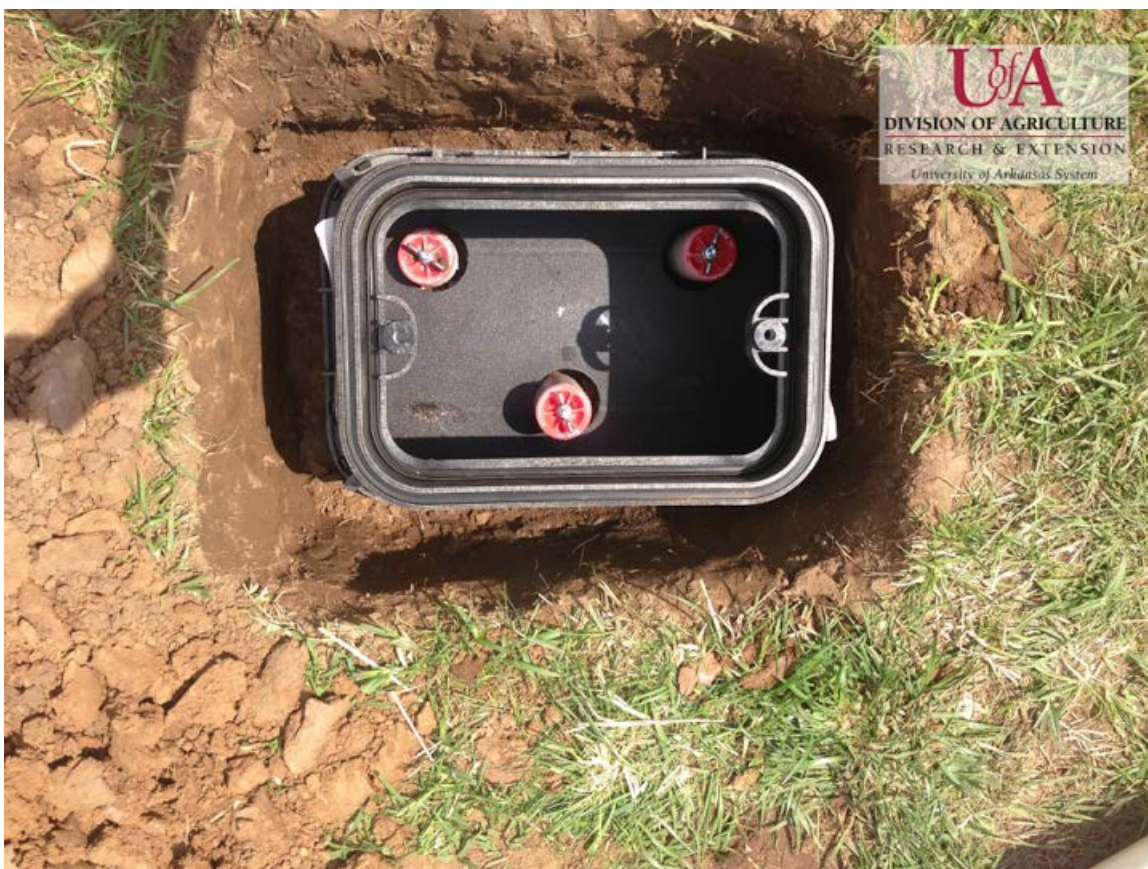
Figure 20. Installed piezometer that measures water table depth and can collect water samples from 15 and 48 inch depths.

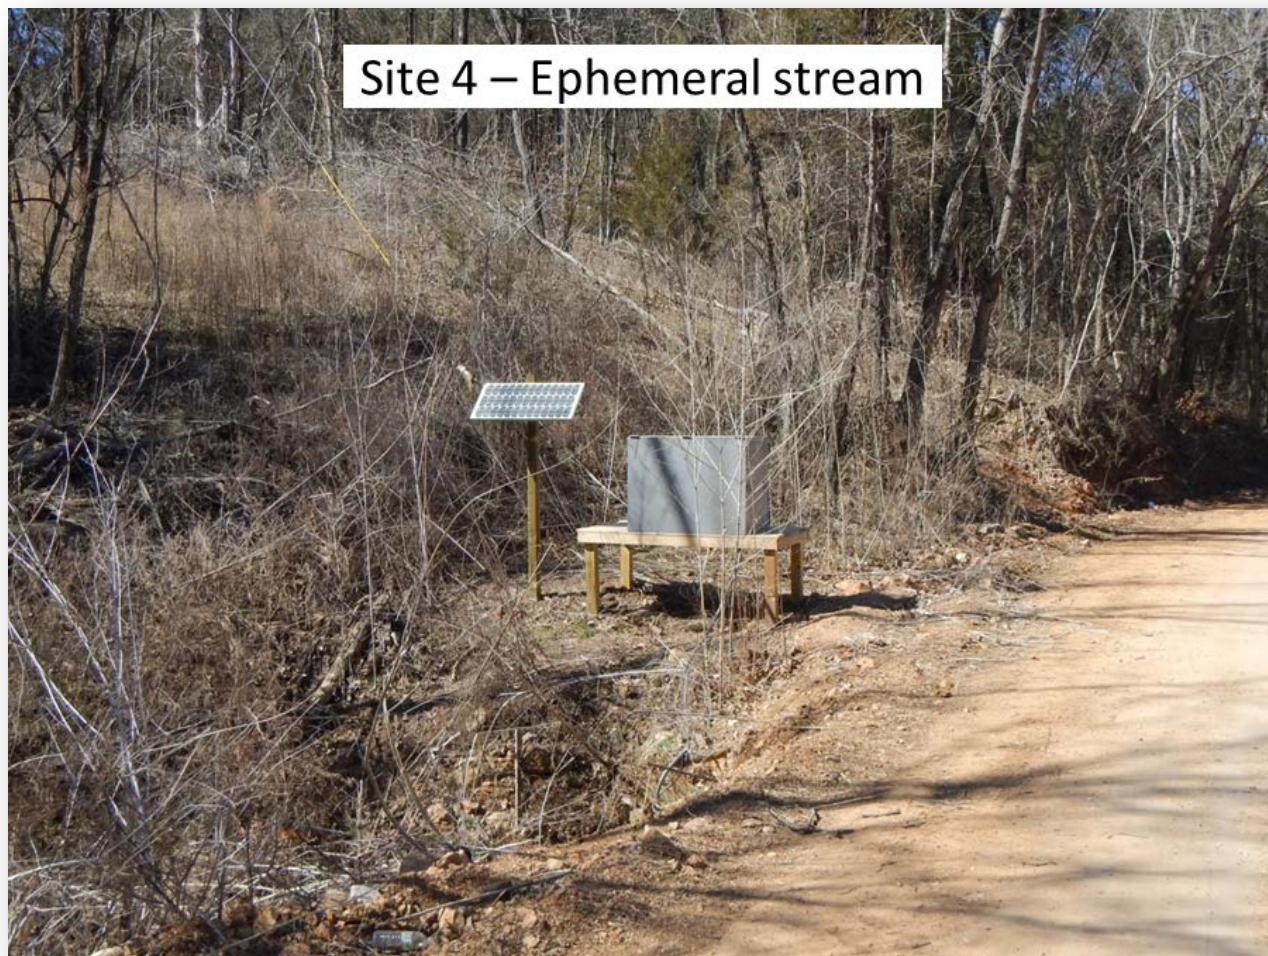
Figure 21. The culvert sampling an ephemeral stream draining a subwatershed containing the C&H Farm operation facilities.

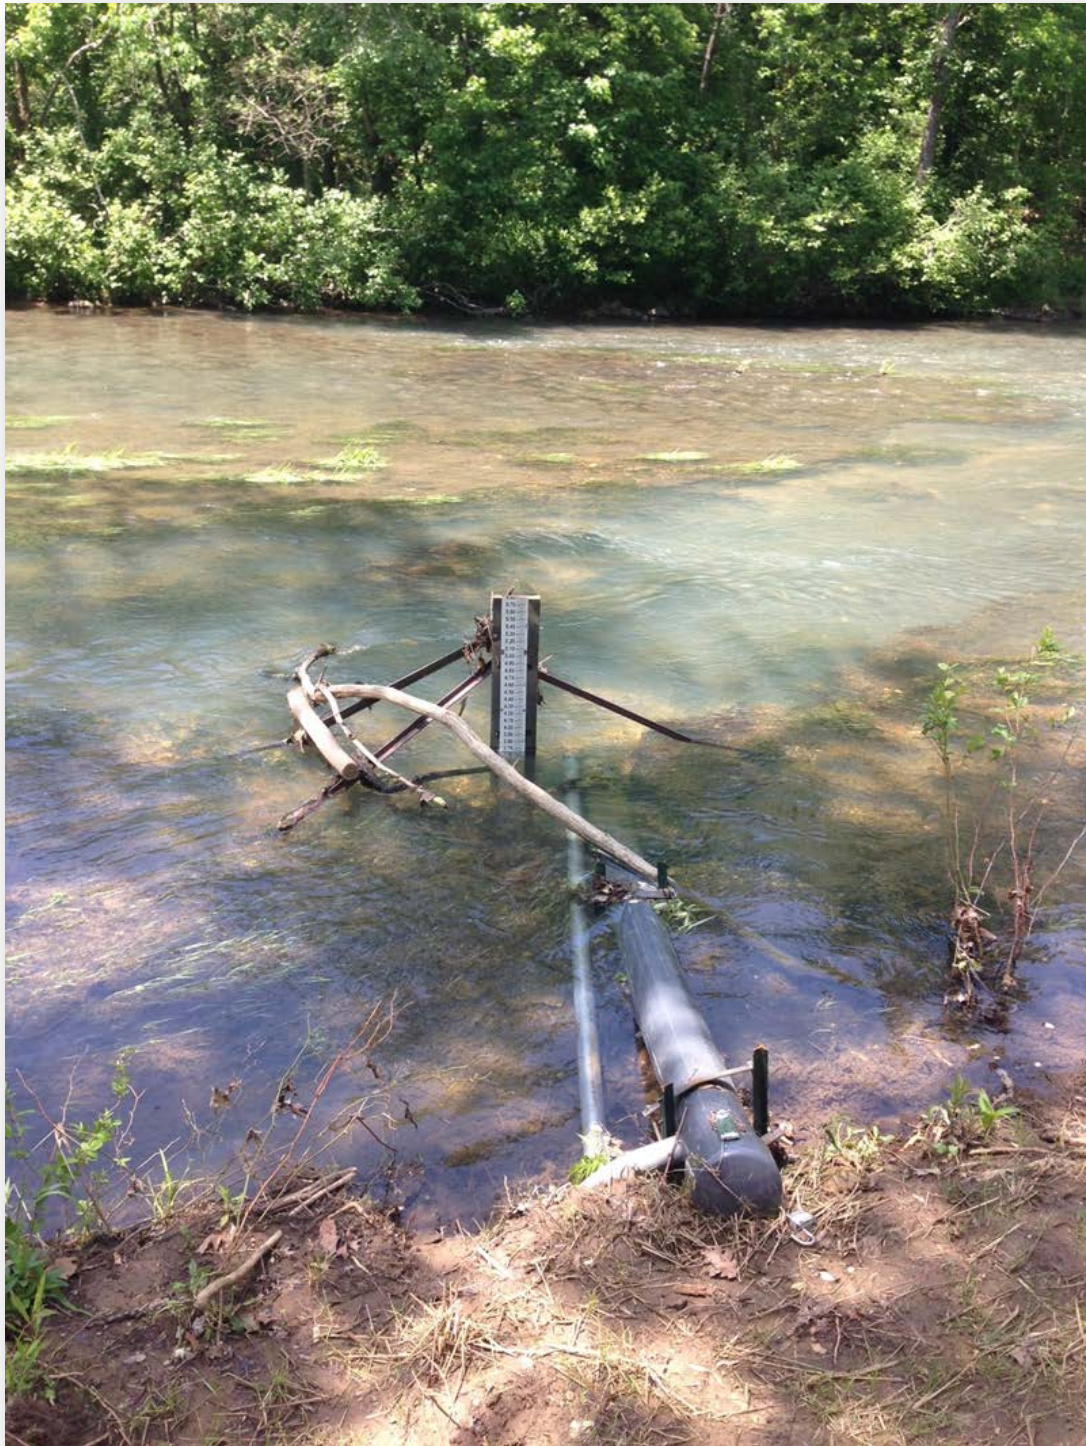
Figure 26. The Big Creek sampling station at the site downstream of the C&H Farm.

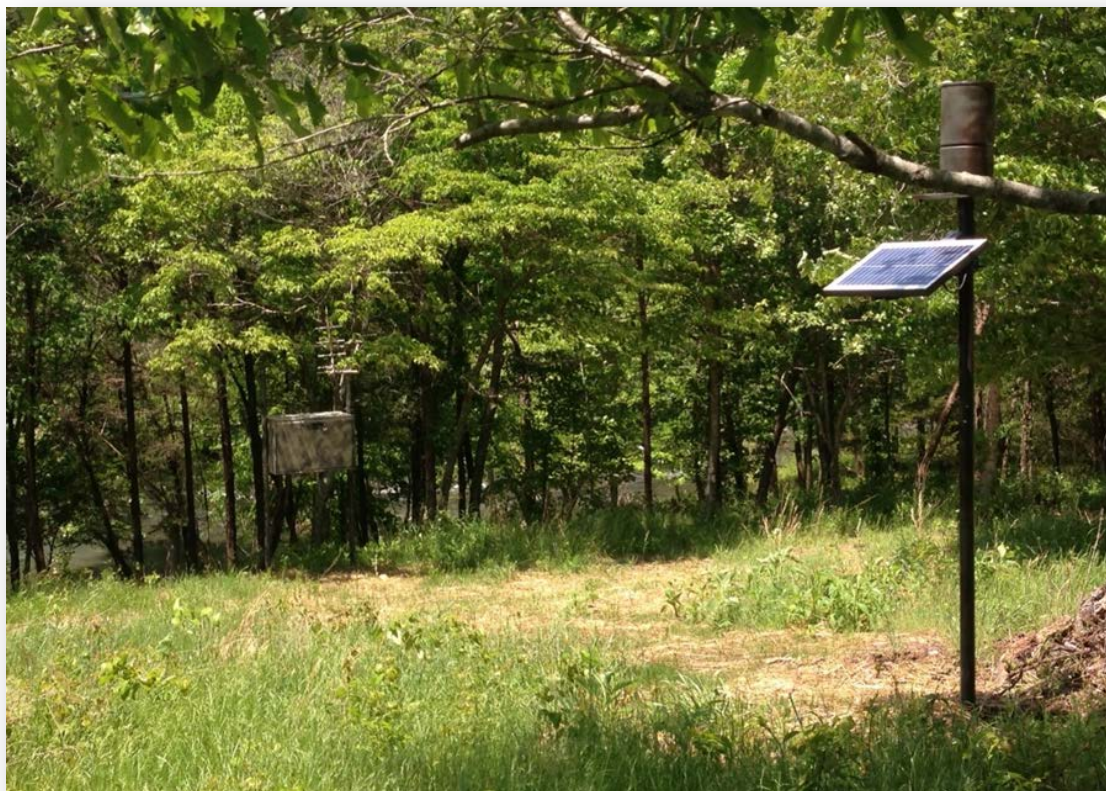
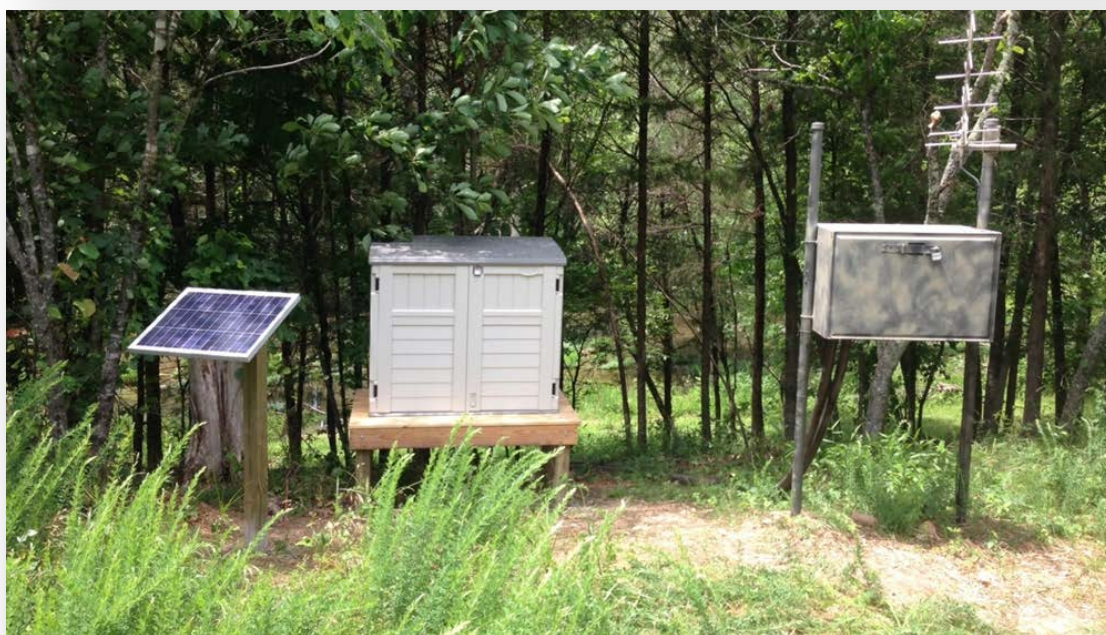
Figure 27. The Big Creek sampling station at the site downstream of the C&H Farm.
