**Region 6 Compliance Assurance and Enforcement Division
INSPECTION REPORT**

Inspection Date(s):		04/15-17/2014	
Media:		Water	
Regulatory Program(s)		NPDES - CAFO	
Company Name:		C & H Hog Farms, Inc.	
Facility Name:		C & H Hog Farm, Inc.	
Facility Physical Location:		HC 72 Box 2	
(city, state, zip code)		Vendor, AR 72683	
Mailing address:		HC 72 Box 2	
(city, state, zip code)		Vendor, AR 72683	
County/Parish:		Newton	
Facility Contact:		Jason Henson	President
		chhogfarmsinc@yahoo.com	
FRS Number:		N/A	
Identification/Permit Number:		ARG590001	
Media Number:		N/A	
NAICS:		112210	
SIC:		0213	
Facility Representatives:		Jason Henson	President 870 688-1318
EPA Inspectors:		Carl Wills	6EN-WR 214 665-7276
		Chris Lister	6EN-WR 214 665-6672
State Inspector(s):		Jason Bolenbaugh	ADEQ Inspection Branch Manager 501 682-0659
Other Inspector(s):		None	
Metadata	Title:	C & H Hog Farms Judea Newton County Arkansas	
	Author:	US EPA Region 6 Compliance Assurance and Enforcement Division Dallas TX	
	Subject:	CAFO Inspection Report

PURPOSE OF THE INSPECTION

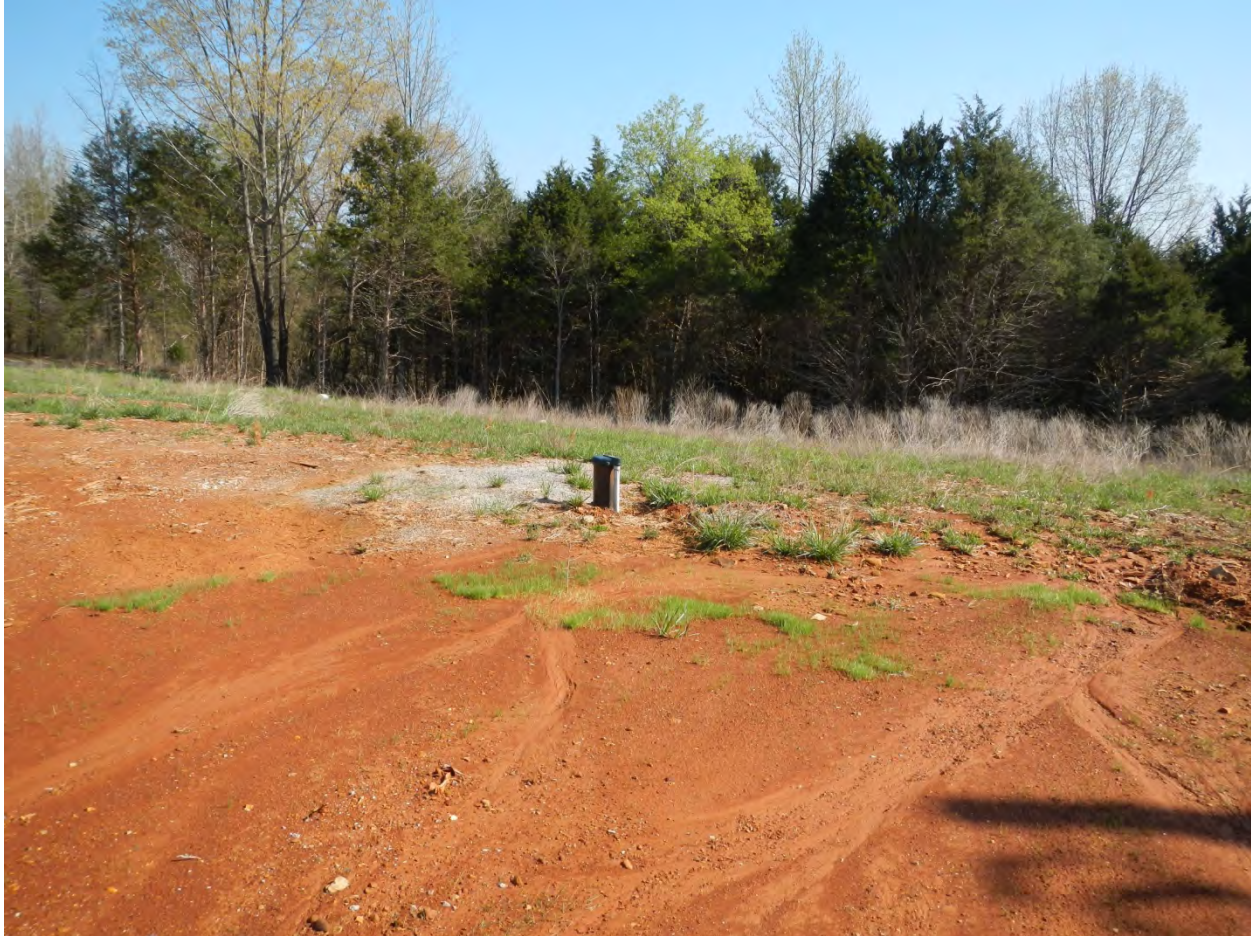
Photo No. 1

Description: View to the north of the water supply well. The well has a total depth of 320 feet with the depth of water being at approximately 280 feet.

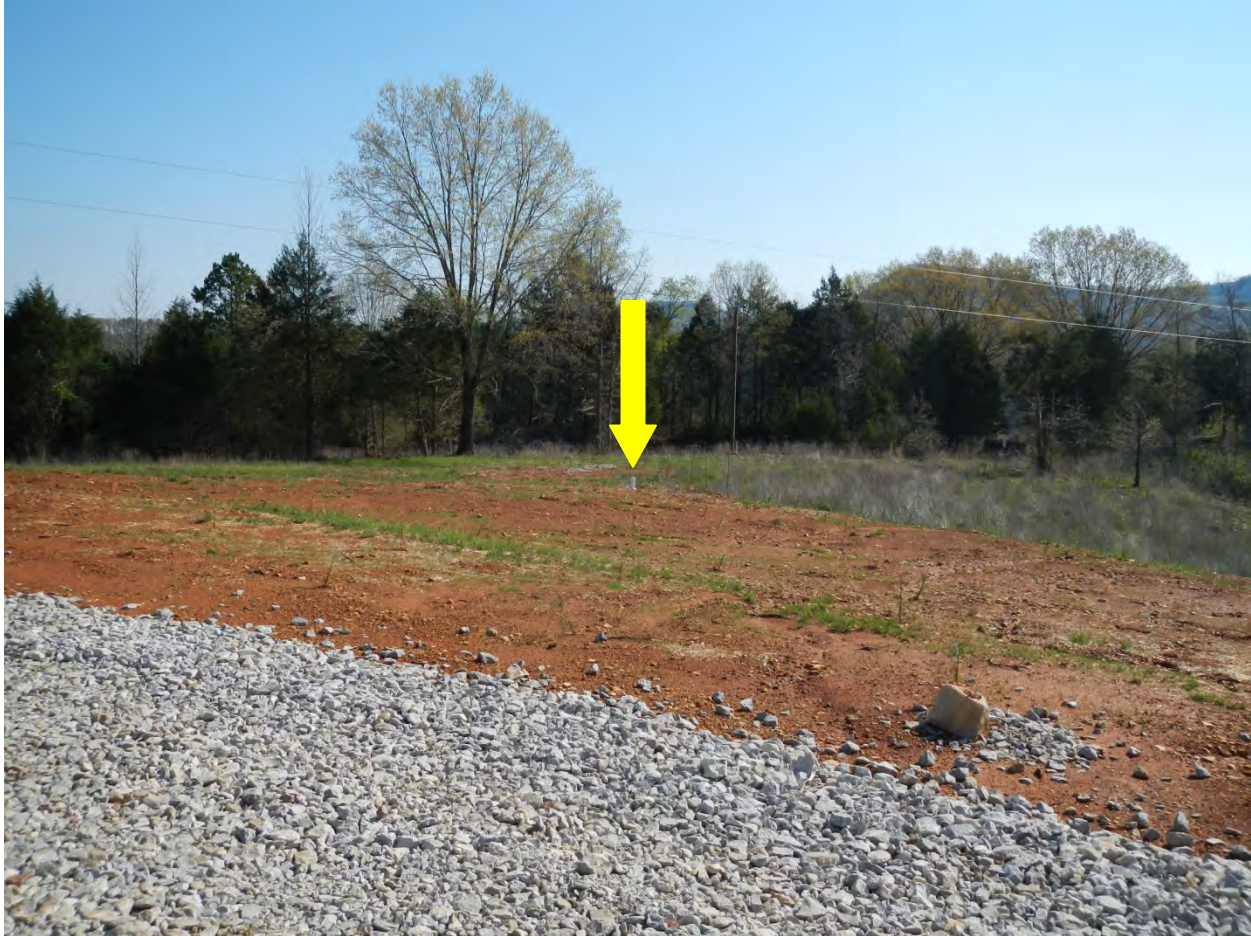
Photo No. 2

Description: View to the northeast of the cleanout (white riser in the center of the photograph) for human septage with the leachfield north of the cleanout.

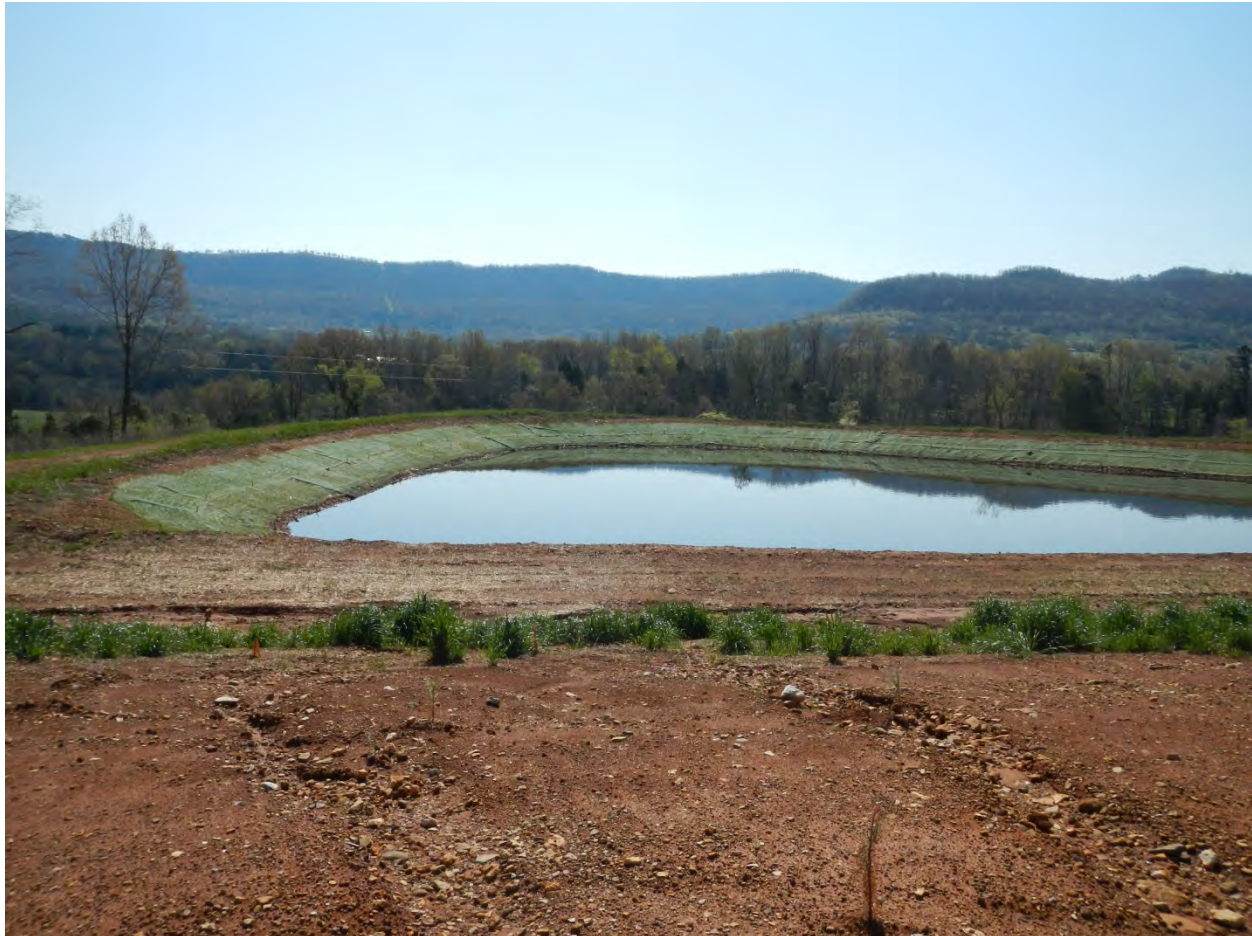
Photo No. 3

Description: View to the east of the secondary lagoon with geotextile fabric in place, to aid in soil stabilization.

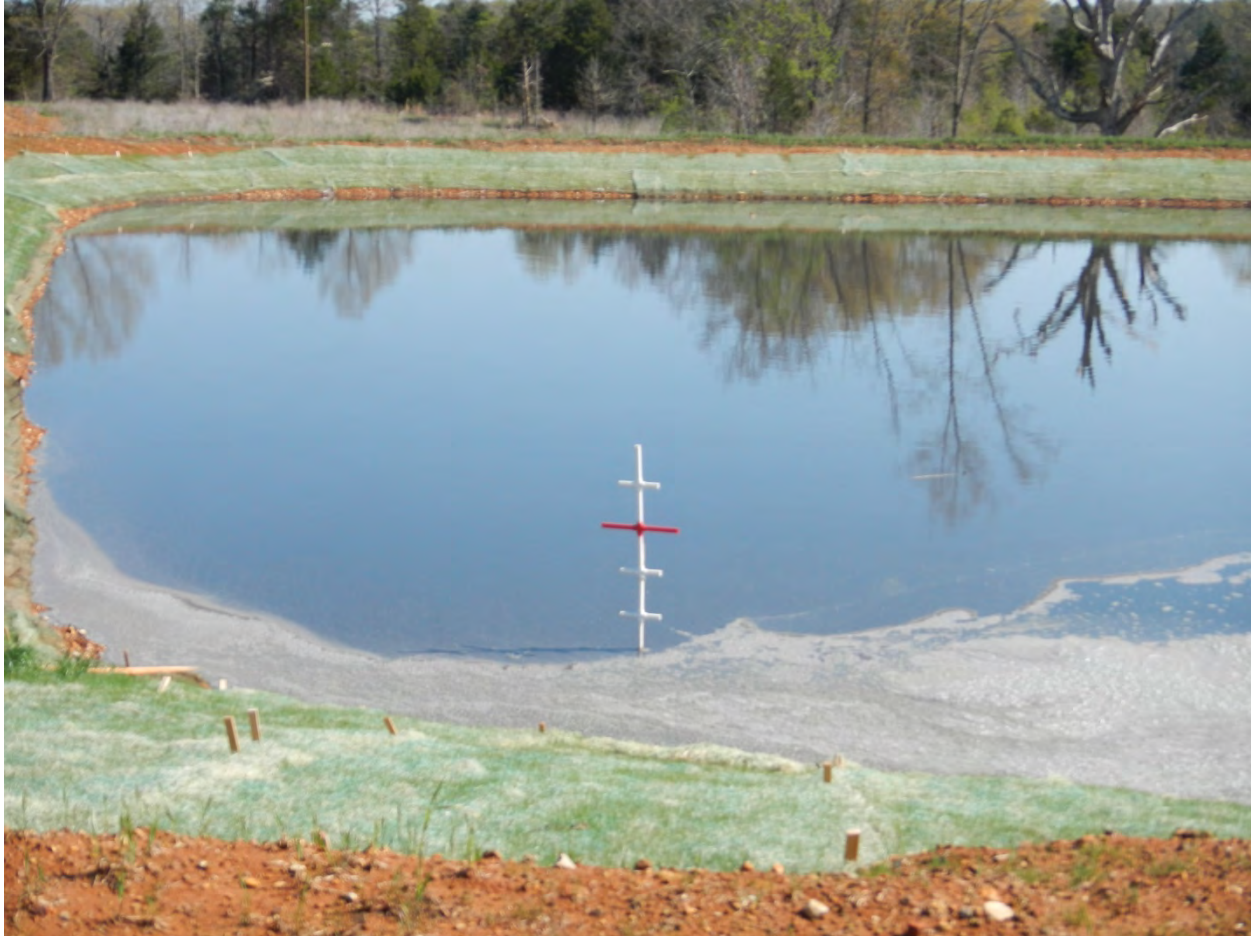
Photo No. 4

Description: View to the north-northeast of the staff gauge in the secondary lagoon – operator needs to extend the top of the gauge to show the lowest point of the lagoon berm, so that they will know when the effluent will overtop the berm.

No follow-up with this facility is anticipated. However, we would recommend that the splash plate on back of the vacuum truck applicator be changed to a spray bar with multiple nozzles in order to provide more even application of effluent. Also the turf reinforcement mats need to be resealed in spots in the primary waste holding pond. The staff gauge in the secondary waste holding pond should to be lengthened in order to define the level at which the contents would actually over top the structure.

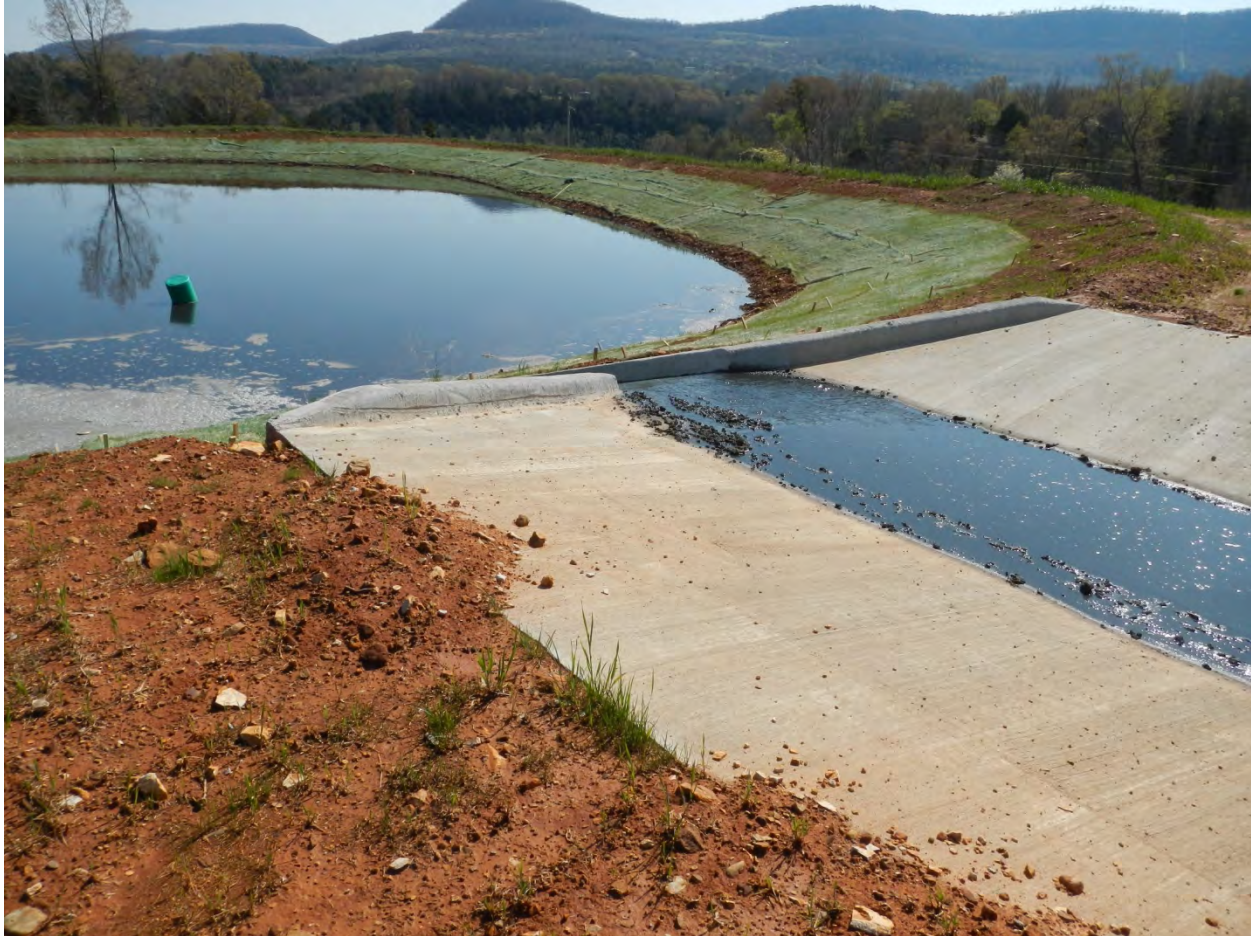
Photo No. 5

Description: View to the northeast of the concrete spillway entering the secondary lagoon and that the barns' flushwater is pumped from the area below the floating blue/green drum.

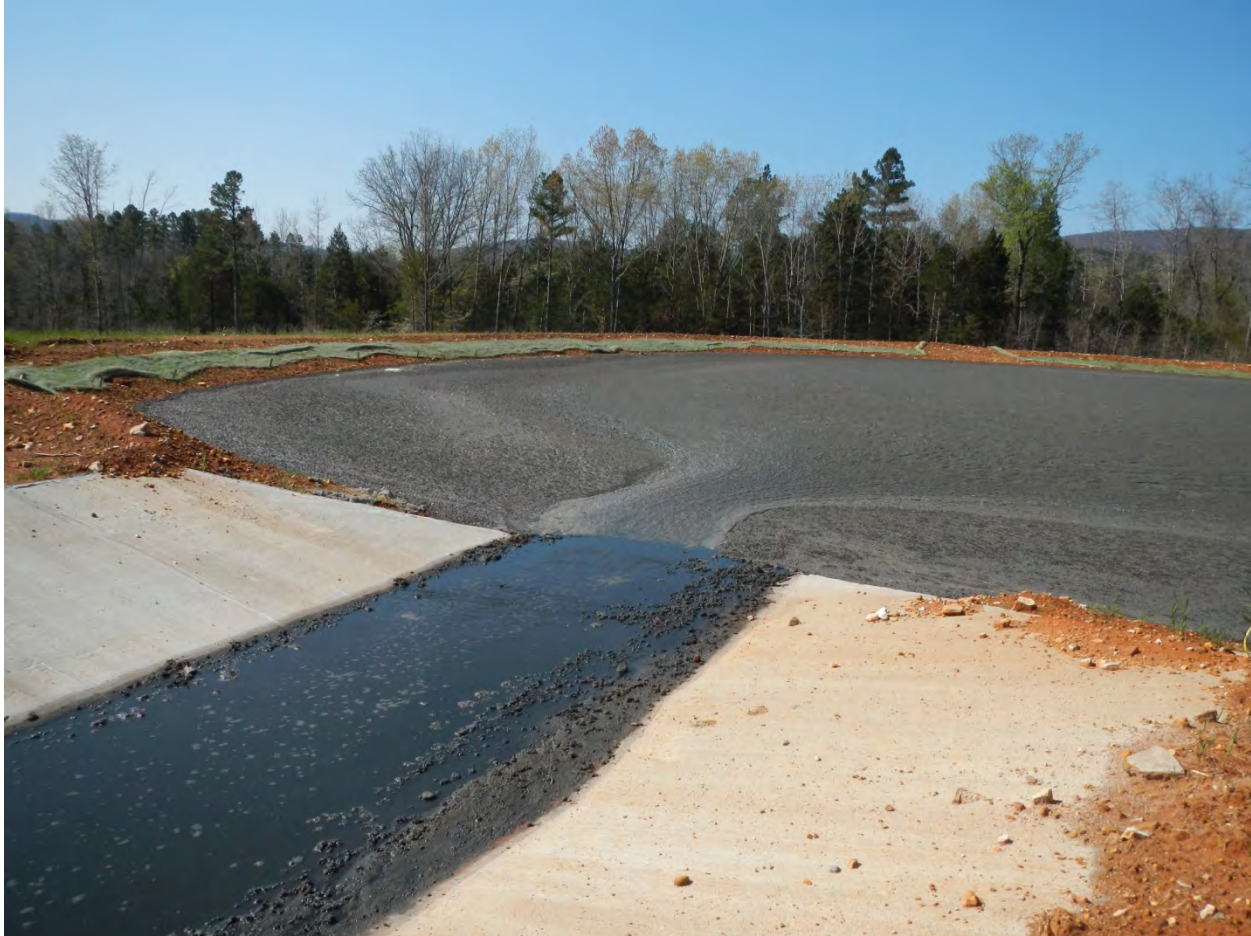
Photo No. 6

Description: View to the south of the primary lagoon and concrete spillway (flow is toward the photographer). The geotextile fabric placed on the primary lagoon's interior berm slopes, for soil stabilization, needs re-anchoring around the perimeter.

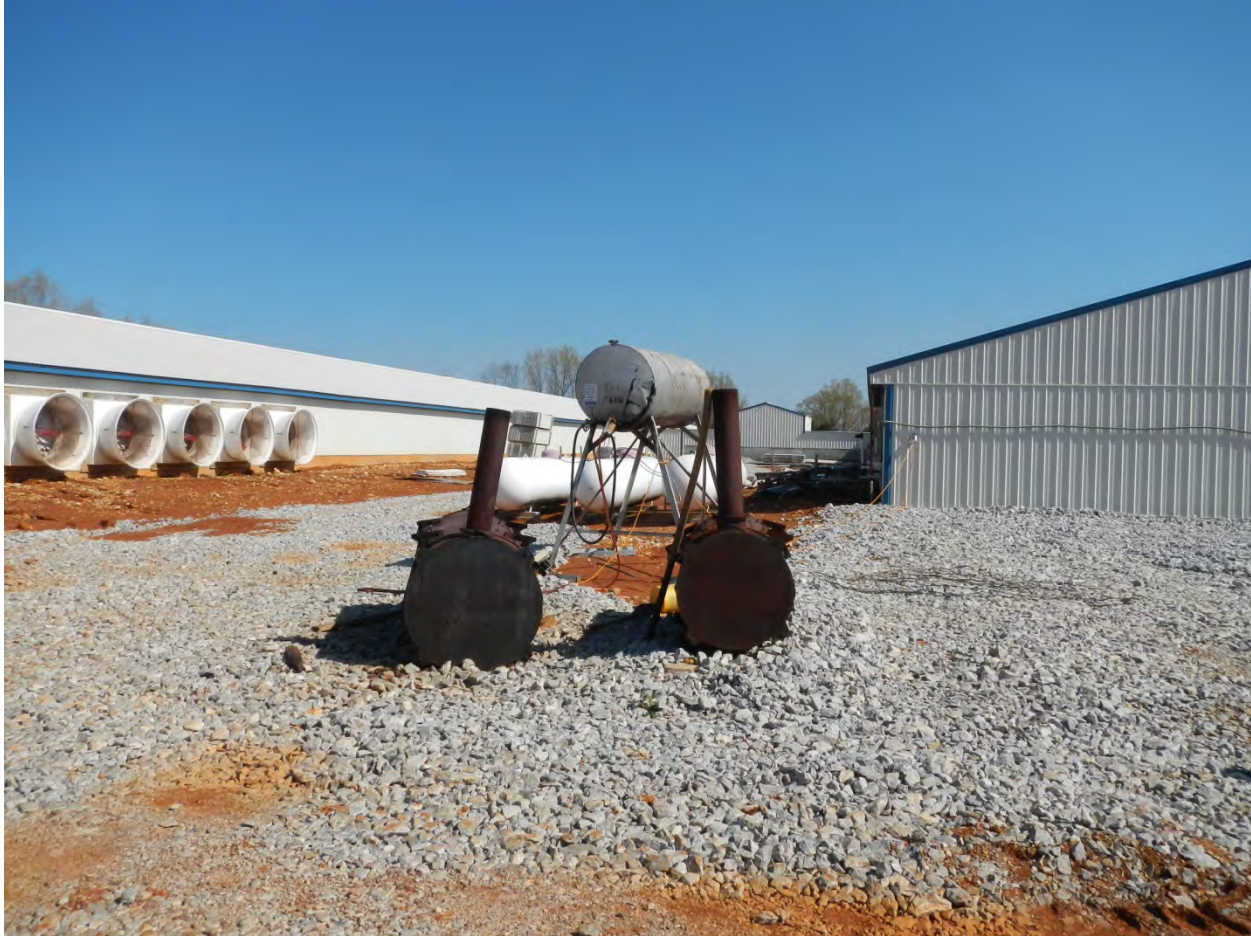
Photo No. 7

Description: View to the north of the two diesel fired incinerators between the south ends of the two barns. There is no evidence that either of the units has had any problems with improperly incinerated mortalities.

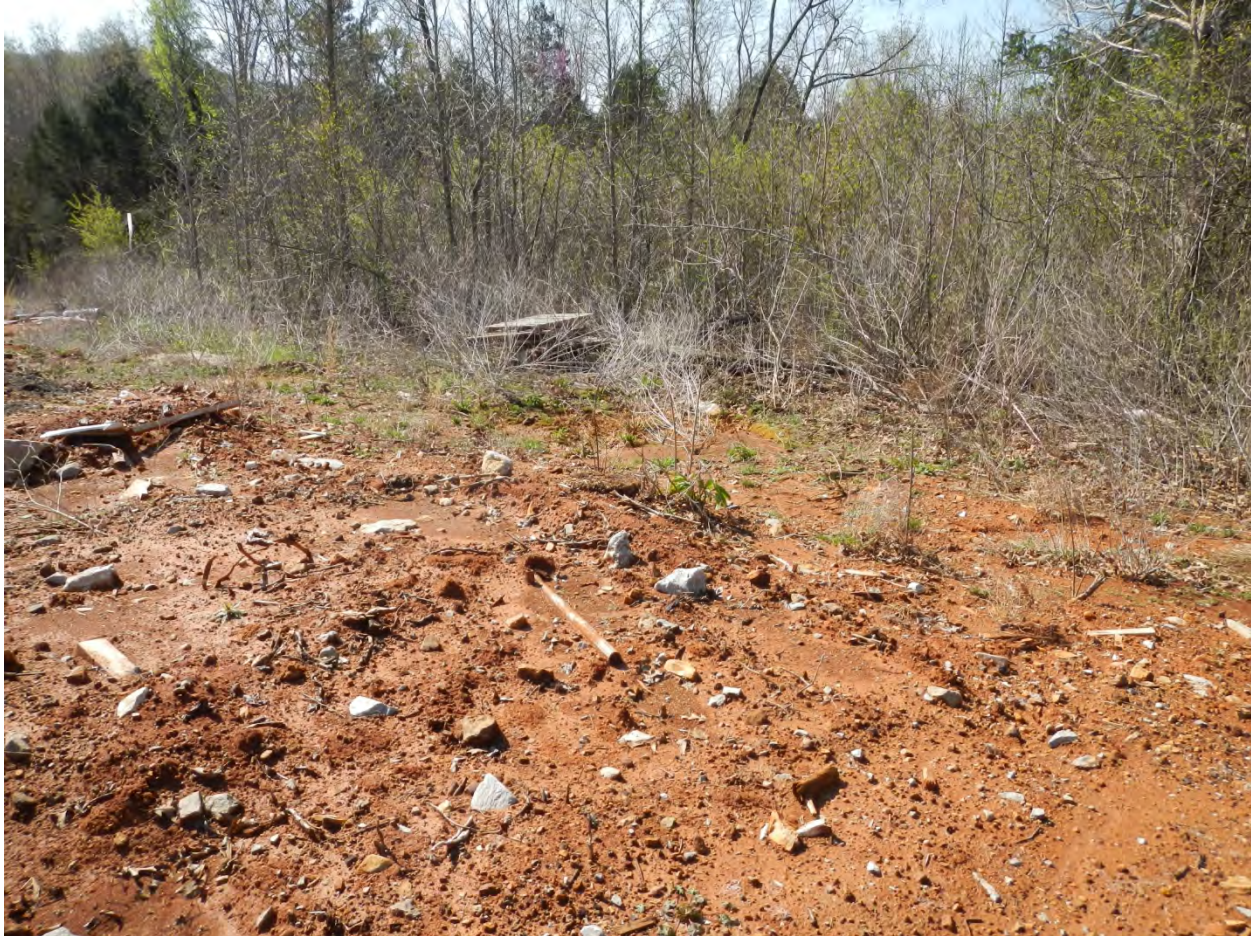
Photo No. 8

Description: View to the southeast of the area where the ashes of incinerated mortalities are buried.

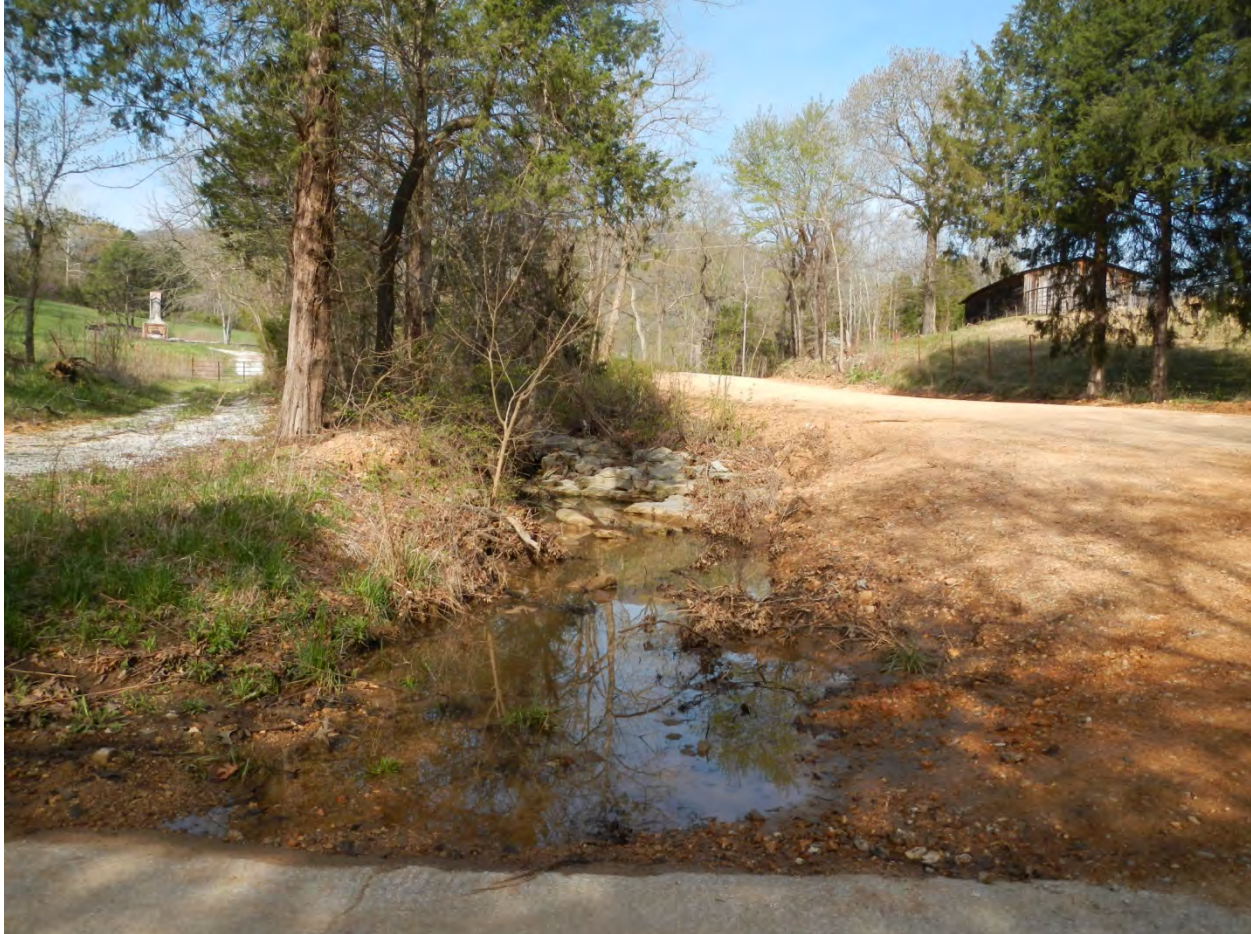
Photo No. 13

Description: View to the west (upstream), where WS-3 was collected (@ 10:03 on 04/16/2014 at which time, water was flowing over the concrete at this low water crossing).

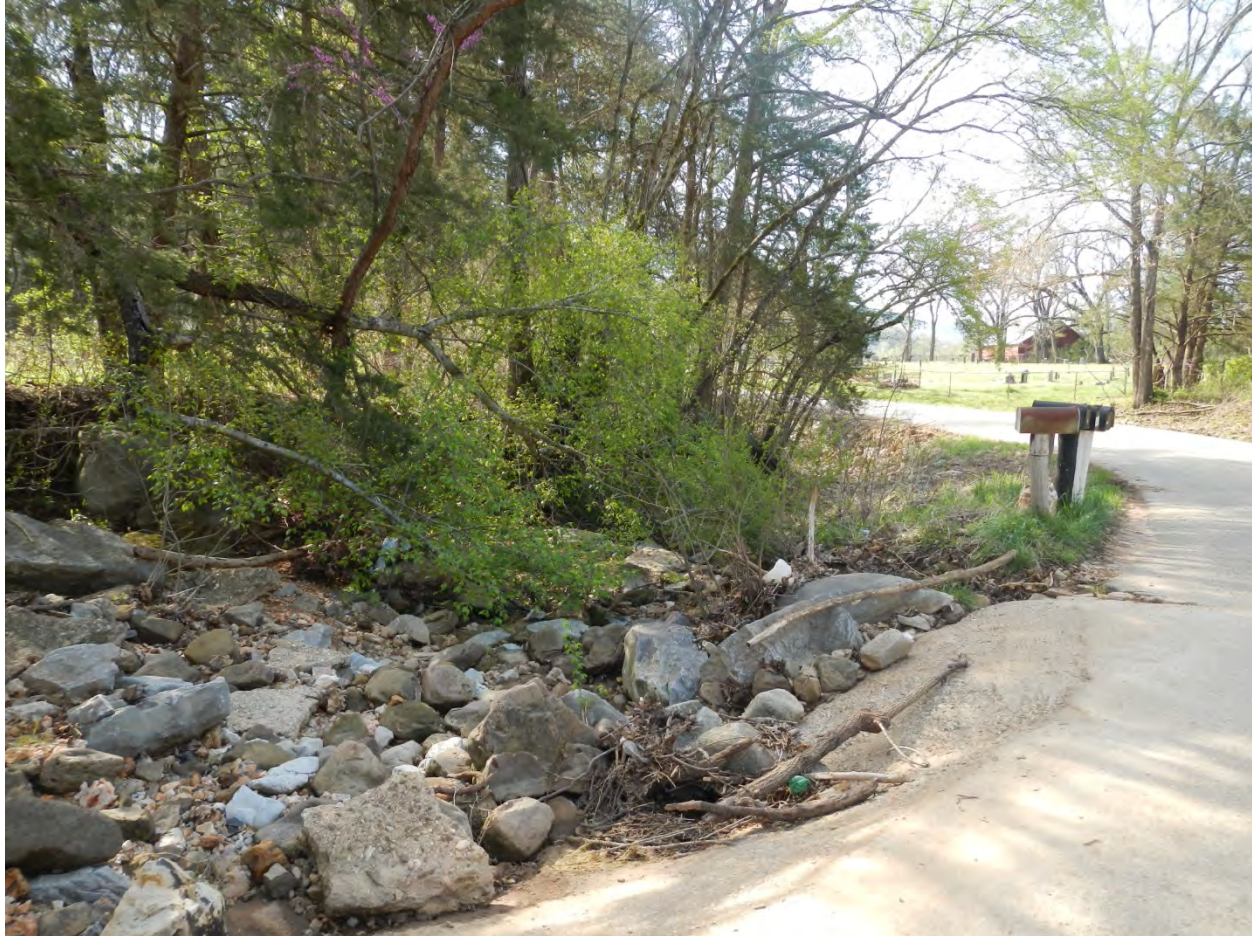
Photo No. 14

Description: View to the southeast (downstream), where WS-3 was collected (@ 10:03 on 04/16/2014 at which time, water was flowing over the concrete at this low water crossing).

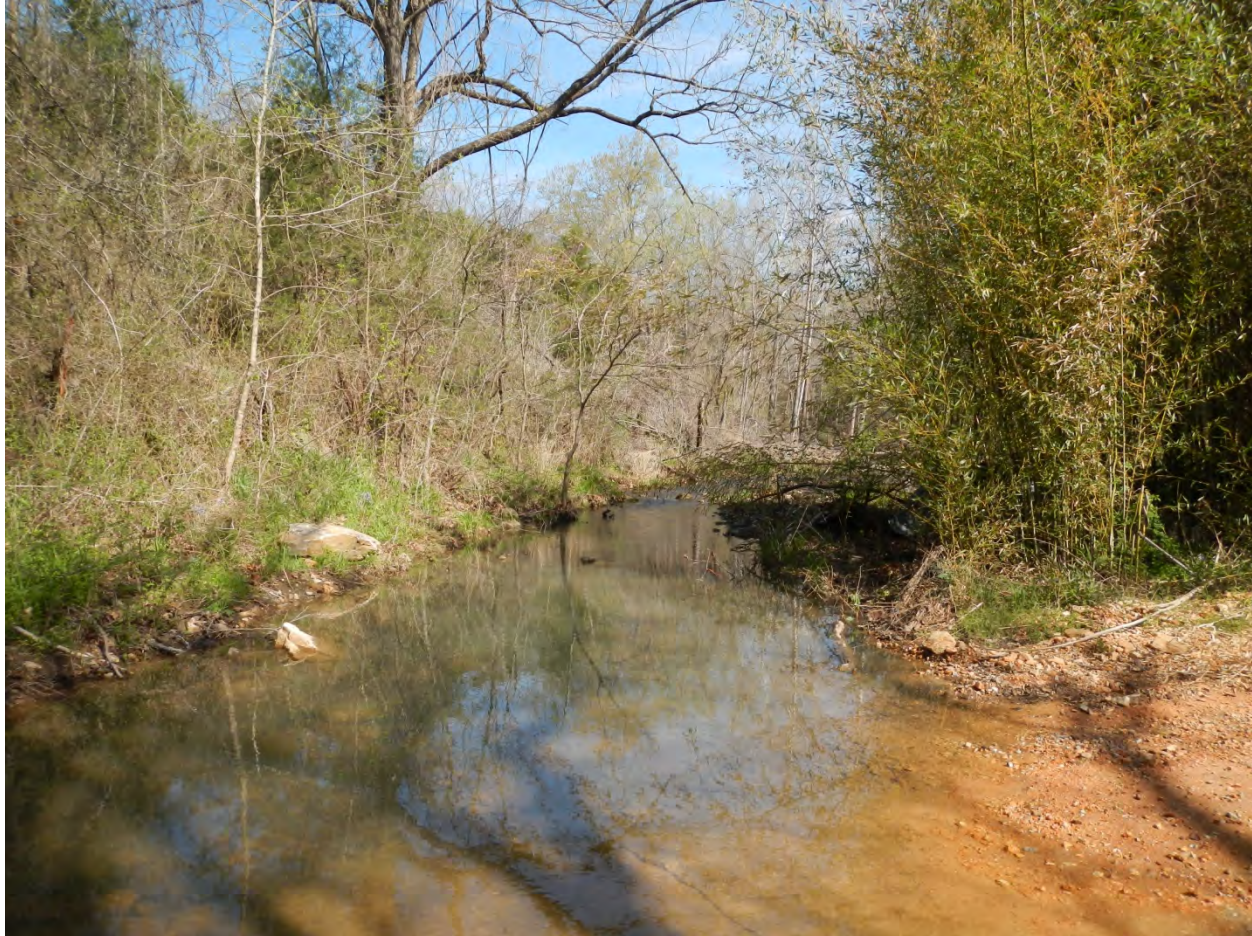
Photo No. 17

Description: View to the northwest (upstream), where WS-5 was collected (@ 10:34 on 04/16/2014).

This is a concrete low water crossing with the photographer standing in the middle of the road.

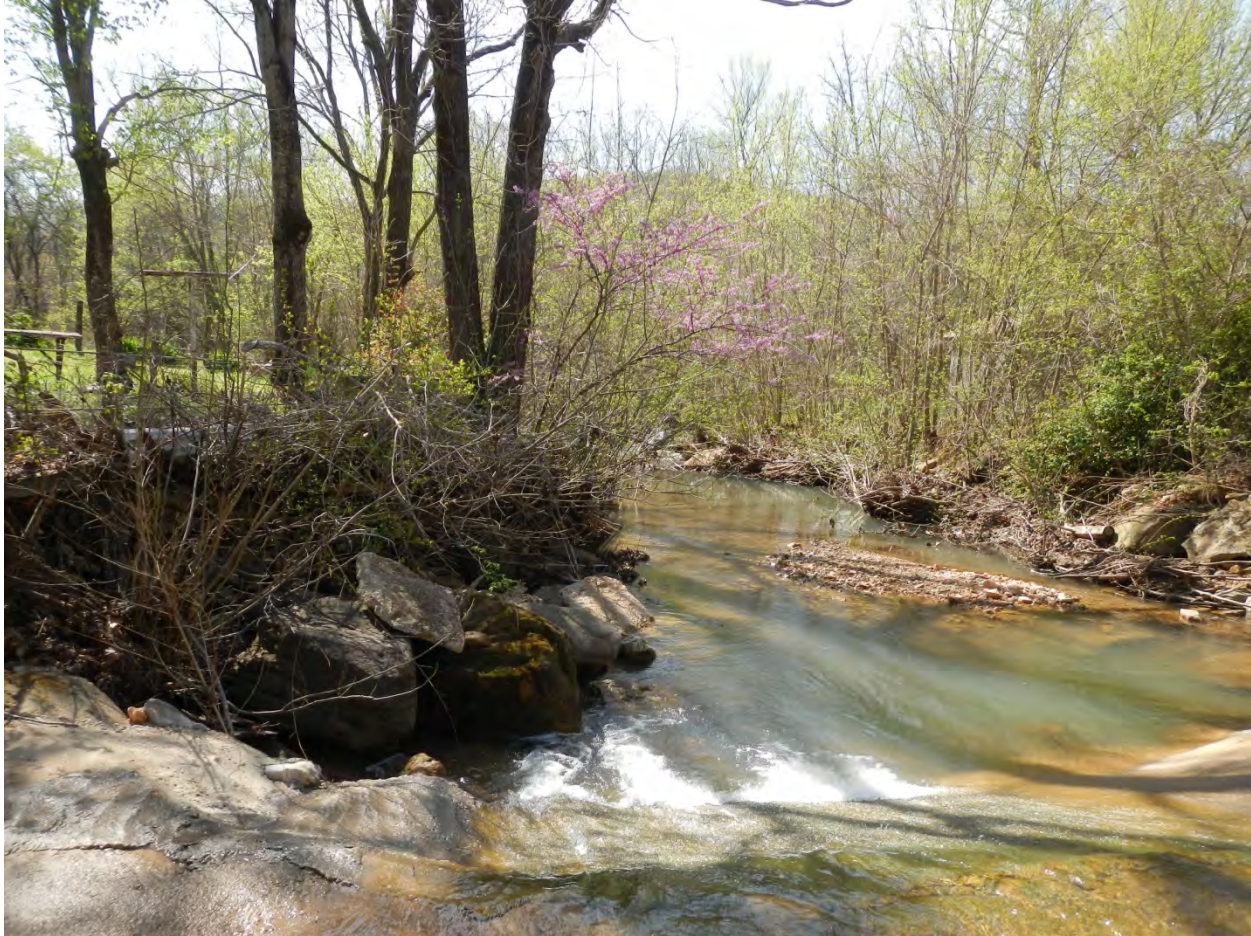
Photo No. 18

Description: View to the east-southeast (downstream), where WS-5 was collected (@ 10:34 on 04/16/2014). You can see the water flowing across the road surface with algae growing on the eastern slope side of the road.
