Why It Is Important to Study Water Flow in Karst in the Area of a Concentrated Animal Feeding Operation, Especially in the Buffalo National River Watershed

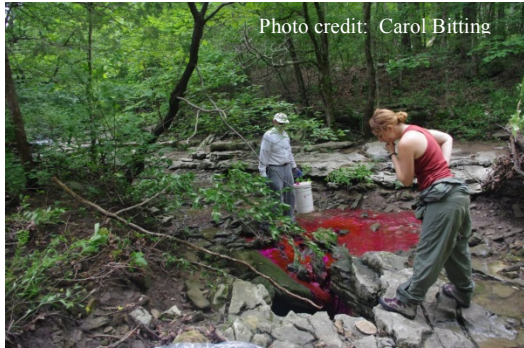
Figure 3. Sinkhole in a tributary stream capturing all streamflow with dye upstream from spreading fields in Ozark National Forest. In karst, surface water and groundwater are one resource, going into sinkholes and coming out springs.

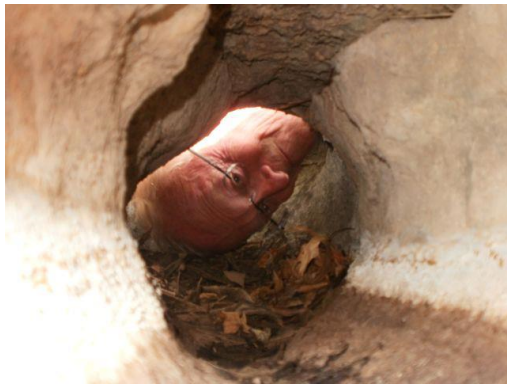
Figure 5. Karst conduit in pure limestone showing stain from sediment and water that moved through this void previously. Because the water can move so fast in karst openings, there is little chance for contaminants to be filtered or attenuated.

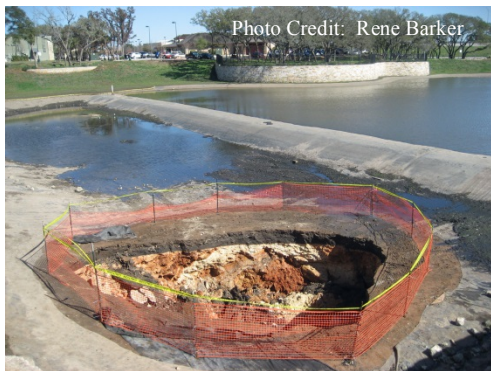
Figure 7. Collapse of a water treatment lagoon in Texas, which was caused by the weight of the overlying water breaching the approximately 1 foot protective seal. Catastrophic collapses in karst are not uncommon.
