**SUBJECT:** 2017 Buffalo River Nuisance Algae Report

## 2017 Buffalo River Nuisance Algae Report

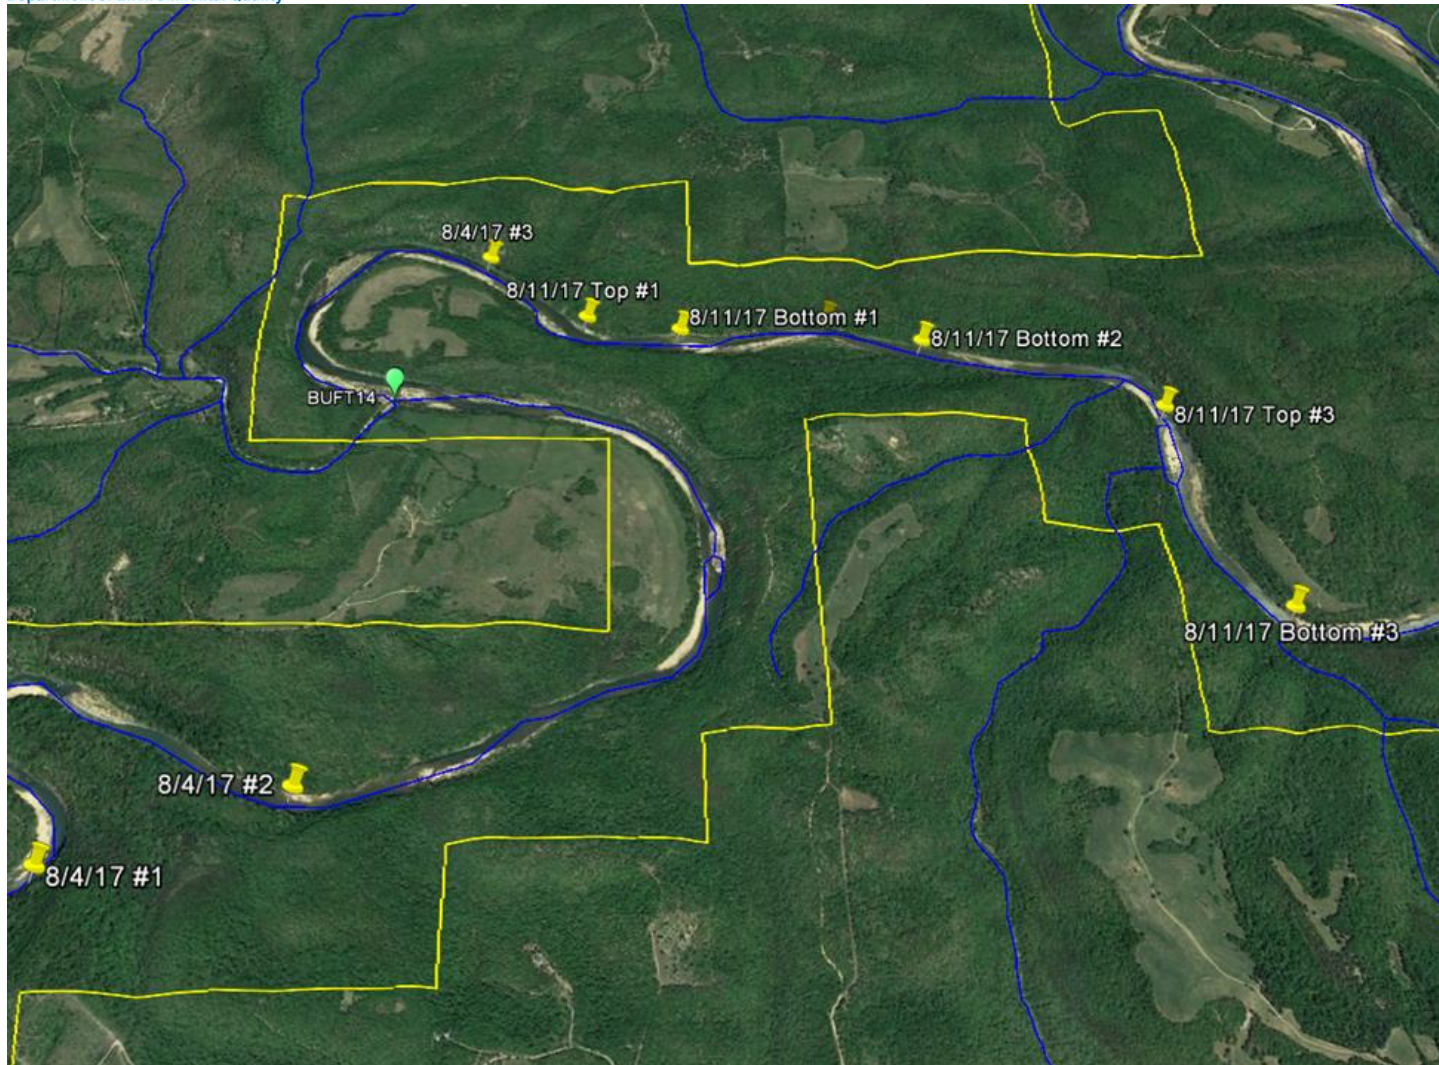
Figure 1. Locations of complainant observed events (August 4, 2017) and those observed by ADEQ and NPS on 11 August 2017.

The ADEQ Nuisance Algae Complaint tool received two notifications of nuisance algae blooms on the Buffalo River near Sand Hole which were observed on August 4, 2017 (Figure 1). Complaints were received by Ms. Jessie Green and Mrs. Carol Bitting on August 6, 2017 and August 7, 2017, respectively. ADEQ Office of Water Quality Planning Branch investigated the reported occurrence of the lower event approximately 1 mile below Tomahawk Creek confluence. Planning Branch representatives were Mandy Bates and Tate Wentz. National Park Service staff Shawn Hodges and Ashley Rodman assisted Planning in accessing and measuring extent of the events. Three separate locations were reported to ADEQ (Figure 1) and spanned approximately 4.5 miles, starting downstream of the confluence of Brush Creek and terminating 1 mile downstream of Tomahawk Creek confluence. Further discussion with complainants indicated that the lower event near Rocky Hollow was significantly larger than the other two.

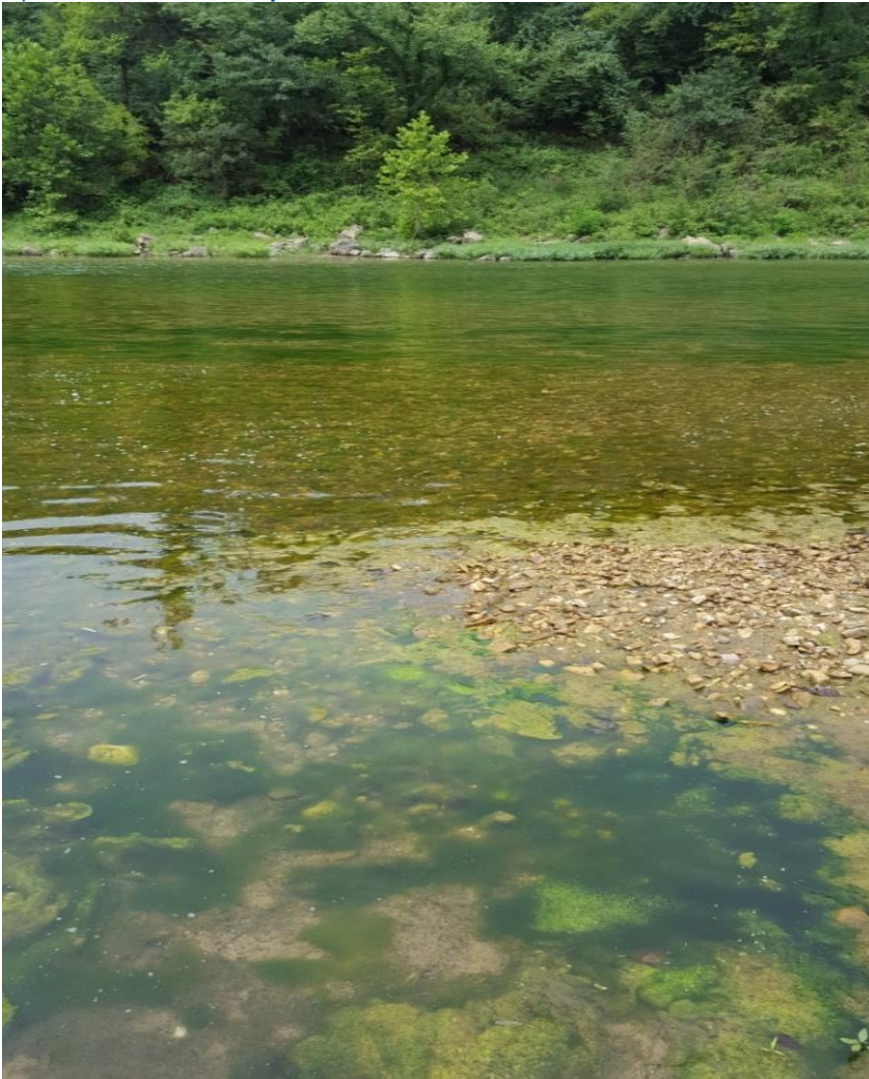
Figure 2. Presence of gelatinous algae within pool margins.

Bloom 1 began approximately 1 mile downstream of Tomahawk Creek confluence and extended unabated through a pool-glide complex for 555 meters. Average pool depth was 1.5 meters. Average in-situ parameters for bloom 1 were 9.16 mg/L dissolved oxygen, 114.3 % saturation, 230.5  $\mu\text{S}/\text{cm}$ , 27.1°C, and 7.67 pH. Algae observed in the pool were loose, unattached, and gelatinous forms ranging in color from dark to neon green (Figure 2). Algae present in shallow, higher velocity habitat were more filamentous, developed long strands, and were attached to the substrate (Figures 3-4).

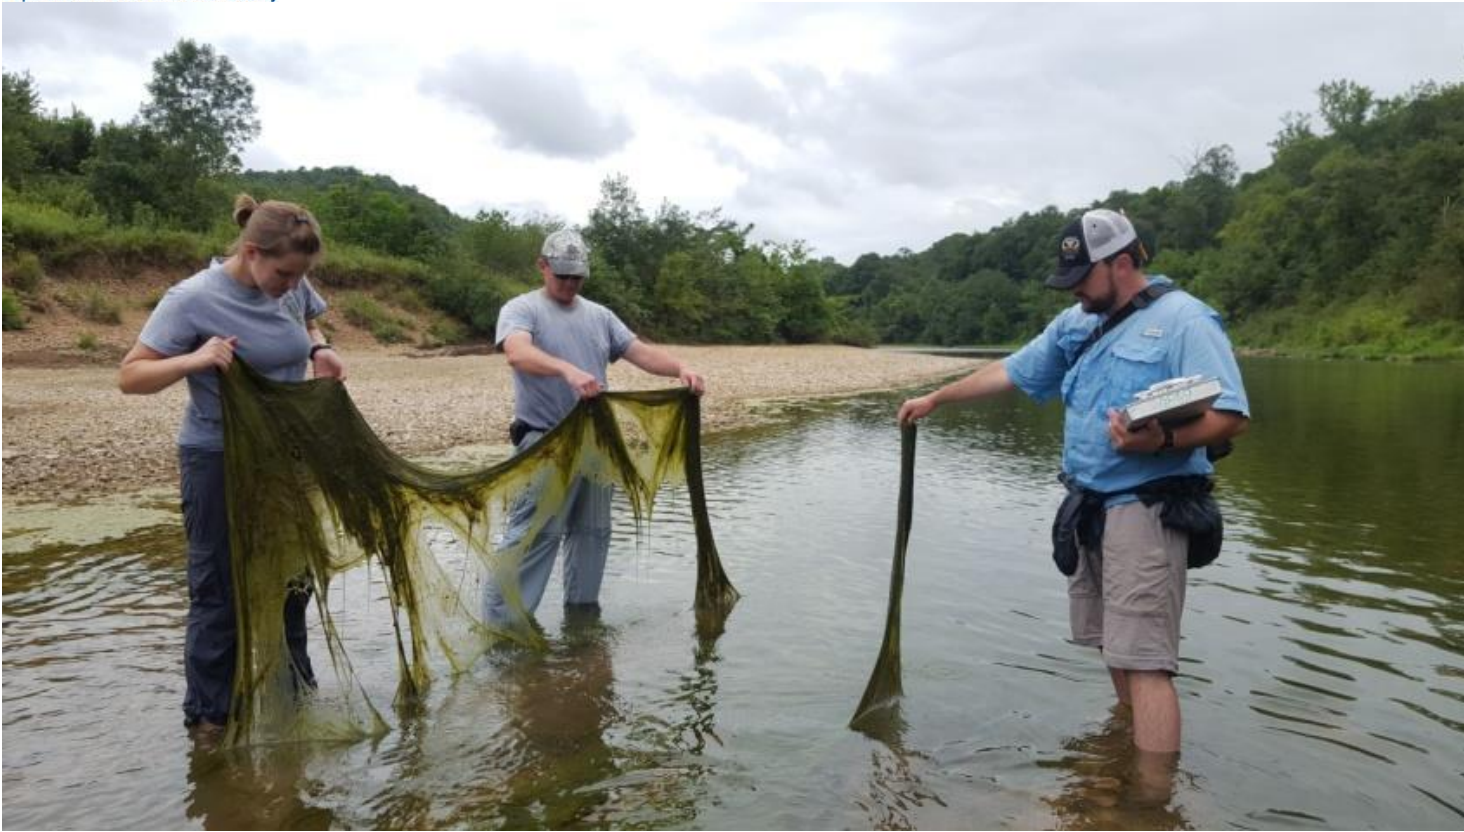
Figure 3. Long filamentous algae present at bloom 3.

Bloom 3 was the most extensive in terms of coverage, density, and habitats. Bloom length was approximately 930 meters and began almost 1 kilometer downstream from bloom 2. Average in-situ readings were 10.3 mg/L dissolved oxygen, 130.5 % saturation, 228  $\mu\text{S}/\text{cm}$ , 27.5 °C, and 7.76 pH.

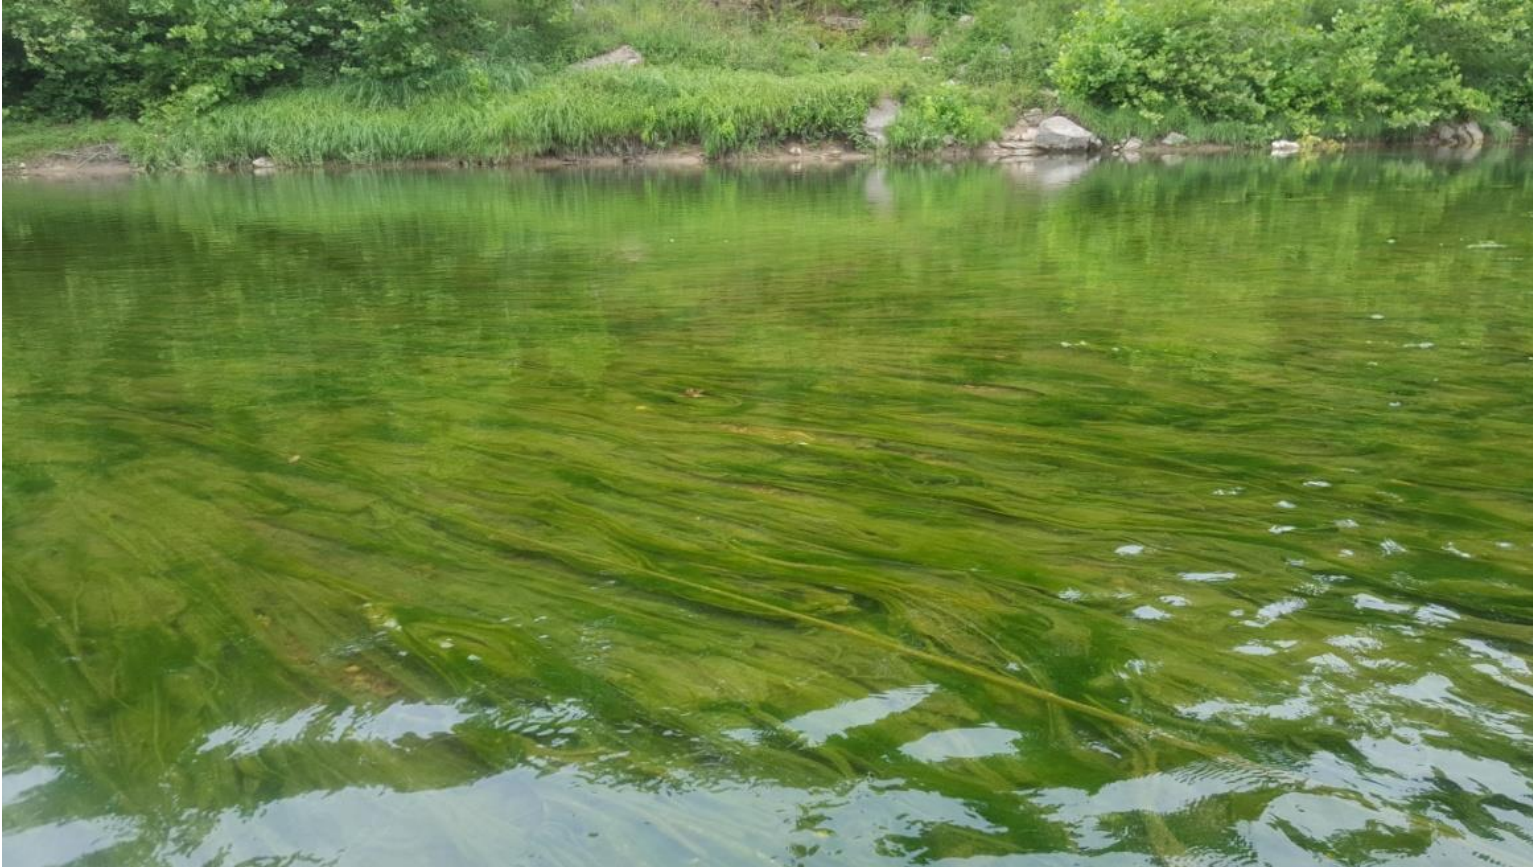
Figure 4. Long filamentous algae across wetted width at bloom 3.

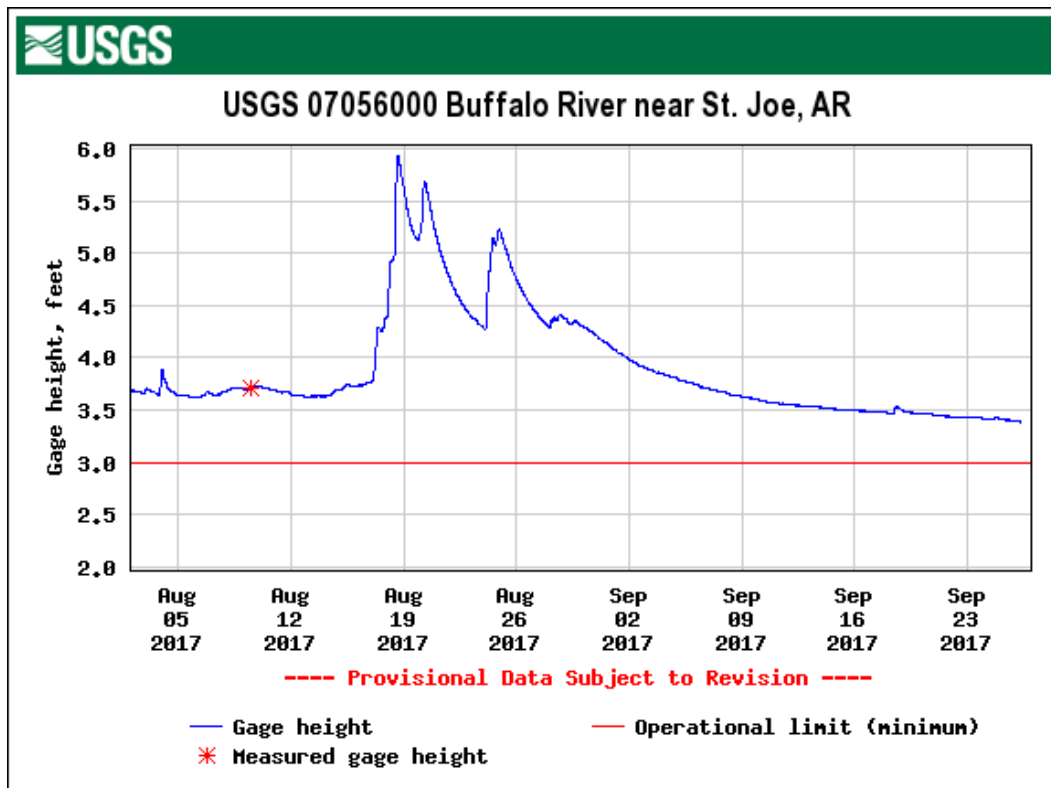
Figure 5. Measured gage height for the Buffalo River near St. Joe, Arkansas.

Flow conditions were evaluated from the USGS 07056000 Buffalo River gage near St. Joe. On the day of the investigation, gage height (feet) was 3.6 ft (Figure 5).

Heavy rains fell for several day throughout the watershed. The Buffalo River near St. Joe rose approximately 2.5' (Figure 5).

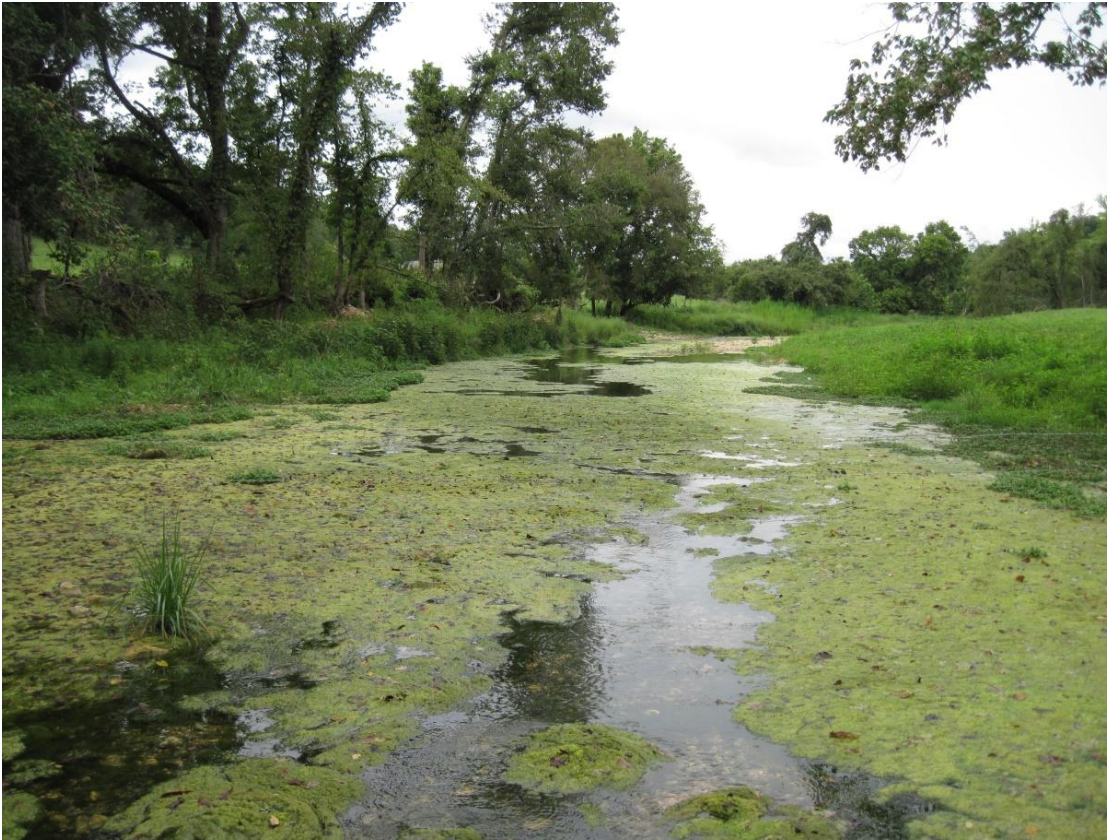
Figure 6. Brush Creek on August 24, 2017 upstream of Searcy County Road 416.

Algae reported in isolated pools of Brush Creek by NPS staff (Figure 6). The river crested, but visibility is poor to evaluate whether a scour occurred.

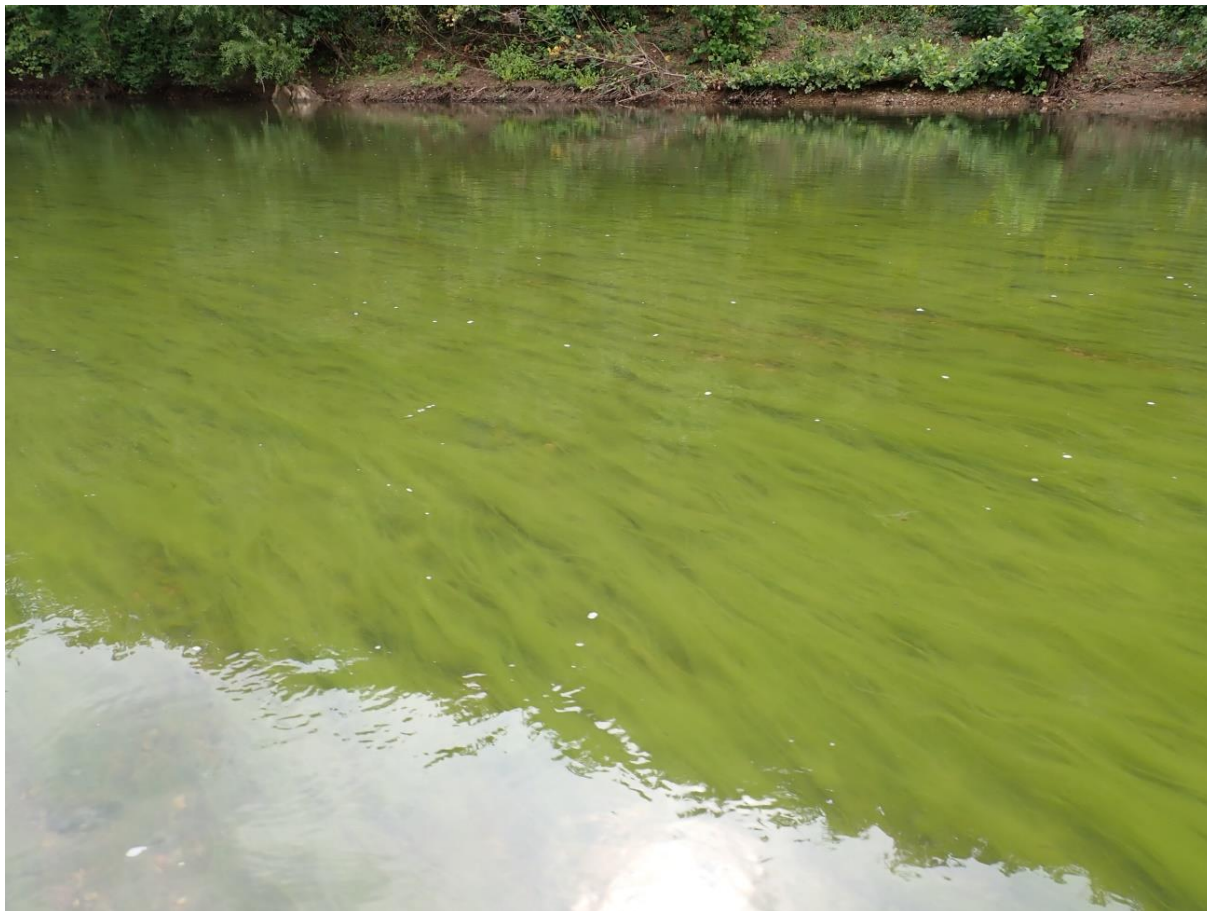
Figure 7. Long filamentous algae coverage observed in the Lower Wilderness Area by NPS staff on August 29, 2017.

NPS staff reported to ADEQ that no major algae coverage was observed at Highway 14 (Dillard's Ferry) as of August 29, 2017. Algal blooms were observed on August 28, 2017 within the Lower Wilderness Area and on August 30, 2017 above Highway 65 near Mt. Hersey (Figure 7-8). Bloom coverage was not included with the NPS observation.

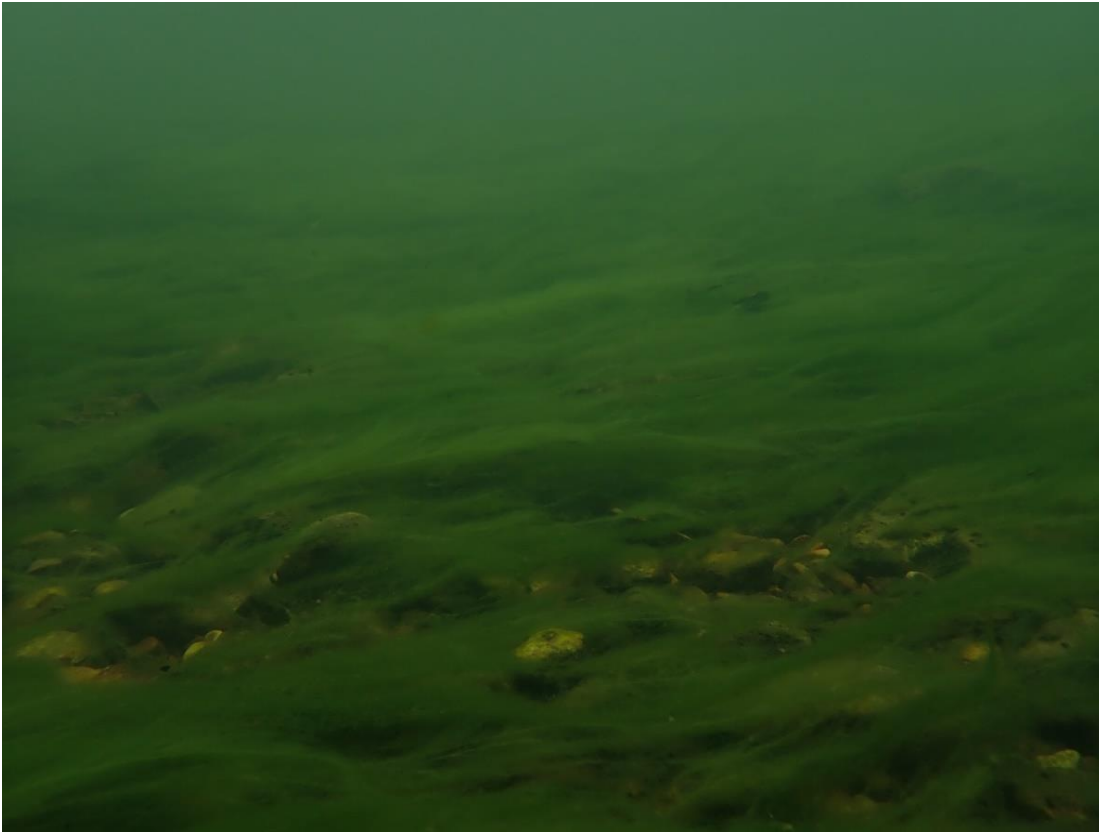
Figure 8. Underwater photo of attached algae at NPS reported bloom at Mt. Hersey on August 30, 2017.

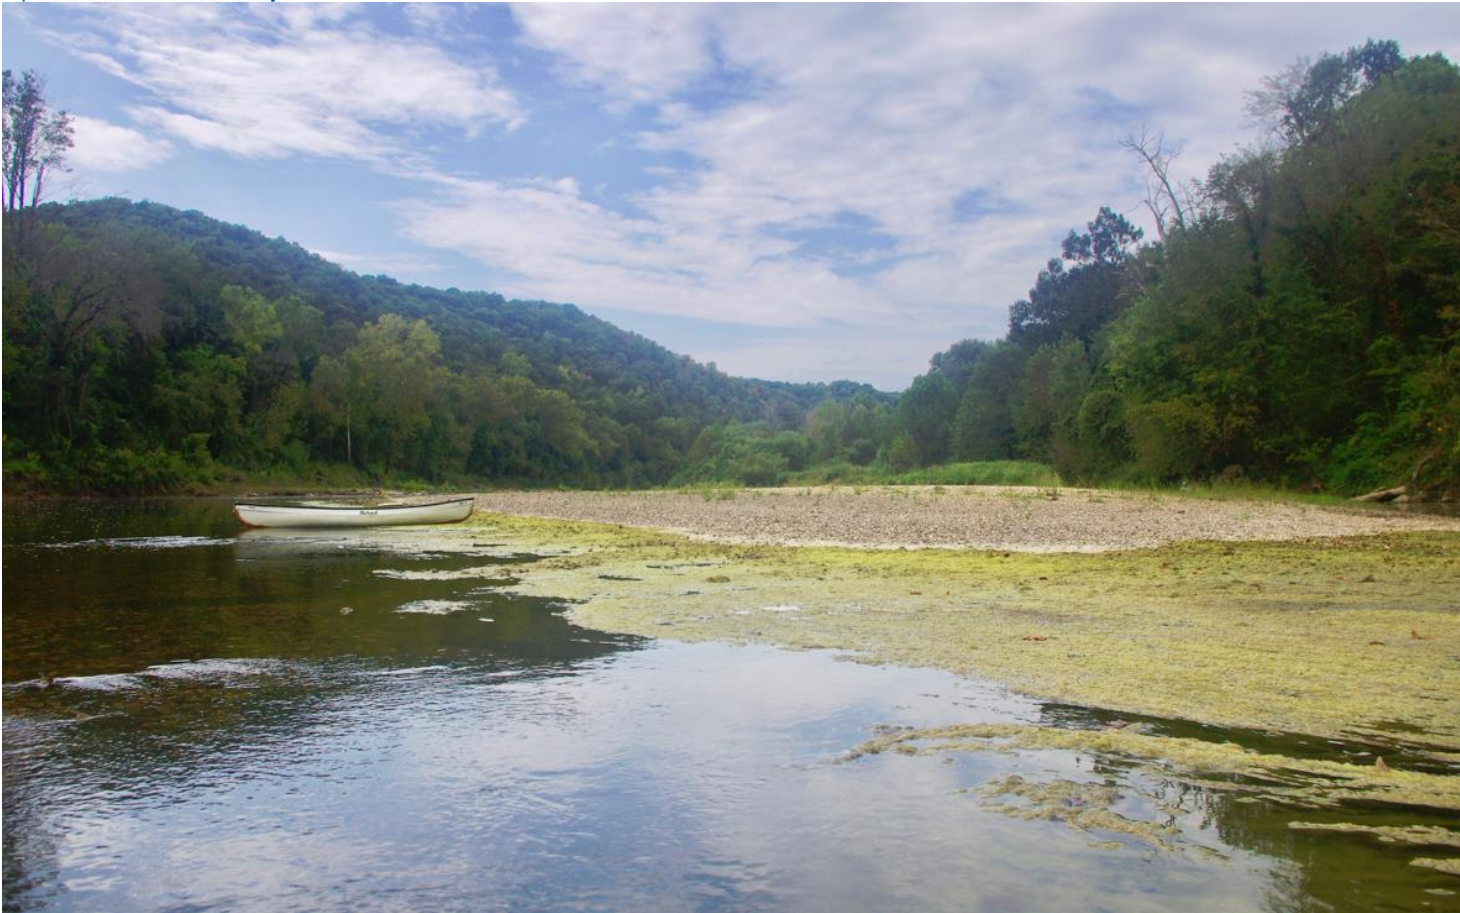
Figure 9. Photo taken on September 19, 2017 just downstream of the Gilbert access and submitted by complainant on September 20, 2017.

Ms. Carol Bitting submitted a complaint and photos from the 11.5 mile portion of the Buffalo River from Gilbert to North Maumee and "algae was continuous through the trip" (Figure 9). Correspondence with NPS staff observed less algal coverage in the area of Sand Hole, which was a previously submitted bloom on August 14, 2017. Verbal correspondence with NPS and USGS staff did indicate increased coverage in pools above Highway 65 in the vicinity of Mt. Hersey.
