Re: *In the Matter of C&H Hog Farms* - Docket No. 18-001-P

Motion to Intervene and Request for Hearing of Buffalo River  
Watershed Alliance, Arkansas Canoe Club, Gordon Watkins and  
Marti Olesen

MOTION TO INTERVENE AND REQUEST FOR HEARING  
BY BRWA-ACC INTERVENORS,  
AND  
MOTION TO DISMISS C&H HOG FARMS'S REQUEST FOR HEARING

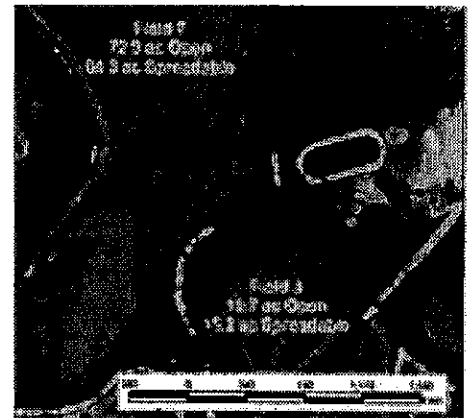
The fields appear to be outside the 500 ft range of buildings as Reg 5 requires, however they are well within 400 feet of school property and the athletic track where children will be present.

Field 7 distance is 314 ft.

Field 3 distance is 389 ft

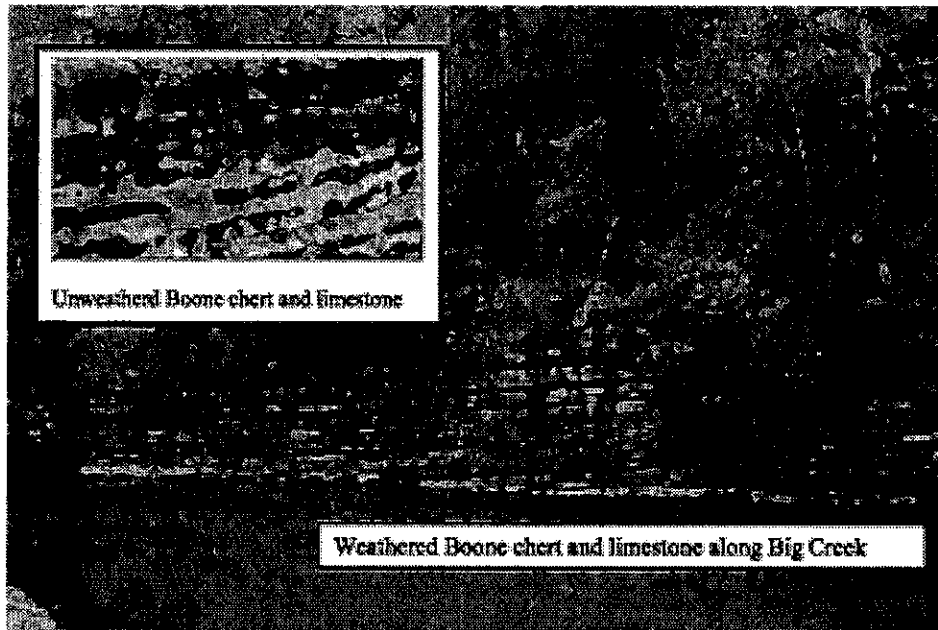
C&H and the spreading fields are located in what is widely and scientifically accepted as a significant karst environment. The presence of karst is not subjective, but obvious to the casual observer from the weathered dissolution features in exposed formations throughout the Mt. Judea area.

For more in depth discussions and references to studies in regard to dye tracing, hydraulic subsurface flows relative to storm events, and evidence of karst see Comments: E2, C2, C11, C12. See also Mott, 2016 which states, "The waste storage ponds and land application sites are predominantly underlain by the Boone Formation; therefore, karst geohydrology." Further, a report titled "Surface-Water Quality In The Buffalo National River, 1985-2011" by the Watershed Conservation Resource Center, 2017 states:

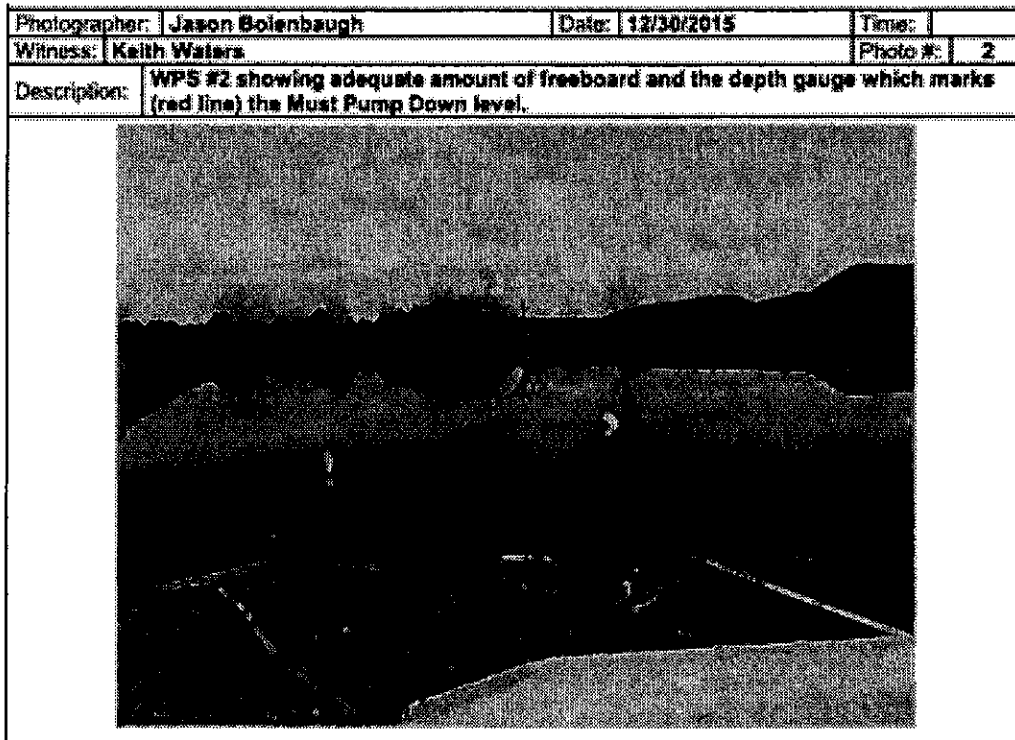
The far side is the top of the 10% slope mentioned that has no stabilized emergency outlet.

Assumptions that overtopping will never occur is an example of how the engineering of the storage ponds was not proportional to the risks as discussed in Part A.

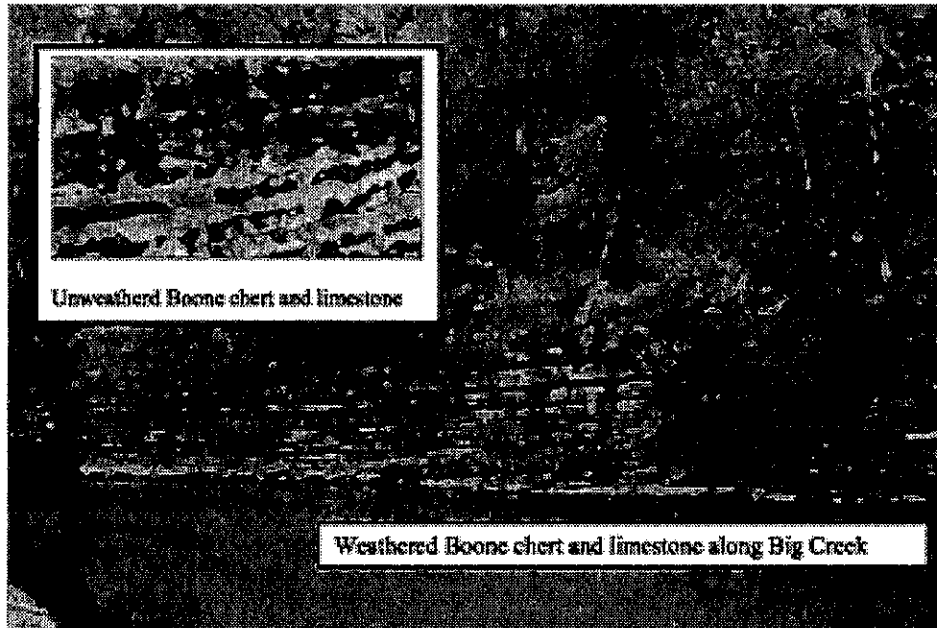
typical fractures in the Boone formation that would not easily be detected by a driller are illustrated in this cross section photo.

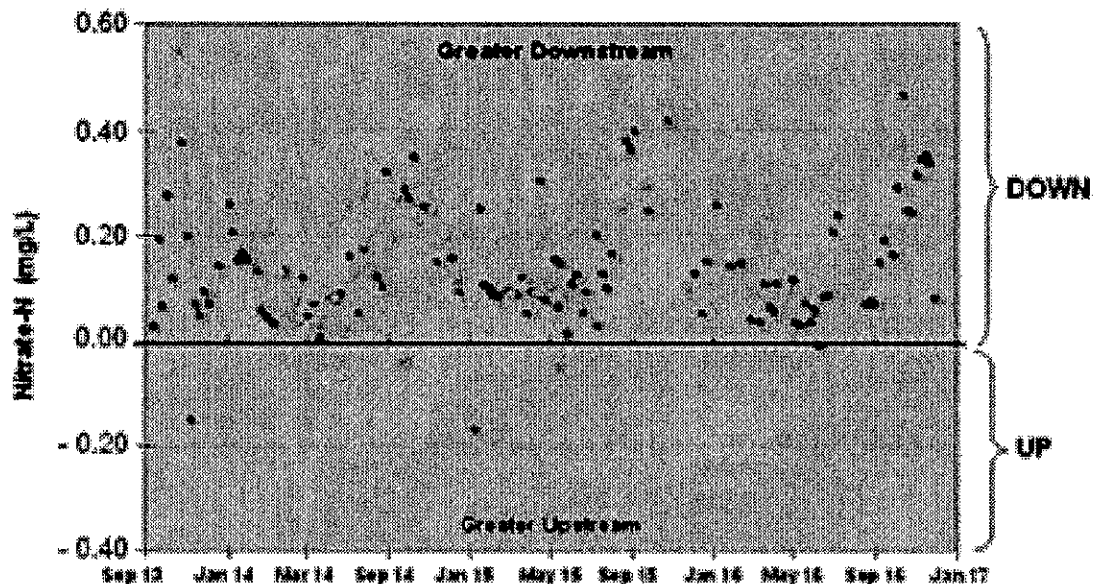
Nitrates are being measured by the *Big Creek Research and Extension Team* (BCRET) of the *University of Arkansas Division of Agriculture* both upstream and downstream of the facility and nearby spreading fields Figure 1.

**Figure 1.** Difference in  $\text{NO}_3\text{N}$  concentration in Big Creek up- and downstream from the C&H CAFO. Following the “upstream vs. downstream” comparative criterion that is the basis of the BCRET study, the data clearly indicate that the C&H CAFO is contaminating Big Creek with nitrate. From BCRET (2017a; note that explanation was not given for the yellow versus red color-coding).

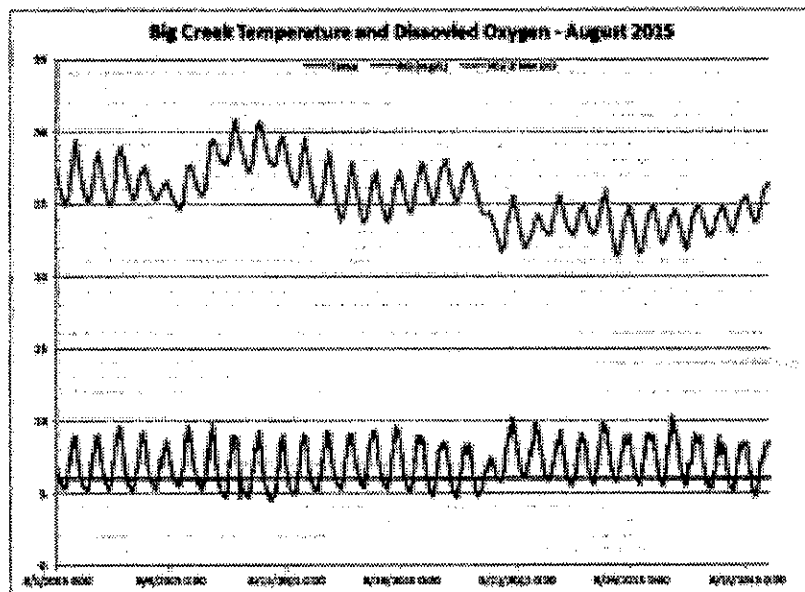
**Figure 3: Dissolved Oxygen data for Big Creek (BUFT06) during August of 2015. (Source: USGS)**

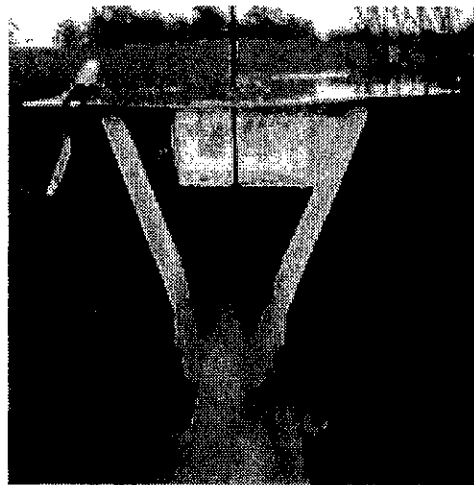
The waste holding ponds were designed and constructed to permit waste leakage to Waters of the State. The final design documents estimate leakage rates of 1,090 gallons per acre per day for Pond 1 and 1,334 gallons per acre per day for Pond No. 2. Pond 2 is also designed to permit a discharge in the event of a large (25 year 24 hour) precipitation event (“the storm volume is only encroached during a 25 year 24 hour storm event.”). C&H NMP at p. 14. The recent “Drilling Report” concludes that the waste ponds sit atop karst features. Karst features provide a mechanism for rapid transport of wastes that leak from the ponds to ground and surface waters.

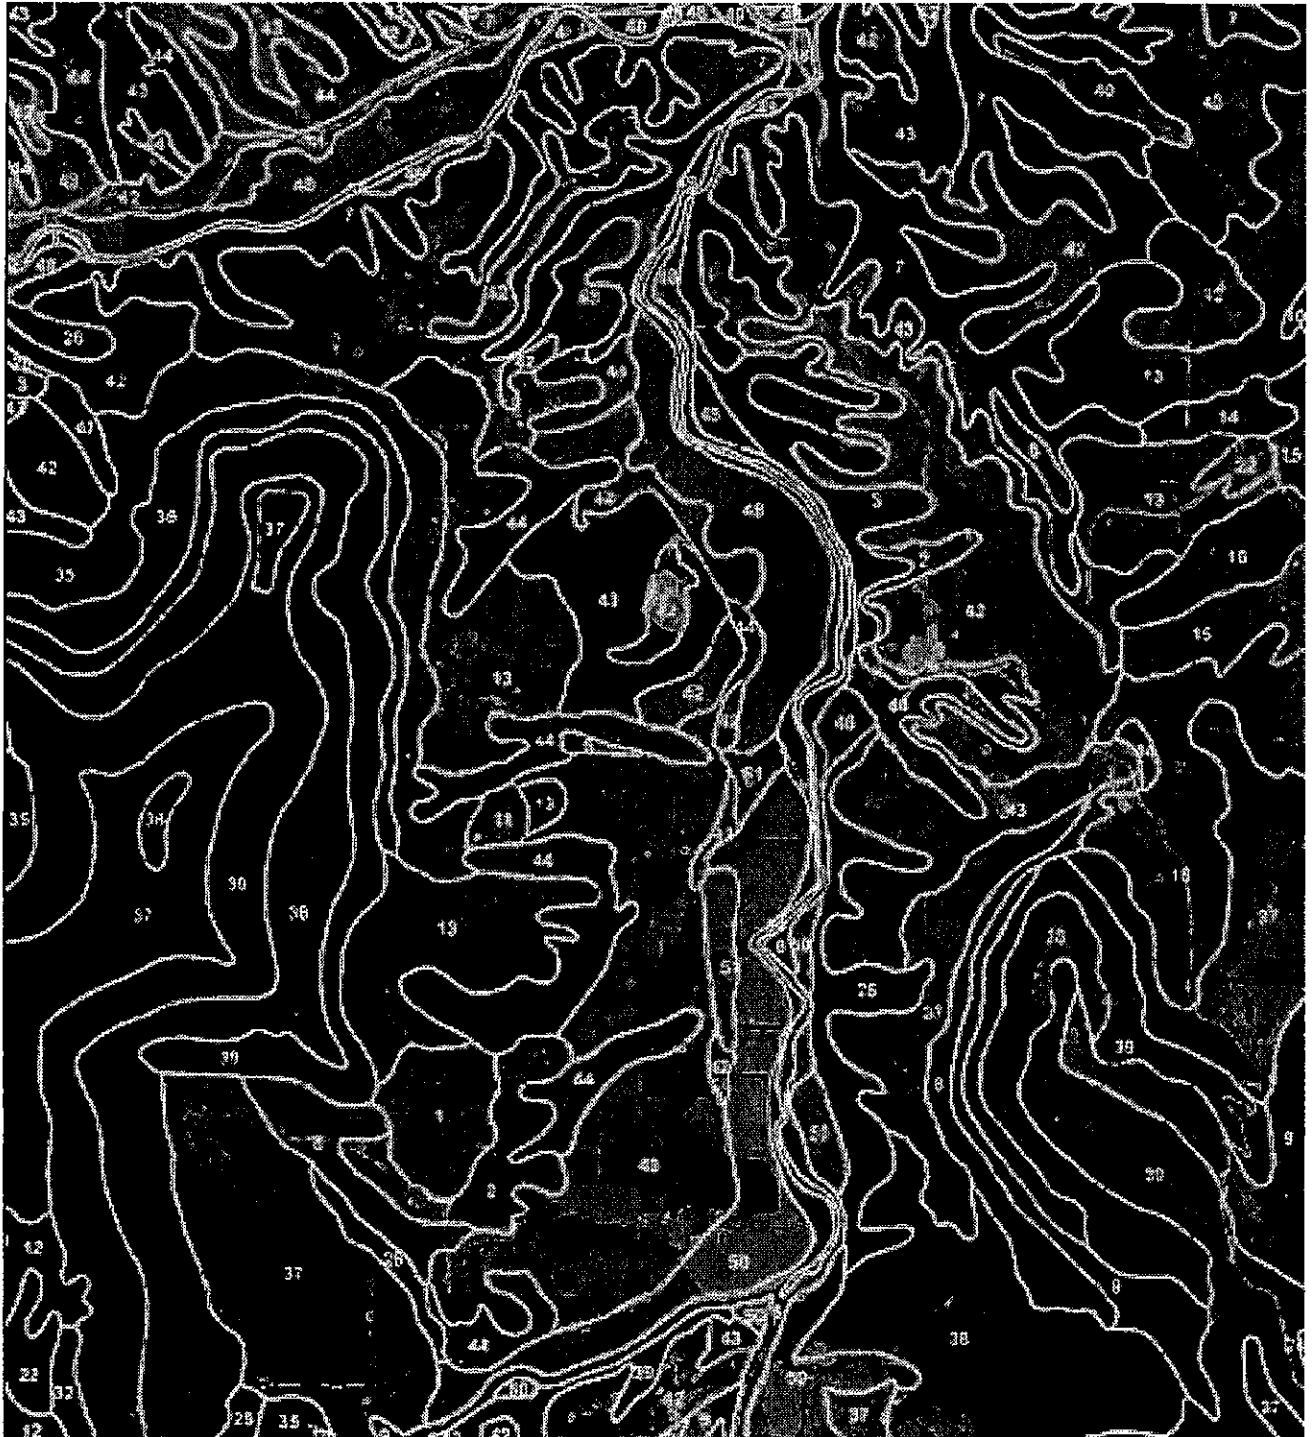
Appendix B2 - Soil types, flood plains 1 of 3

Map of soil types:

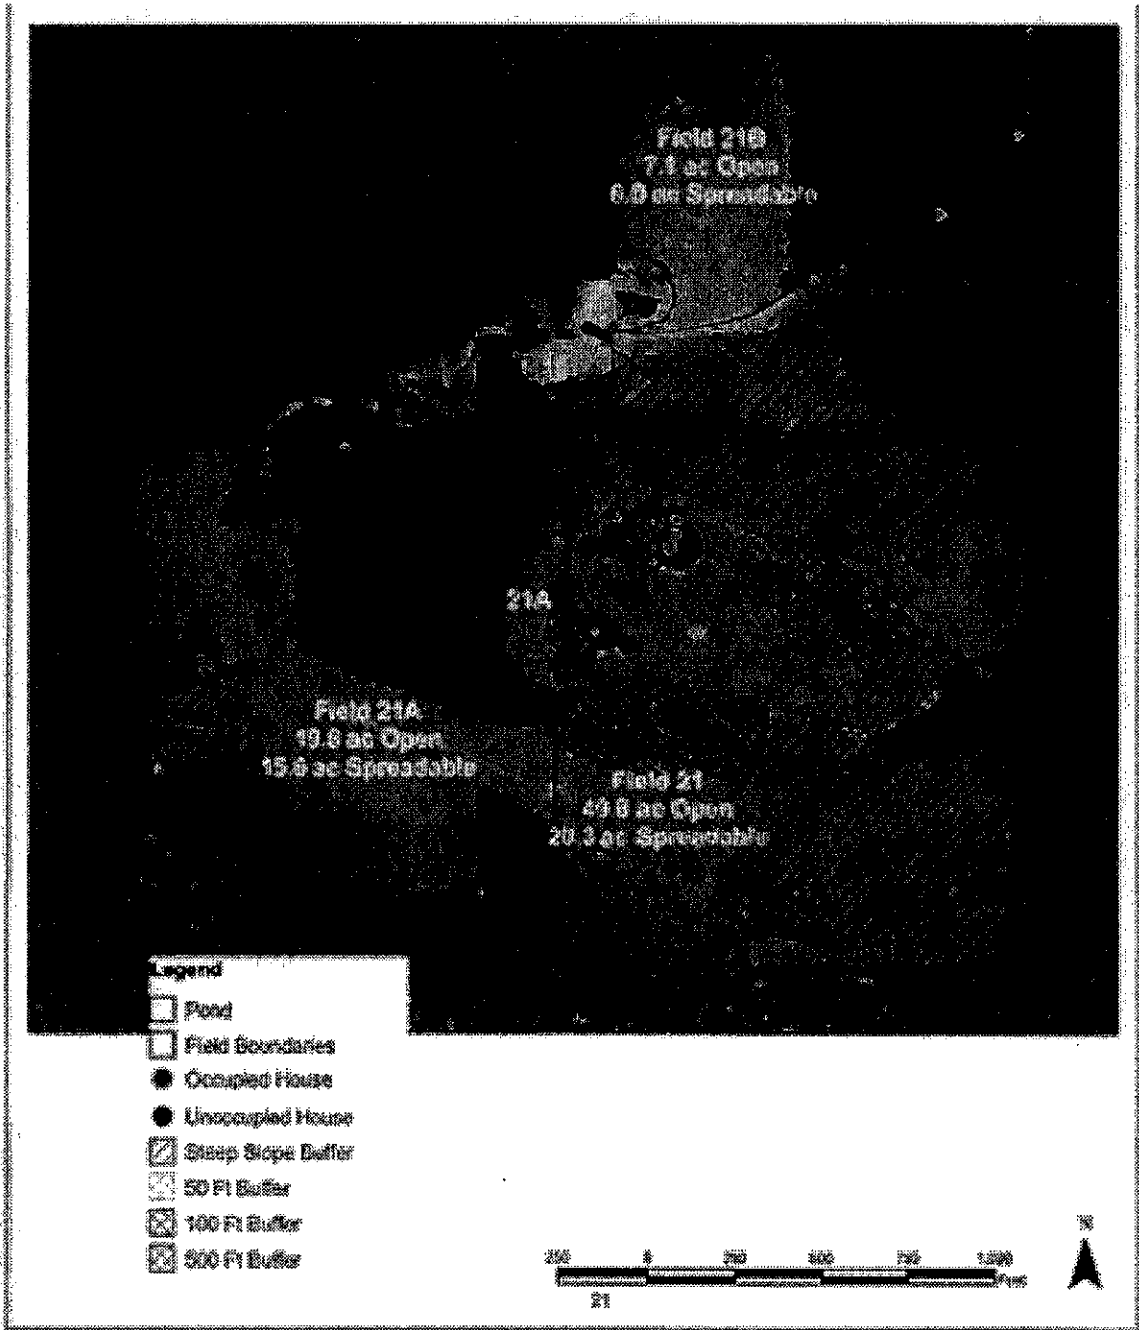
FIGURE 1 EXAMPLE OF A FIELD 21A, WHICH IS CONTORTED AND INAPPROPRIATE FOR WASTE APPLICATION

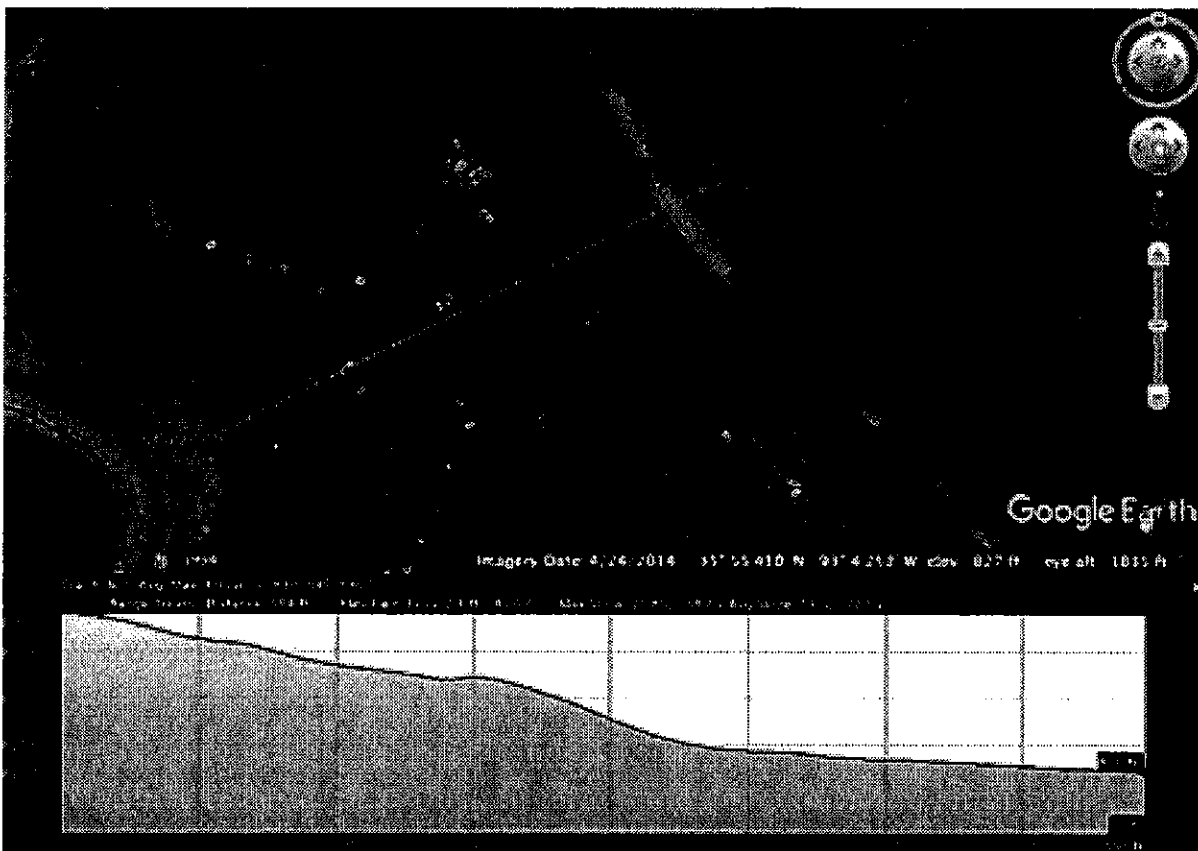
Hand dug well with distance and gradient:

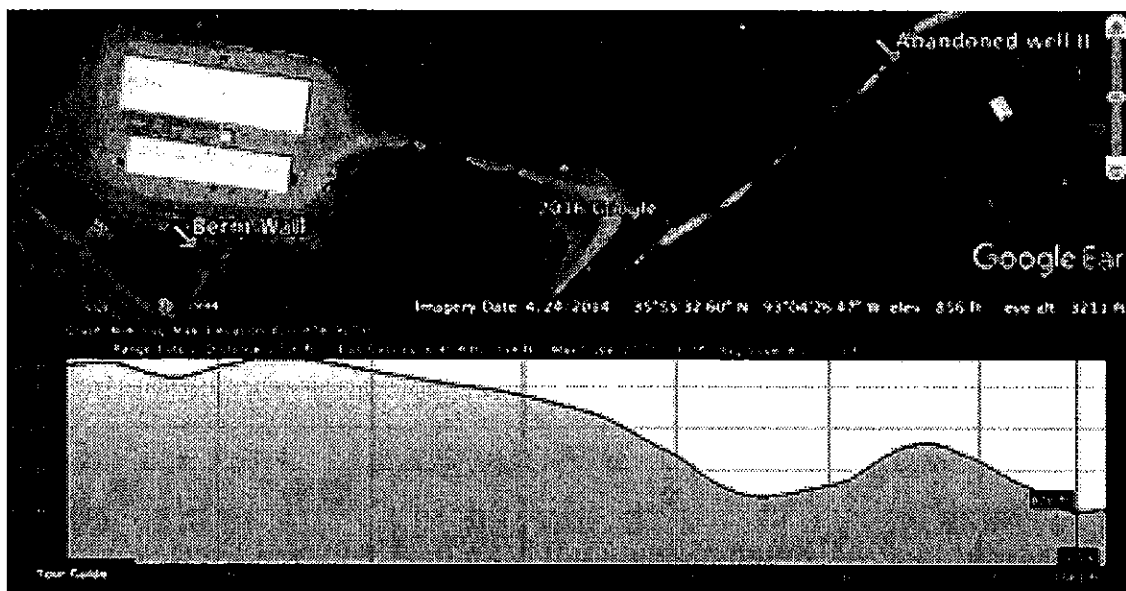
B39 - Wheeler well with distance and gradient:

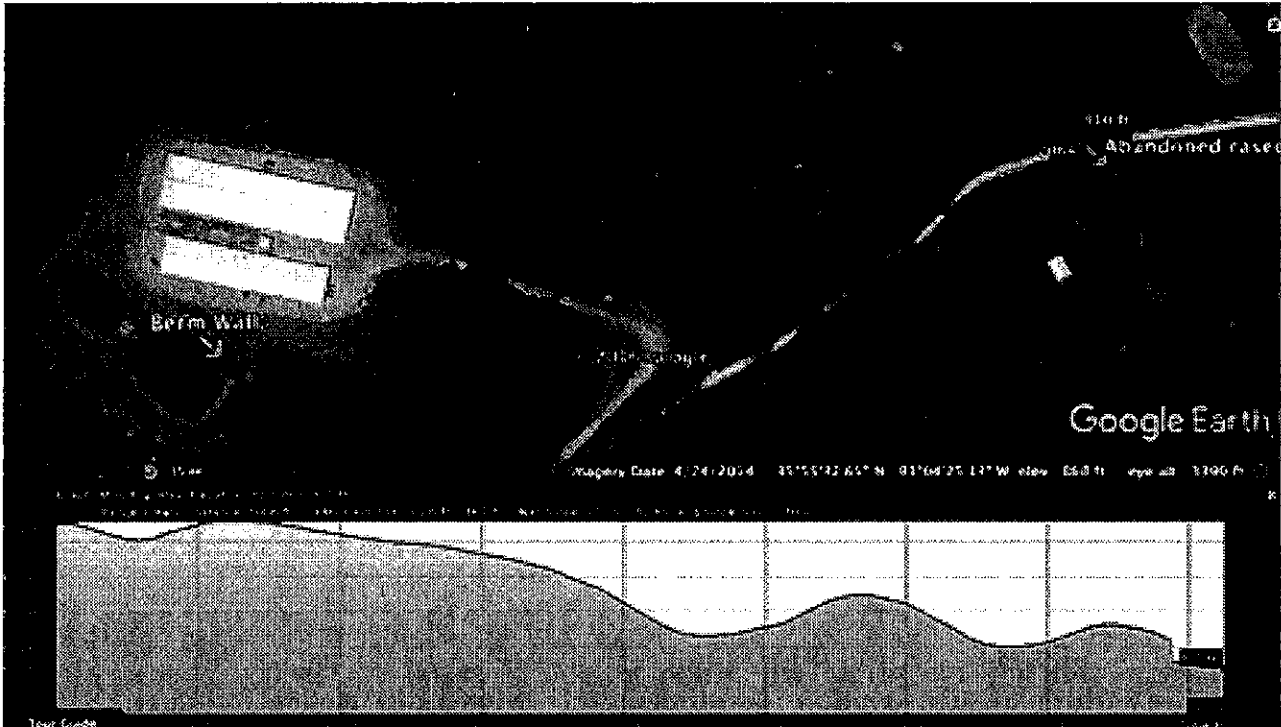
## B-40 Drilled Well

# Appendix C2-A Nearby Wells Page 2 of 3

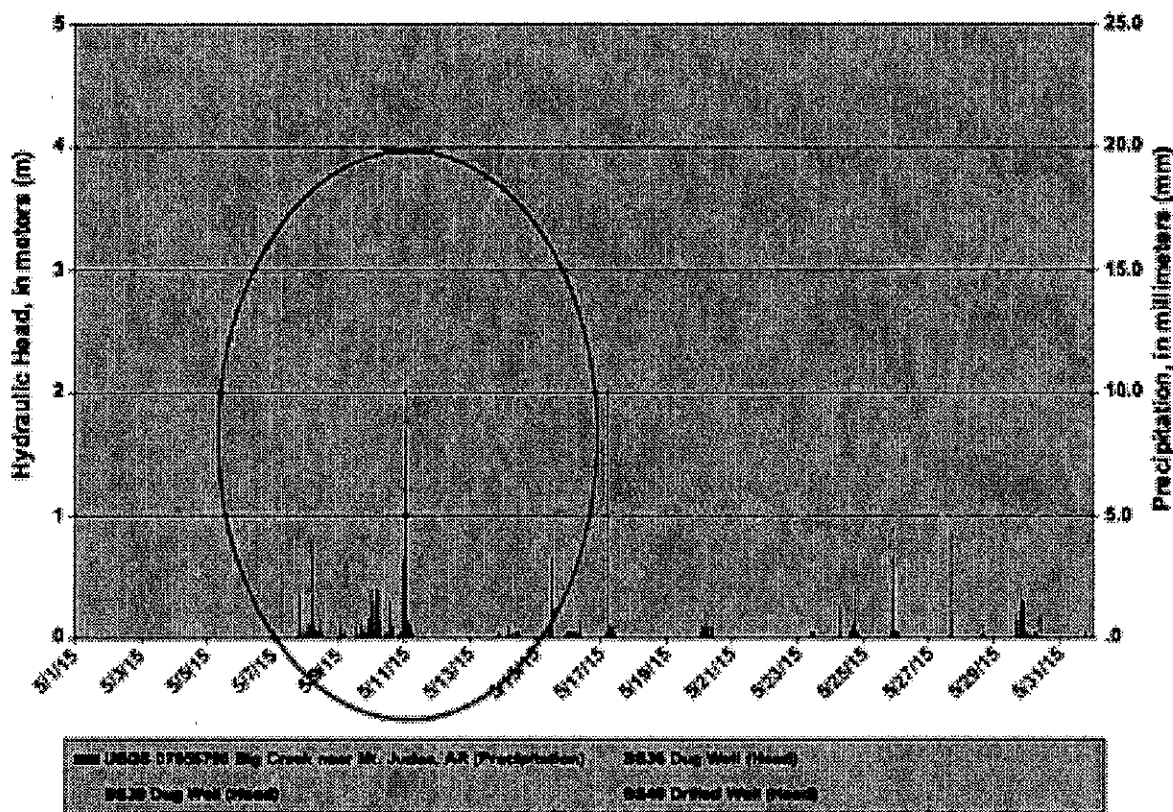
Fig. 13 Hydrographs of three groundwater wells, BS-36, BS-39, and BS-40 for the month of May 2015. The hydrographs show the groundwater level (rise and fall) on the vertical axis plotted against time on the horizontal axis. As in Fig. 12, precipitation is shown by the vertical lines and the scales for the figures are presented in the same locations. The timing of the causes (precipitation) and effects (groundwater-level response) can be subtracted, and is called the lag time. In this case, the time lag was essentially zero, indicating that

groundwater levels started rising as soon as the precipitation started. The magnitude of the water-level increases is a reflection of the change in storage as the groundwater moves downgradient, and varies for different hydrologic settings in the Boone Formation (BS-36), the epikarst at the top of the Boone (BS-39), and the Big Creek alluvium and terrace deposits (BS-40) that lie above the Boone in Big Creek Valley

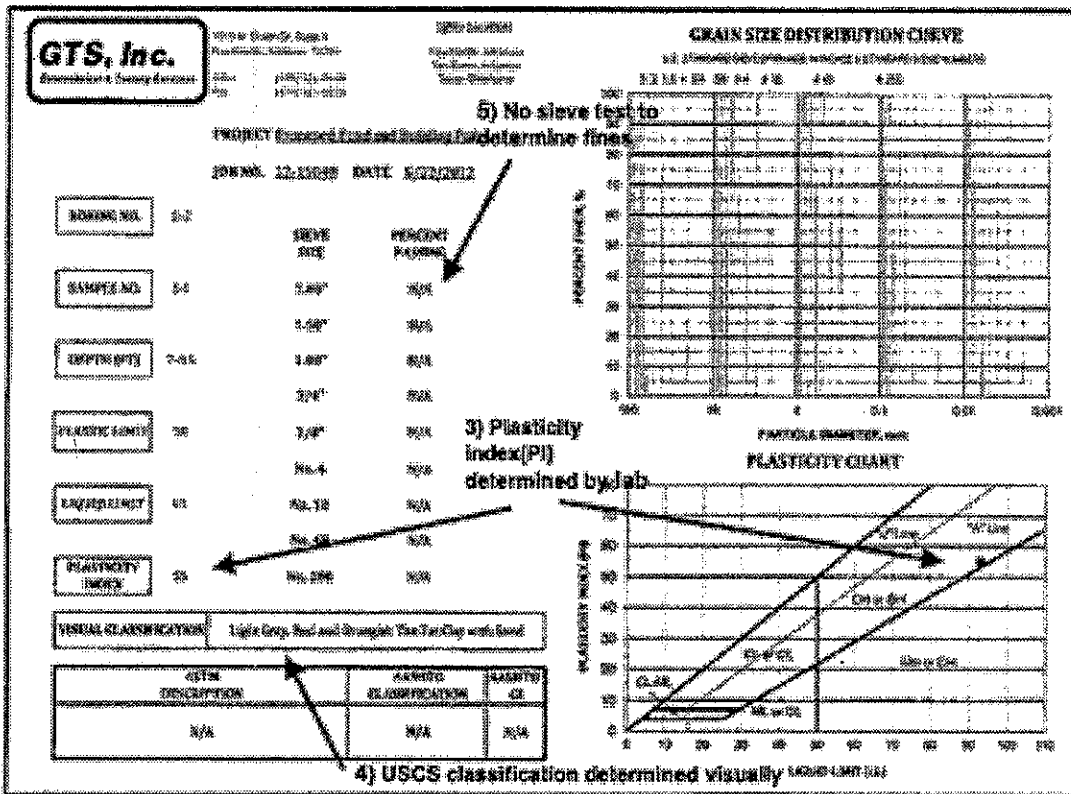
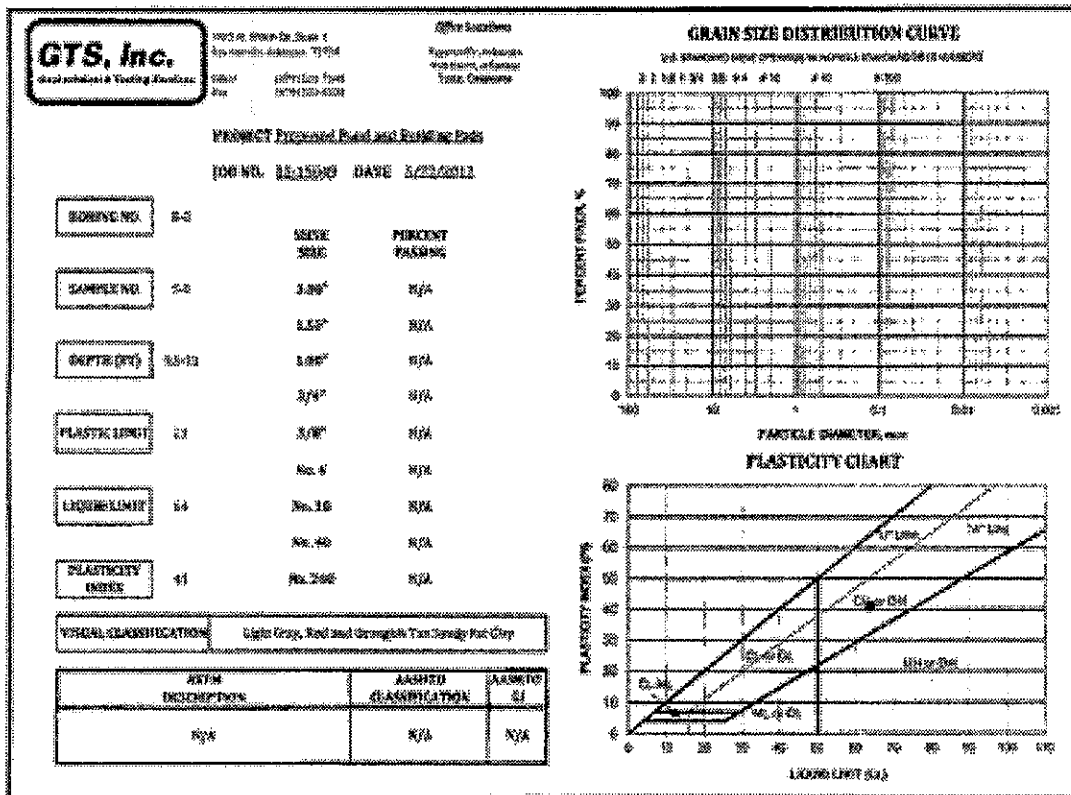
Appendix C3 - Review of permeability determination  
 Page 3 of 6

2) Samples 5 & 6 from Boring No B-2. B-3 samples 5 and 6 are also used but not shown here. USCS designations are not determined yet.

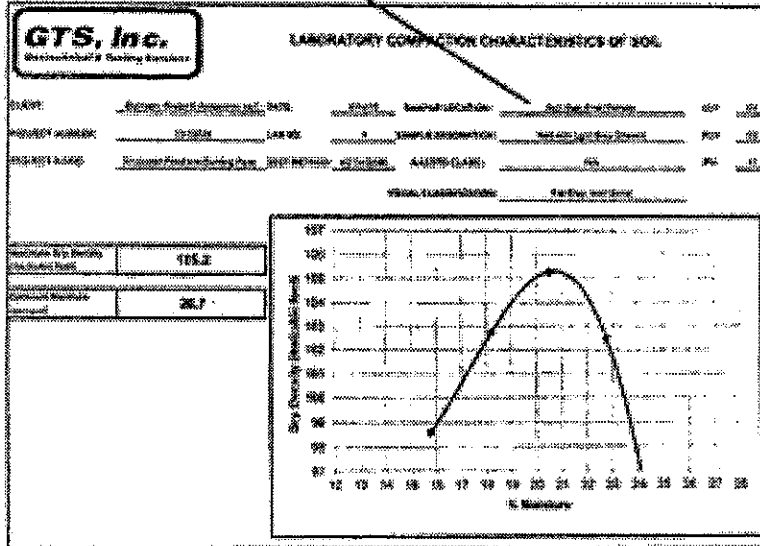
B-2 Bulk Grab Sample

Appendix C3 - Review of permeability determination  
Page 6 of 6

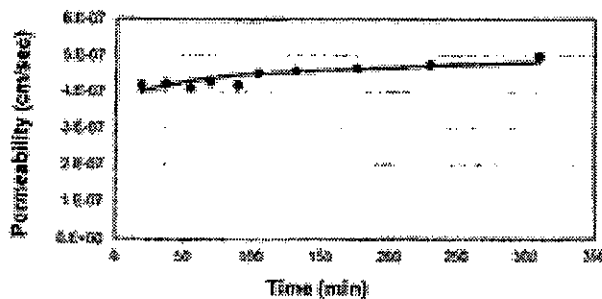
PROJECT: ML 3600 - Proposed Park and Building Park PROJECT NUMBER: 12-13049  
 BORING: B-2 SAMPLE: N/A  
 DEPTH (IN): 3 - 11 SAMPLE TYPE: Remanufactured

Hydraulic Conductivity, $k$ (cm/sec)		
Test Parameters	Initial Sample State	Final Sample State (after consolidation and heating)
Cell Pressure (psf): 5	Diameter (in): 2.57	Diameter (in): 2.55
Inflow Pressure (psf): 4	Length (in): 4.56	Length (in): 4.54
Outflow Pressure (psf): 3	Moisture Content: 21.2%	Moisture Content: 22.2%
Back Pressure (psf): 2	Wet Unit Weight (pcf): 125.7	Wet Unit Weight (pcf): 132.2
Consolidating Pressure (psf): 4	Dry Unit Weight (pcf): 103.2	Dry Unit Weight (pcf): 99.9
	Initial Hydraulic Gradient: 5.2%	Final Hydraulic Gradient: 5.5%

Note: Sample was reconstituted at 98.1% of MDD or a moisture content of 21.2% (w Comp = 6%)

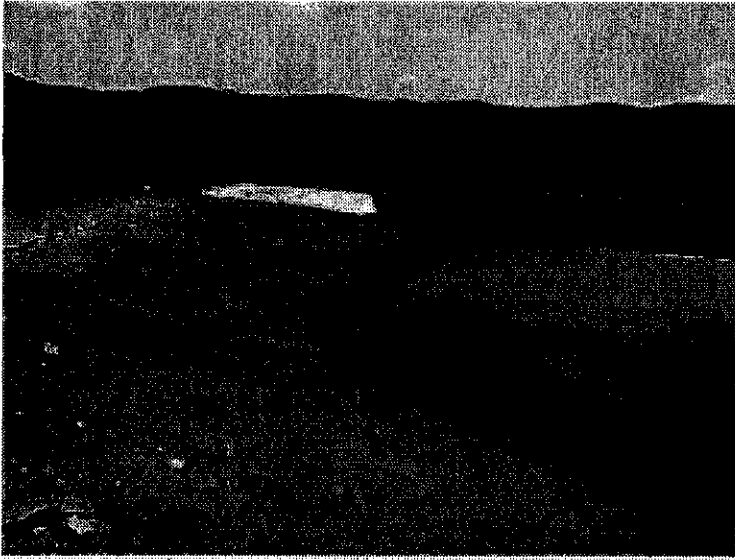
Location:		C&H Hog Farm, Newton County					
Photographer:		Tony Morris			Witness:		Phillip Campbell
Photo #	5	Of	6	Date:	07/23/13	Time:	12:03
Description:		Rill erosion in Settling Basin liner, large rocks in liner. Signs of liner deterioration.

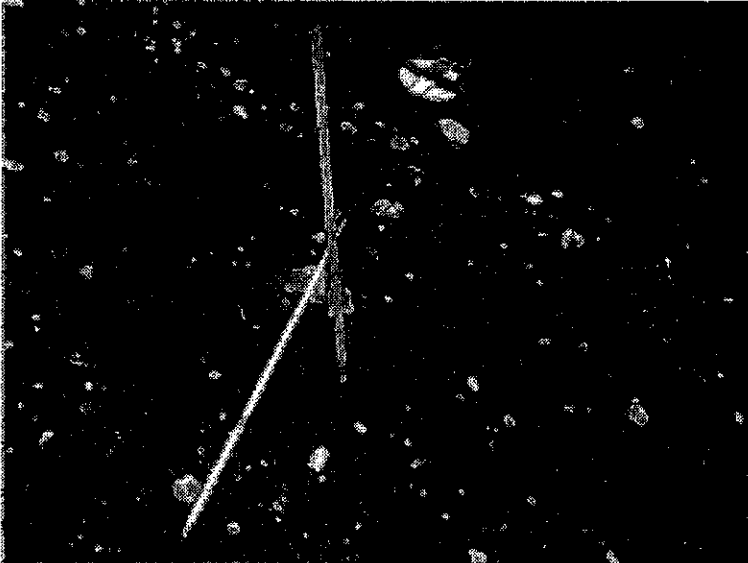
Photographer:		Tony Morris			Witness:		Phillip Campbell
Photo #	6	Of	6	Date:	07/23/13	Time:	17:21
Description:		Rill erosion and desiccation cracks in Holding Pond liner due to extended exposure.

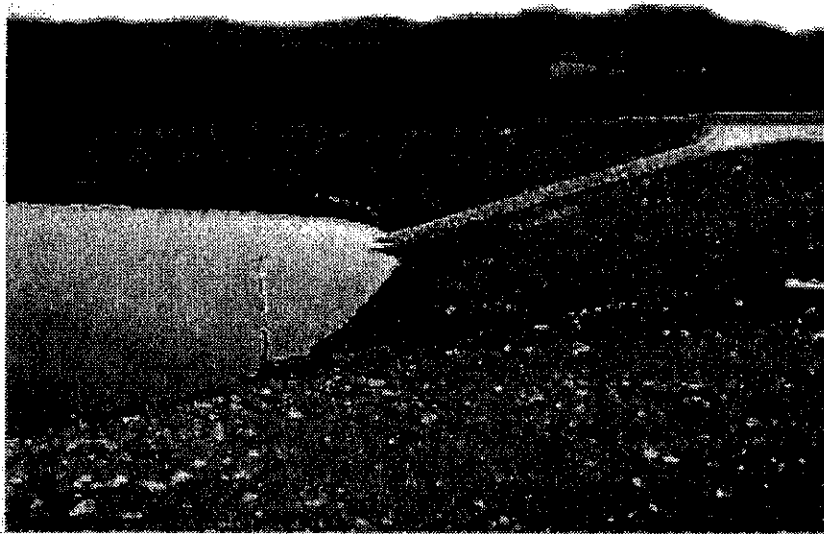
**Location:** C&H Hog Farms  
**Photographer:** Jason Bolenbaugh **Date:** 1/23/2014 **Time:** 12:02  
**Witness:** John Bailey, Jason Henson **Photo #:** 1  
**Description:** Inside of Holding Pond 2. Note erosion rills and unstabilized banks. Holding Pond Must Pumpdown elevation is indicated in red on the Must Pumpdown gauge.

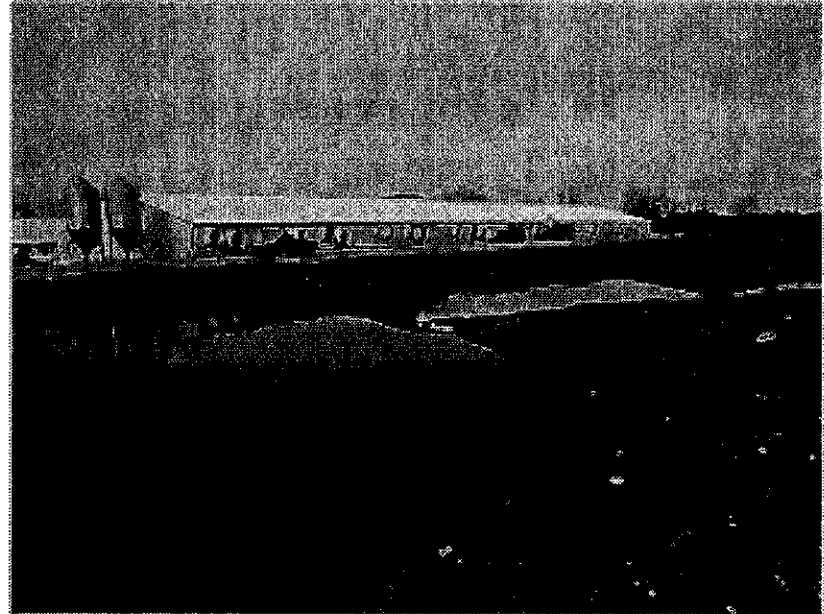
**Description:** Inside of Holding Pond 1. Note the unstabilized banks. Waste water is not currently running over the spillway into Holding Pond 2.

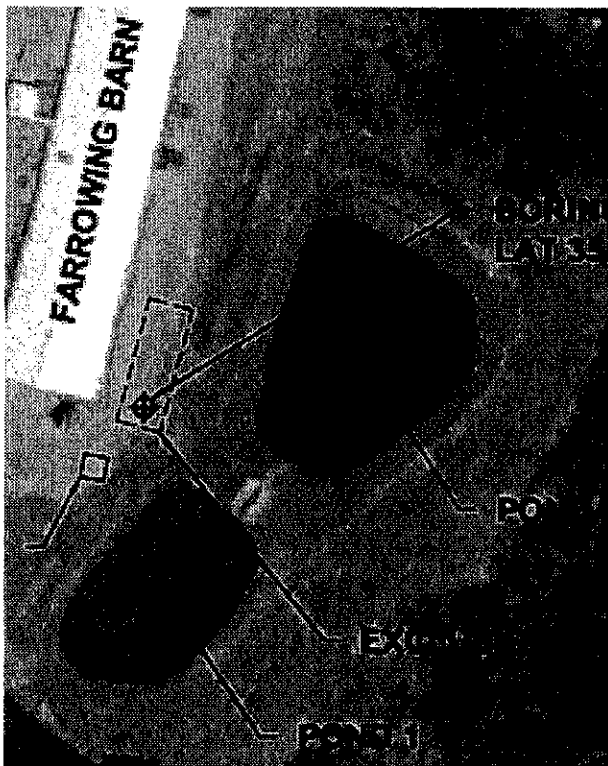
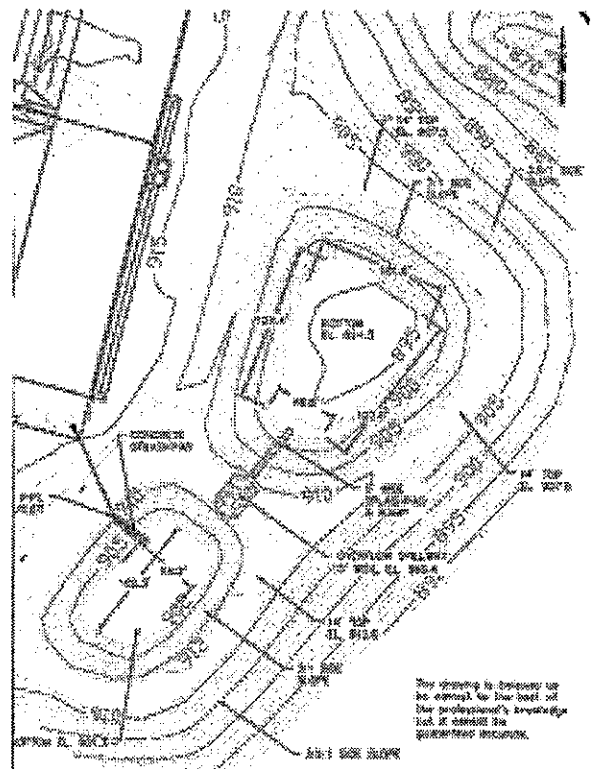
Photo is from the Harbor Environmental Study: FIGURE 2 C & H Hog Farm - Site Layout map

2nd item is the AS BUILT elevations - Engineering Plan Sheets April 12, 2013

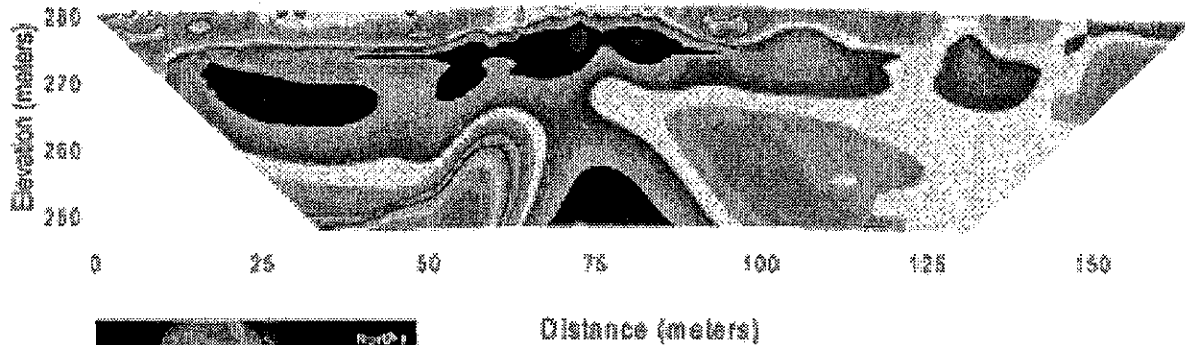
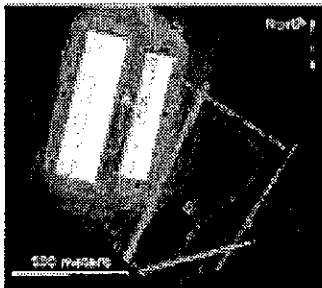
# Appendix C13 Evidence of perched groundwater.

Southwest

Northeast

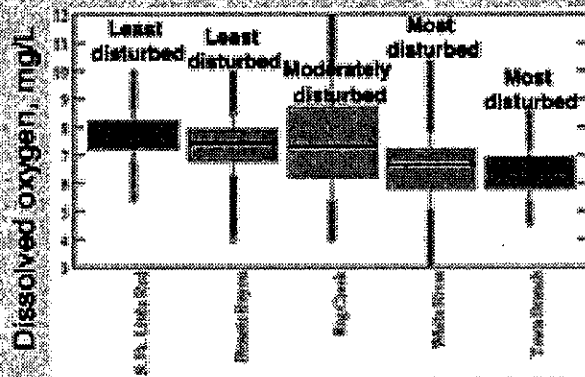
Appendix D5 - USGS reports impairment in Big Creek  
 Page 1 of 1

Continuous DO statistics indicated a strong connection between the nutrient and land-use indices and DO concentrations

Stream name	Site no.	No. of unit values	No. of unit values < 6 mg/L	Percent of unit values < 6 mg/L
South Fork Little Red River	07075250	21,715	75	0.3
Illinois Bayou	07257500	27,986	1,046	3.7
Big Creek	07055814	14,623	2,992	20.5
White River	07048600	11,007	2,976	27.0
Town Branch	07048495	7,488	2,494	33.0

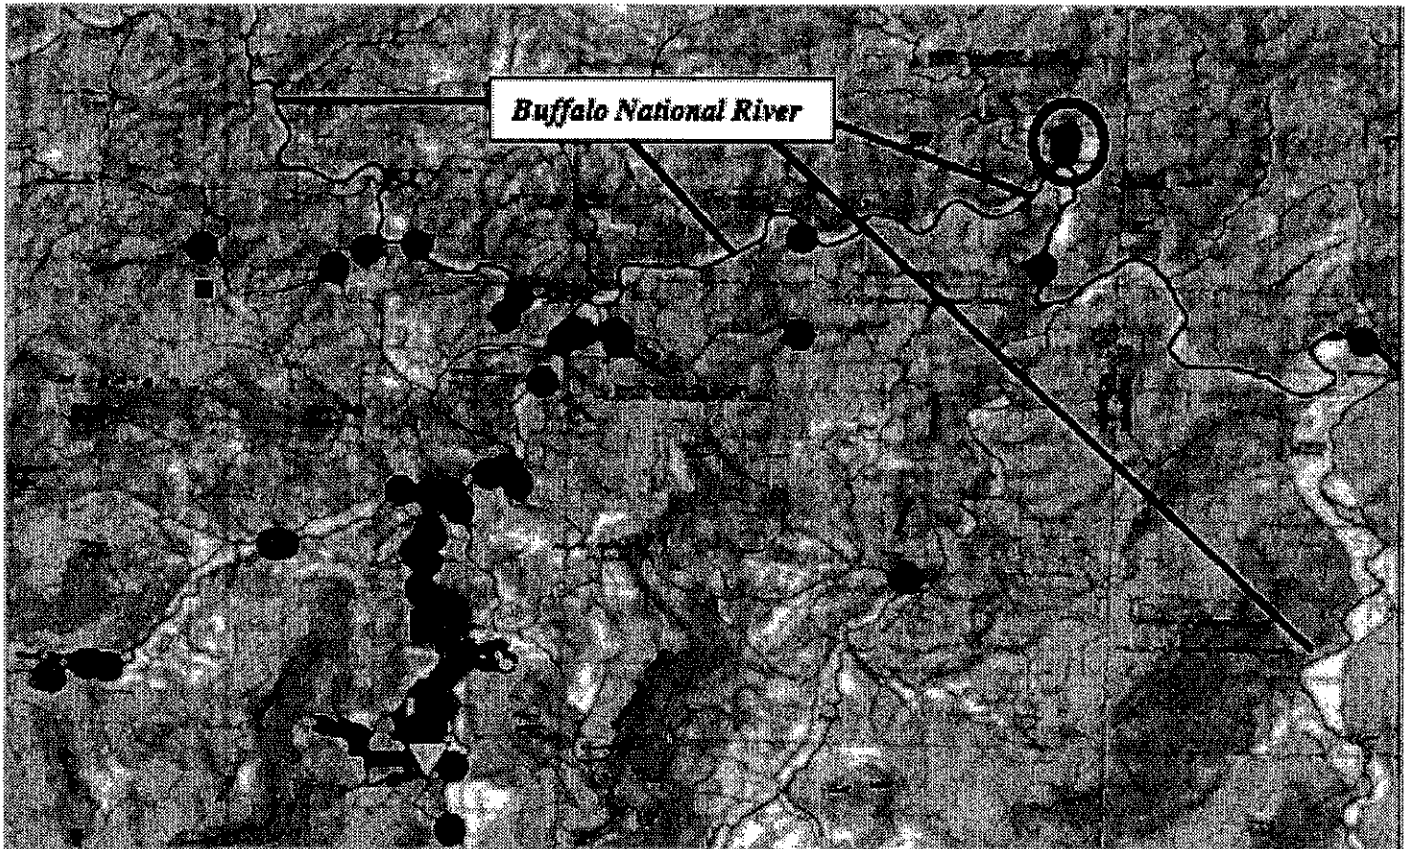
Figure 9. Flow from BS-36 where eosin input was positively traced to outflow springs and streams. This trace shows the full dispersive extent of karst flow in the subsurface into other surface water basins, the Buffalo National River, and even beneath the river to Mitch Hill Spring, identified by the black circle in the northeast quadrant. The yellow triangle is dye input well BS-36, blue shapes are hog-waste spreading fields, and the black rectangle is the CAFO. The Buffalo Nation River is the blue irregular sinuous feature that extends from the northwest to the southeast corner of the map. Pink circles are positive dye detections, five of which were retrieved from the rivet

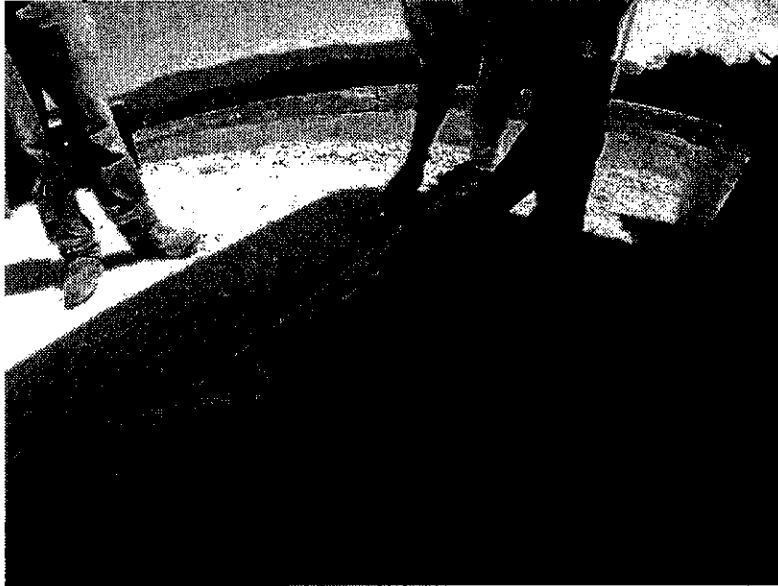
Photo #:	12	Date:	9/21/16	Time:	1415	Photographer:	C. Yeatman
Description:	Core recovery from 18.5 to 28.5'

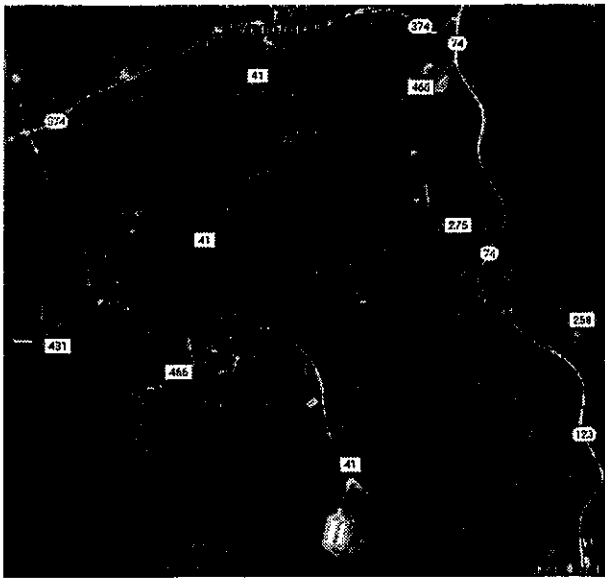
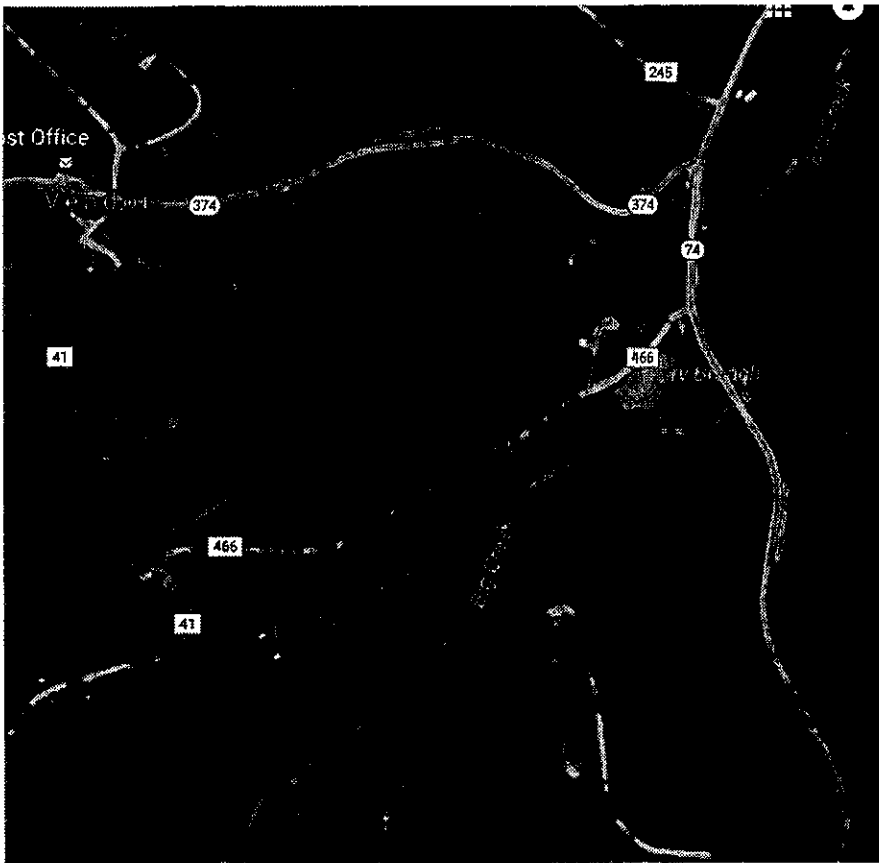
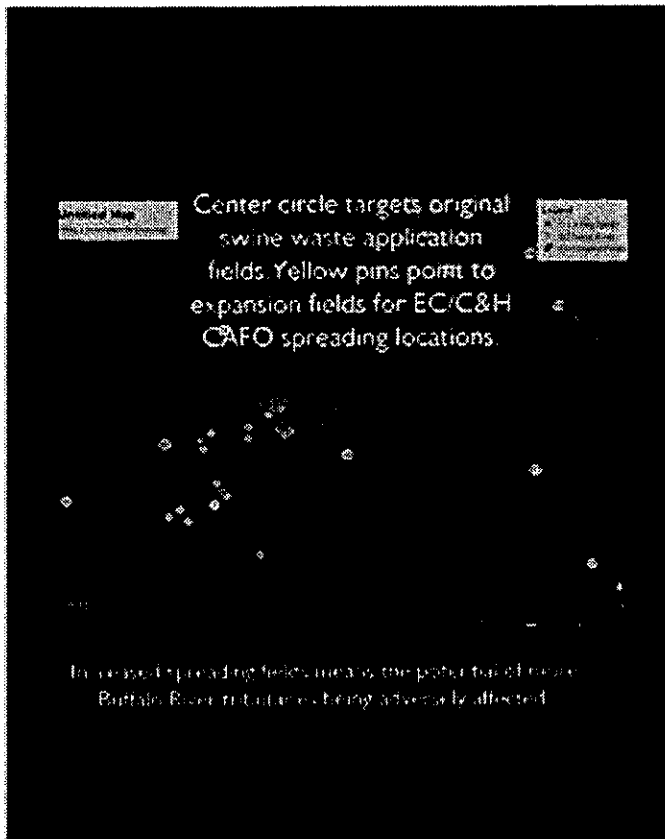
See the photographs below for the location of this "improvement" and its connection to C&H and its swine waste application fields:

In the first photo, C&H is on the bottom right. The second photo shows the route to added EC fields. The third shows a Google map of locations of the increased number of fields in the BR watershed. After just three years most of these fields will likely be at above optimum phosphorus levels, just as the original application fields are right now. With a Reg 5 permanent permit how will ADEQ even know when this actually occurs since reporting soil test results is only required every 5 years? Where will C&H find additional fields as fields become oversaturated with phosphorus? Will state government approve additional remote "improvements" to rural roads then to ease the continuing spread of C&H waste across more fields in the watershed? When will enough be enough to end the mitigations that obviously only serve to amplify the original permitting mistake? Isn't it time to deny the permit instead of making it permanent?
