# Buffalo River Watershed Alliance Comments on C&H Reg 5 Permit Denial

Position Summary	2
Part A - Permit risk	3
Part B - Application Fields	7
Part C - Geologic and Engineering Site Investigation	29
Part D - Degradation	62
Part E - Miscellaneous	69
<b>Part F - <i>Additional Comments added for recent proposed denial</i></b>	<b>93</b>

## Comments on C&H Reg 5 Permit Denial

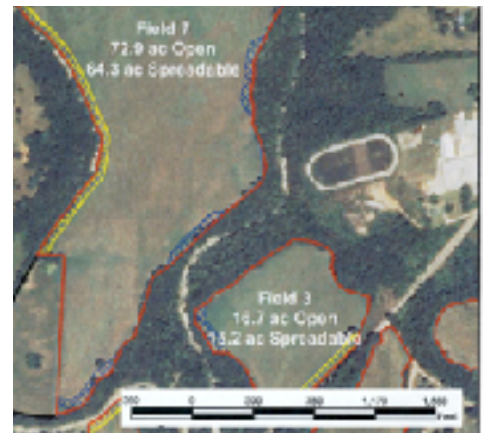
The fields appear to be outside the 500 ft range of buildings as Reg 5 requires, however they are well within 400 feet of school property and the athletic track where children will be present.

Field 7 distance is 314 ft.

Field 3 distance is 389 ft

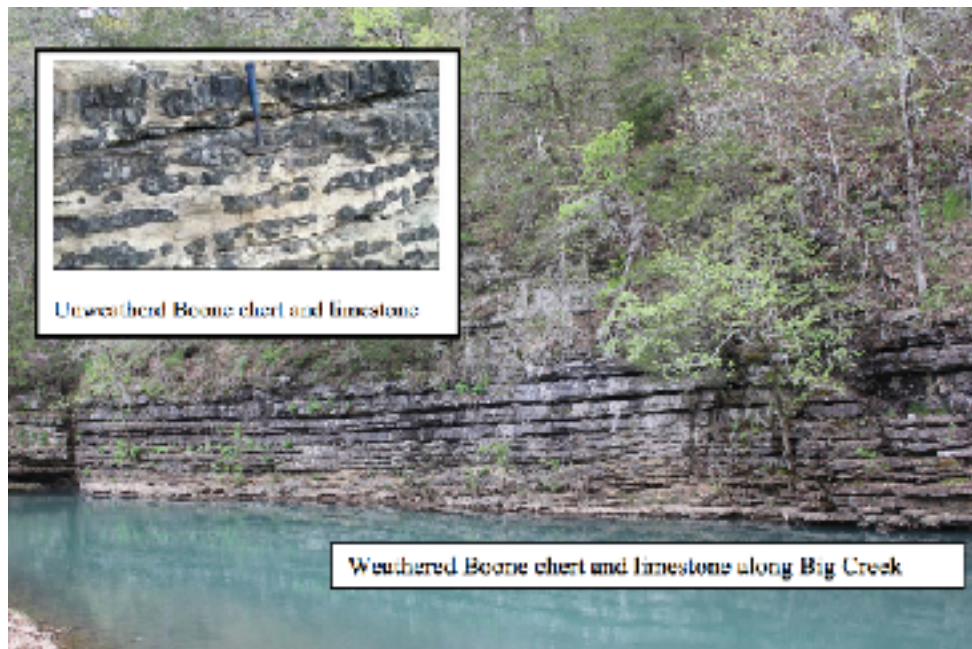
C&H and the spreading fields are located in what is widely and scientifically accepted as a significant karst environment. The presence of karst is not subjective, but obvious to the casual observer from the weathered dissolution features in exposed formations throughout the Mt. Judea area.

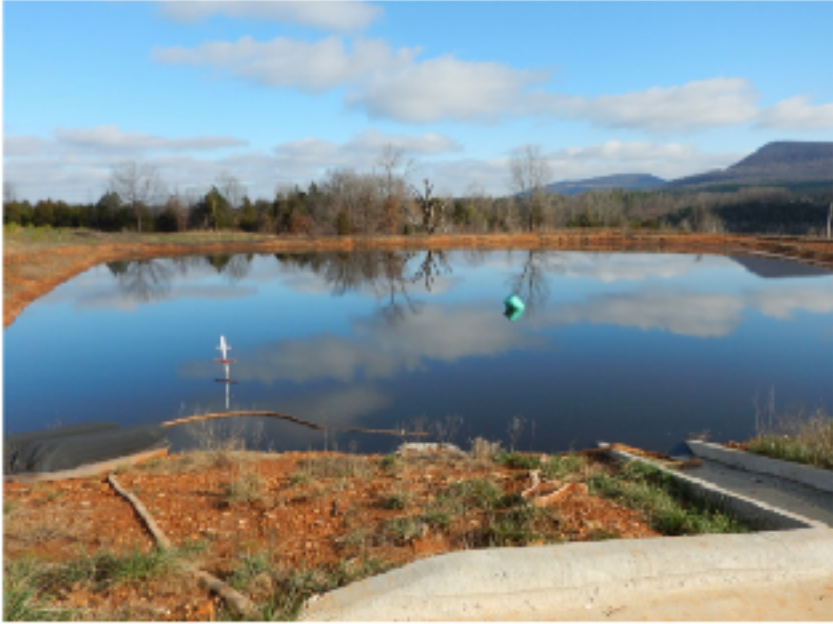
Photographer:	Jason Bolenbaugh	Date:	12/30/2015	Time:	
Witness:	Keith Waters	Photo #:	2		
Description:	WPS #2 showing adequate amount of freeboard and the depth gauge which marks (red line) the Must Pump Down level.

The far side is the top of the 10% slope mentioned that has no stabilized emergency outlet.

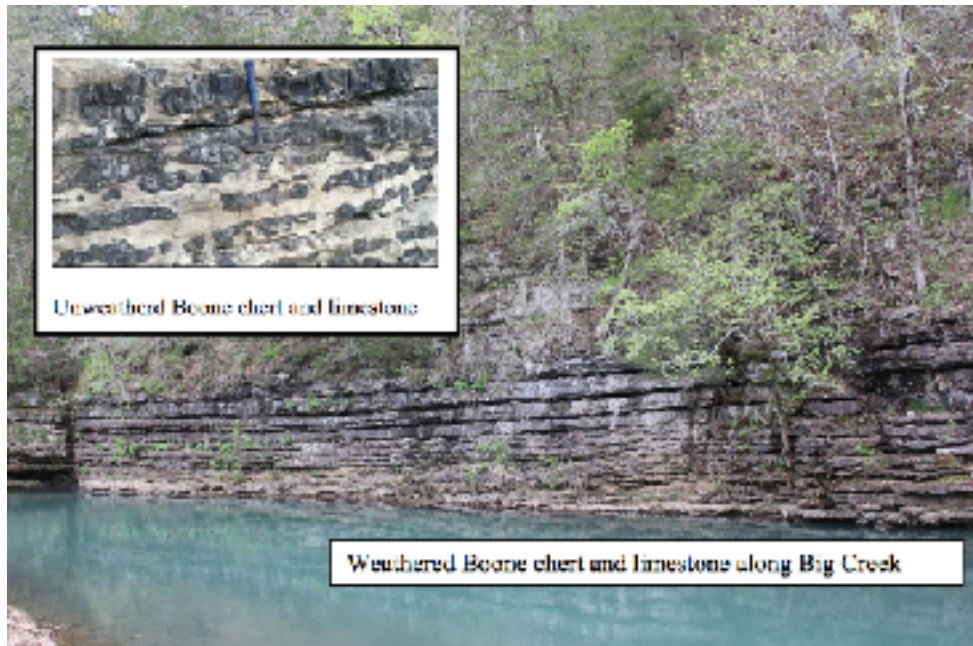
of considerable volume may not be noticeable by the driller. An example of typical fractures in the Boone formation that would not easily be detected by a driller are illustrated in this cross section photo.

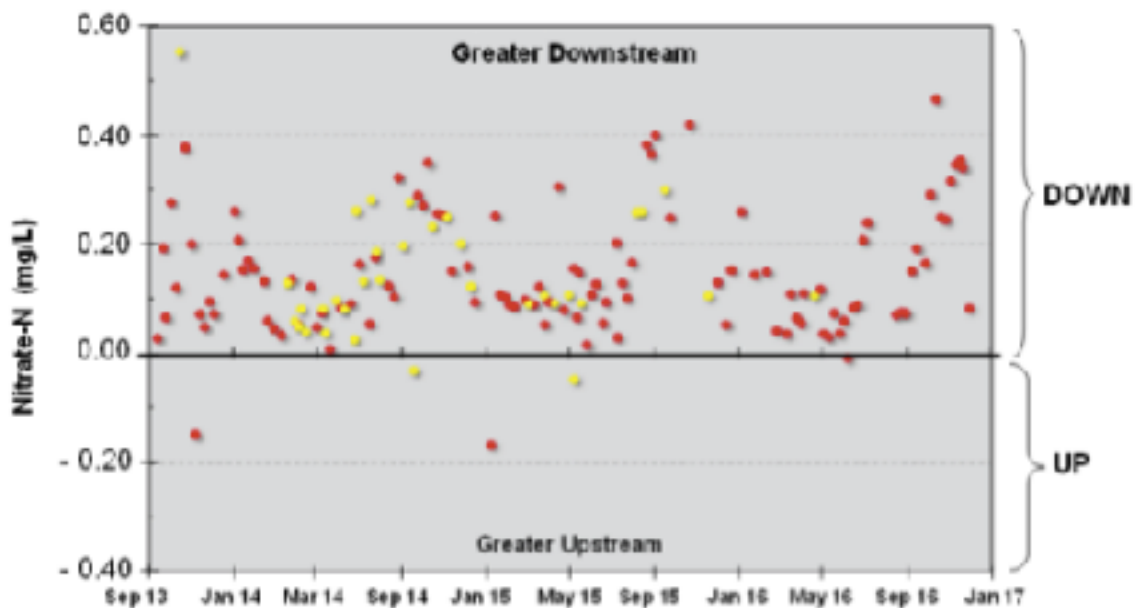
**Figure 1.** Difference in NO<sub>3</sub>-N concentration in Big Creek up- and downstream from the C&H CAFO. Following the “upstream vs. downstream” comparative criterion that is the basis of the BCRET study, the data clearly indicate that the C&H CAFO is contaminating Big Creek with nitrate. From BCRET (2017a; note that explanation was not given for the yellow versus red color-coding).

Nitrates are being measured by the *Big Creek Research and Extension Team* (BCRET) of the *University of Arkansas Division of Agriculture* both upstream and downstream of the facility and nearby spreading fields Figure 1.

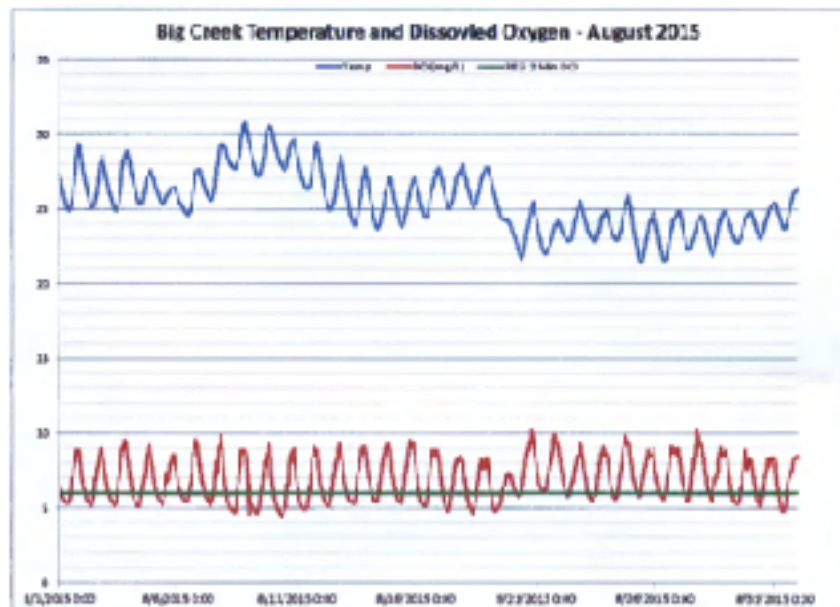
Figure 3: Dissolved Oxygen data for Big Creek (BUFT06) during August of 2015. (Source USGS)

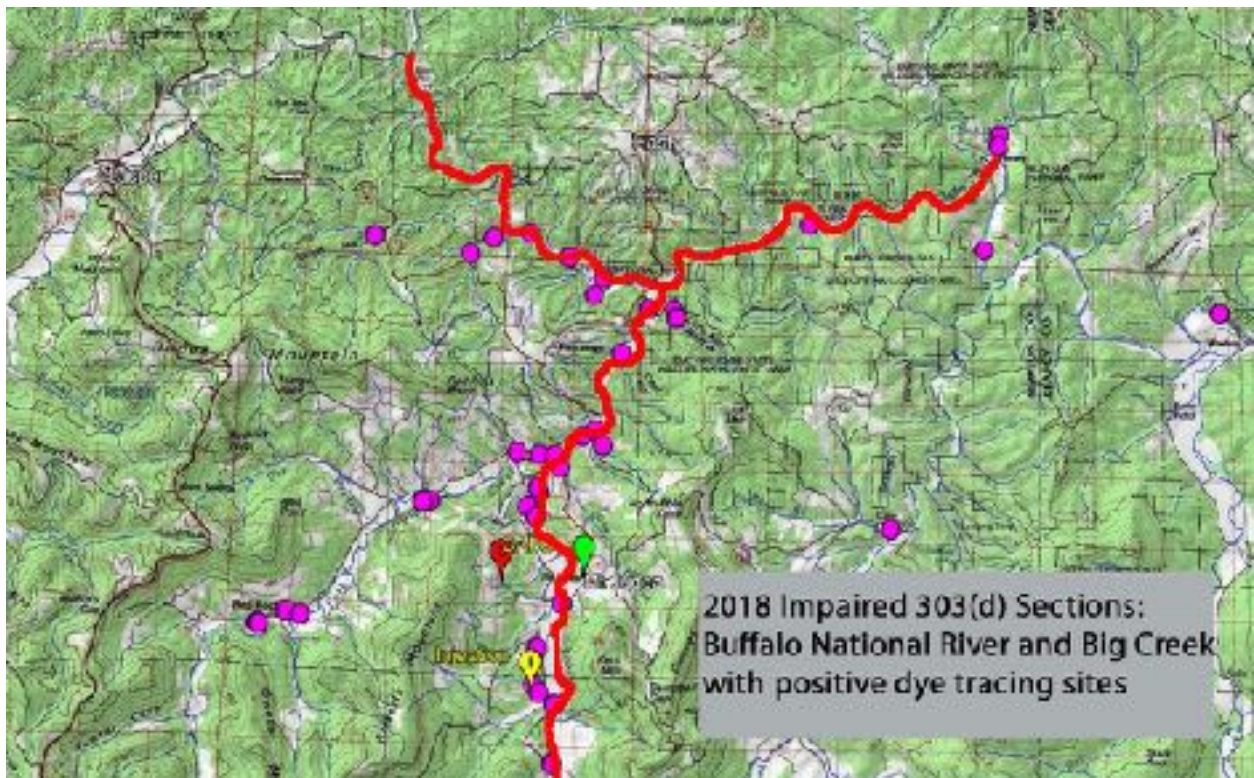
ADEQ's 2018 proposed 303(d) list of impaired waterbodies include Big Creek and 14.32 miles of the Buffalo National River. The Buffalo shows impairment both upstream and downstream of Big Creek's confluence. In regard to how C&H might be implicated as a source, the following illustration from the peer-reviewed study, *"Using Fluorescent Dyes to Identify Meaningful Water Quality Sampling Locations And Enhance Understanding Of Groundwater Flow Near A Hog CAFO on Mantled Karst, Buffalo National River, Southern Ozarks. Dr. Van Brahana, et al."* shows impaired segments correlate closely with the dye trace study conducted by Dr Van Brahana. Dye injected at Mt Judea, in close vicinity of the C&H spreading fields, makes its way into the Buffalo, not just at the mouth of Big Creek, but a considerable distance both upstream and downstream as well. This clearly shows the possibility that a single waste source of a large size in a karst location, such as C&H Hog Farms, could very well impair waters throughout the impacted area.

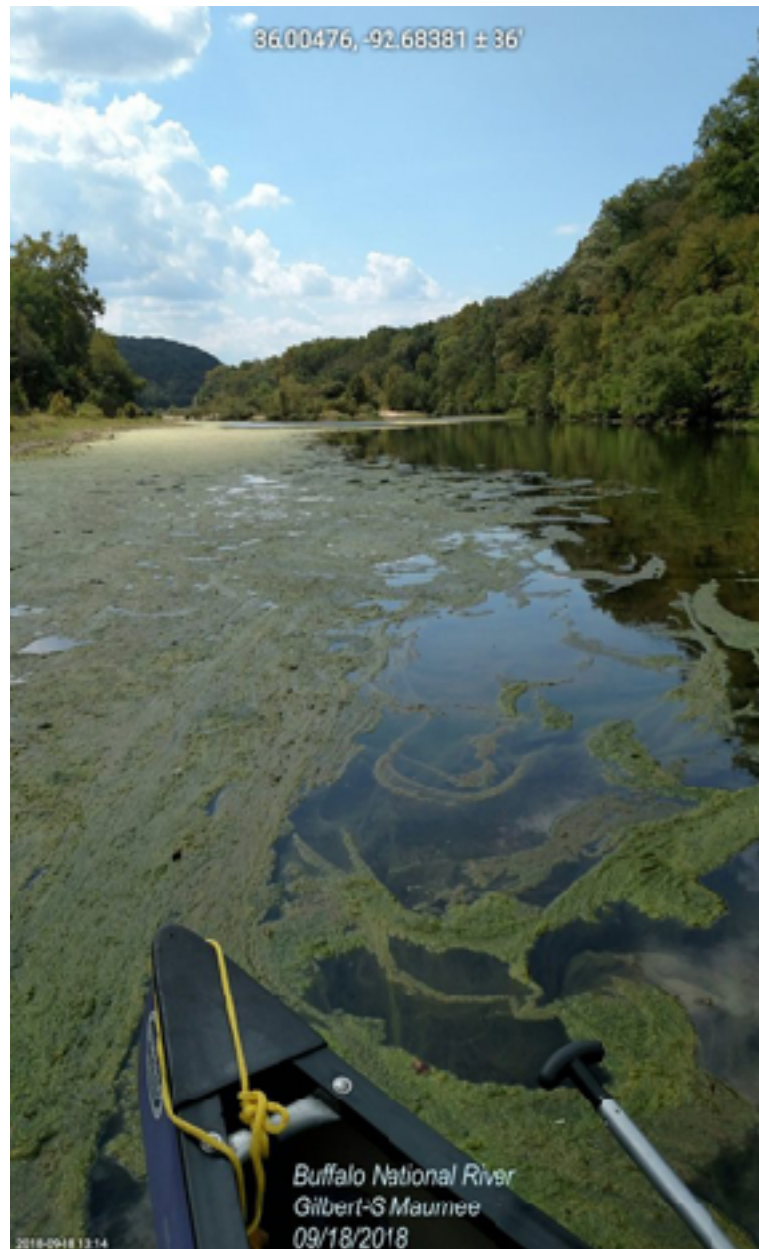
At this time, Arkansas does not have standards for measuring or recognizing changes in algal growth. West Virginia in response to algae on the Shenandoah River has an easily applied standard that looks at the amount of algae coverage from bank to bank at a given point along the river. If there are three such consecutive points at intervals along the river's length that are 80% covered by algal growth from bank to bank, then that part of the river is declared "*recreationally impaired*". The three lengthwise intervals correspond to the river width. "*Recreationally impaired*", indicates unsuitability for swimming, fishing, or even boating and raises health concerns. If Arkansas were to measure the 2018 algae on the Buffalo between Gilbert and Maumee using such a standard, that entire section would meet the West Virginia measure of "*recreationally impaired*". In West Virginia this would trigger actions to determine nutrient sources.

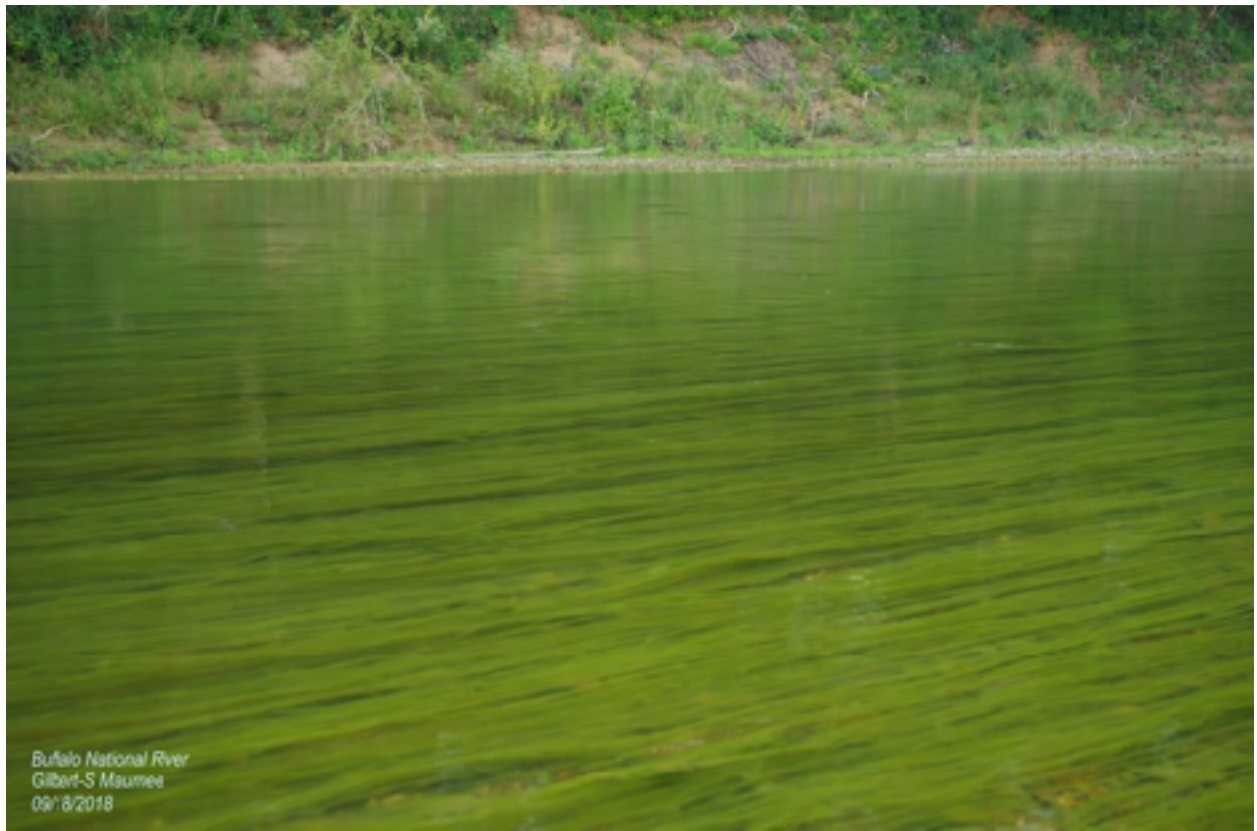
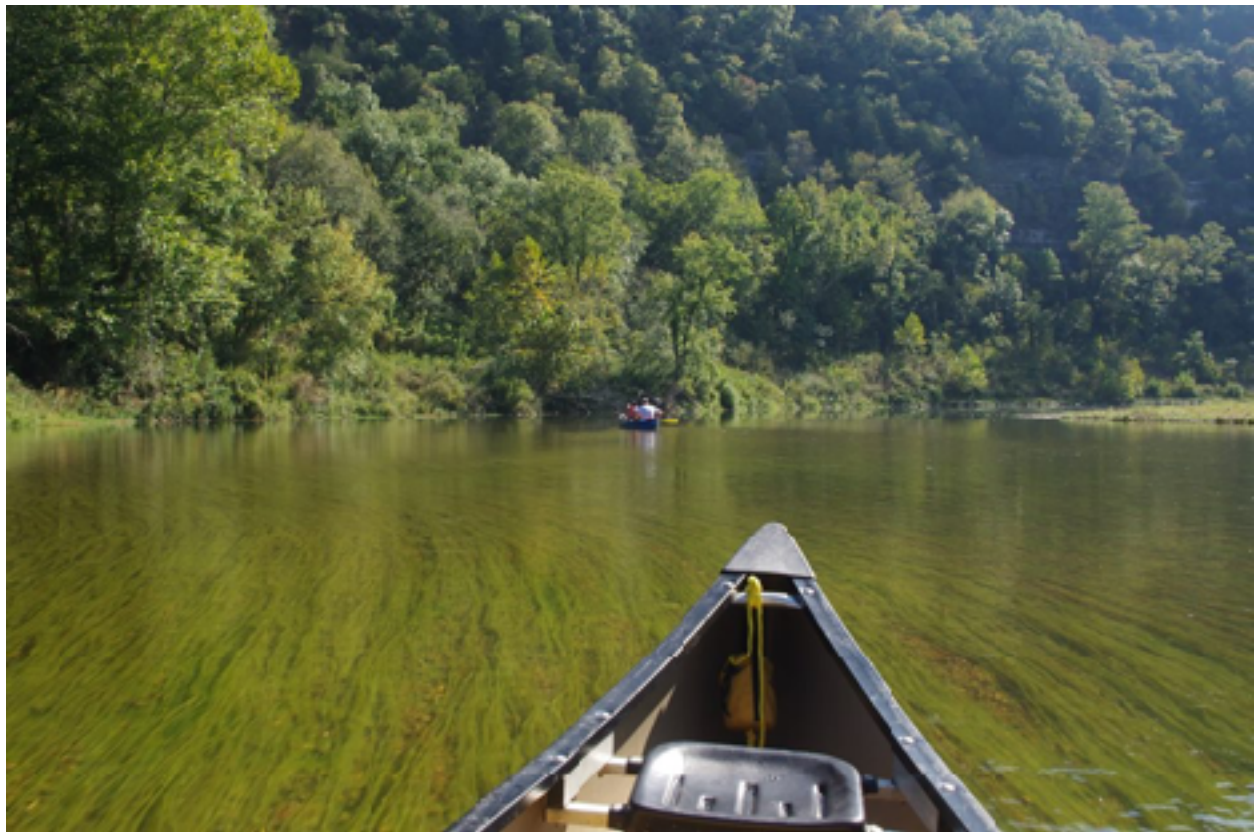
ADEQ has proposed adding Big Creek and 14.32 miles of the Buffalo National River above and below the Big Creek confluence to the 303(d) list of impaired waterbodies (see Comment F2). The Buffalo segment is proposed as impaired for low dissolved oxygen which is frequently a result of excessive algae and affects fish and biota. Excessive algae, in turn, is frequently influenced by excessive nutrient loads. It has been recognized by ADEQ that C&H is adding nitrates between monitoring stations (Comment F2), and this does not include reliable storm flow data which is when most nutrients are moving. As a result, it is not a huge leap of the imagination to conclude that increasing algae volumes are being influenced by C&H operations.
