ARKANSAS
Department of Environmental Quality

WATER DIVISION COMPLAINT REPORT

COMPLAINANT NAME: Brian Thompson MAILING ADDRESS: 3428 E. Wyman Rd. CITY, STATE, ZIP: Fayetteville AR 72701 PHONE & EXT: / FAX: / EMAIL: thompsonaddc@gmail.com RESPONSE REQUESTED BY COMPLAINANT: Yes	COMPLAINT AGAINST: C&H Hog Farms, Inc. SITE ADDRESS: MAILING ADDRESS: HC 72, Box 2 CITY, STATE, ZIP: Vendor AR 72683 PHONE & EXT: / FAX: / EMAIL:
--	---

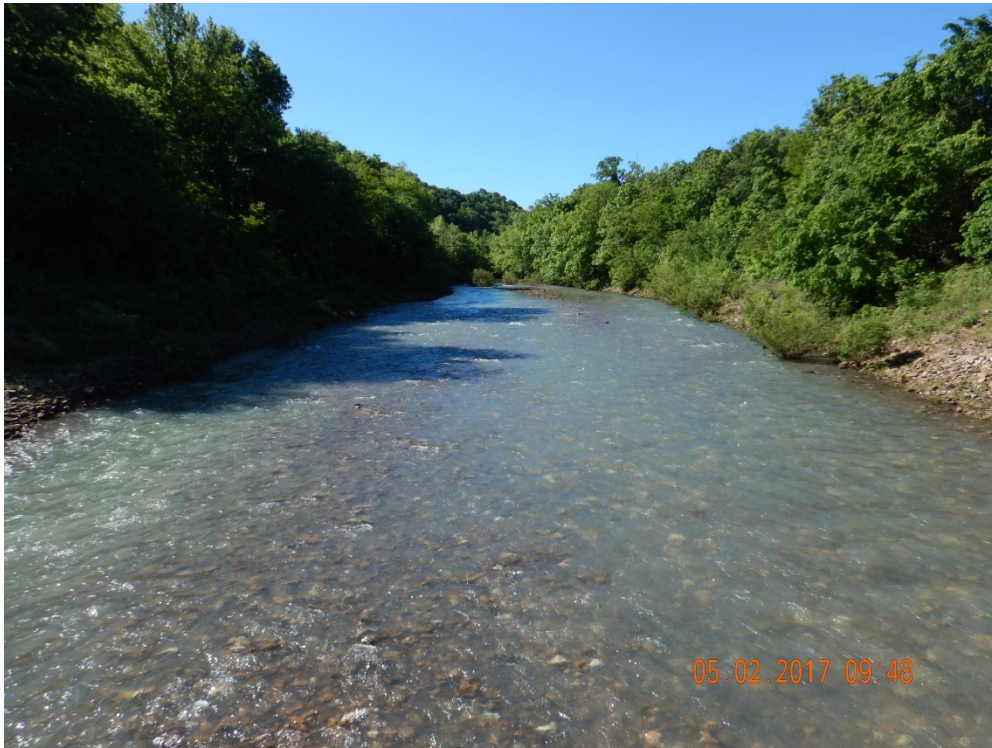
Location:	C&H Hog Farms, Inc.		
Photographer:	Jason Bolenbaugh	Date:	5/2/2017
Witness:		Time:	09:48
		Photo #:	1
Description:	Big Creek looking downstream at the C.R. 54 bridge.

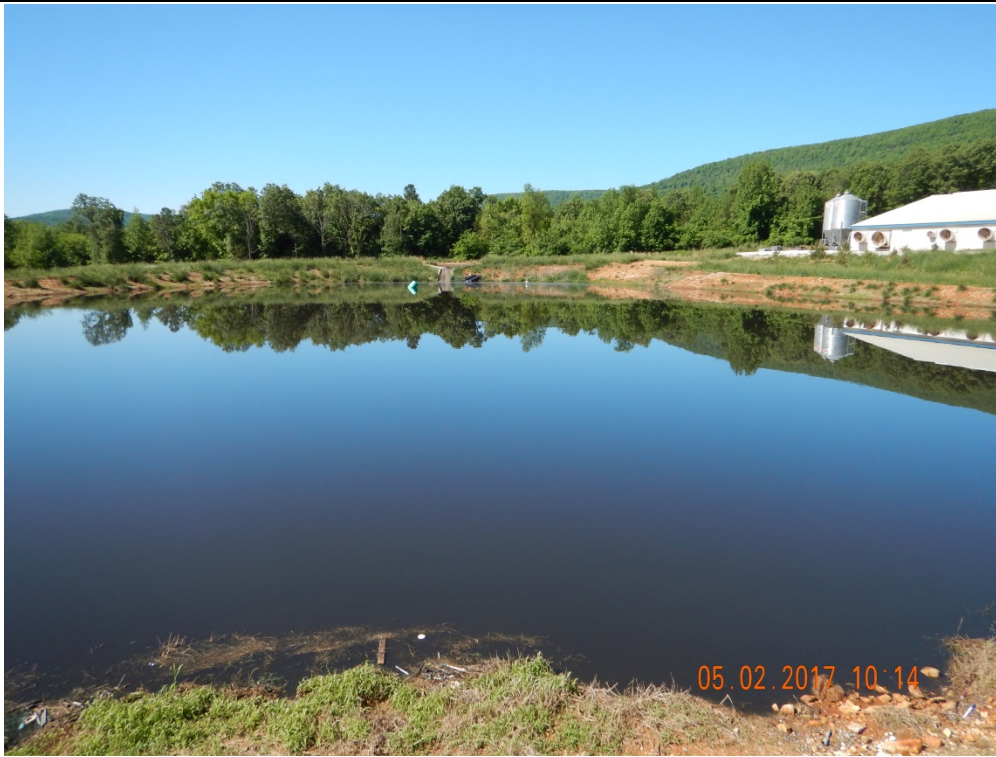
Location:	C&H Hog Farms, Inc.				
Photographer:	Jason Bolenbaugh	Date:	5/2/2017	Time:	10:14
Witness:				Photo #:	5
Description:	Pond #2 looking southwest.

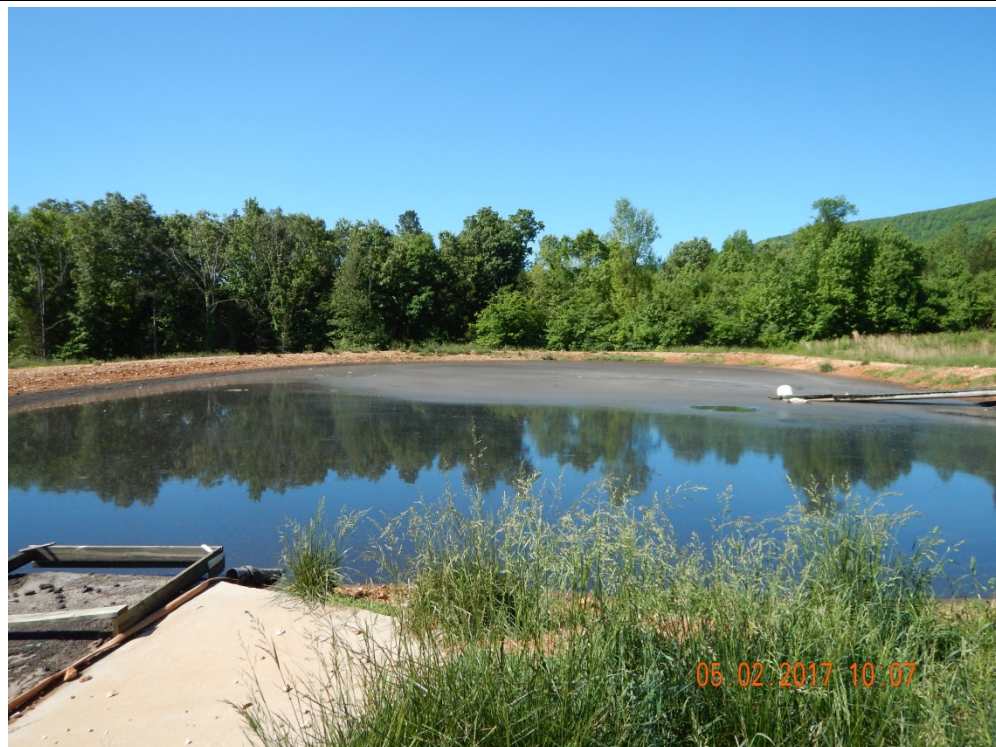
Photographer:	Jason Bolenbaugh	Date:	5/2/2017	Time:	10:07
Witness:				Photo #:	6
Description:	Pond #1 looking southwest.

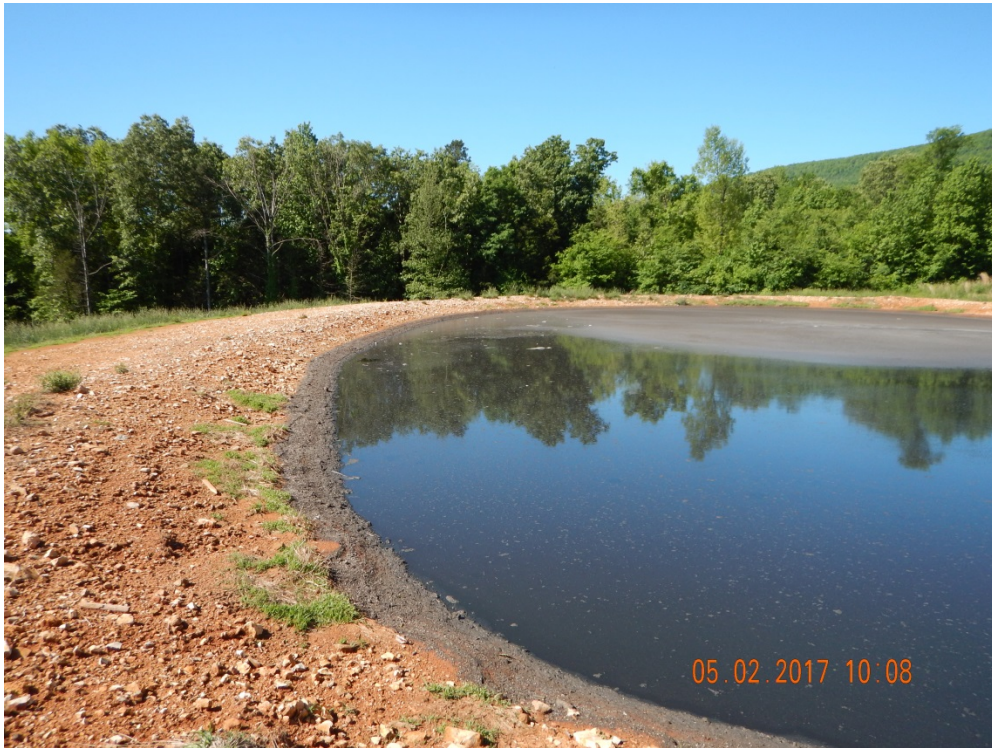
Location:	C&H Hog Farms, Inc.		
Photographer:	Jason Bolenbaugh	Date:	5/2/2017
Witness:		Time:	10:08
		Photo #:	7
Description:	Pond #1 showing approximately 12-15 inches of drawdown.

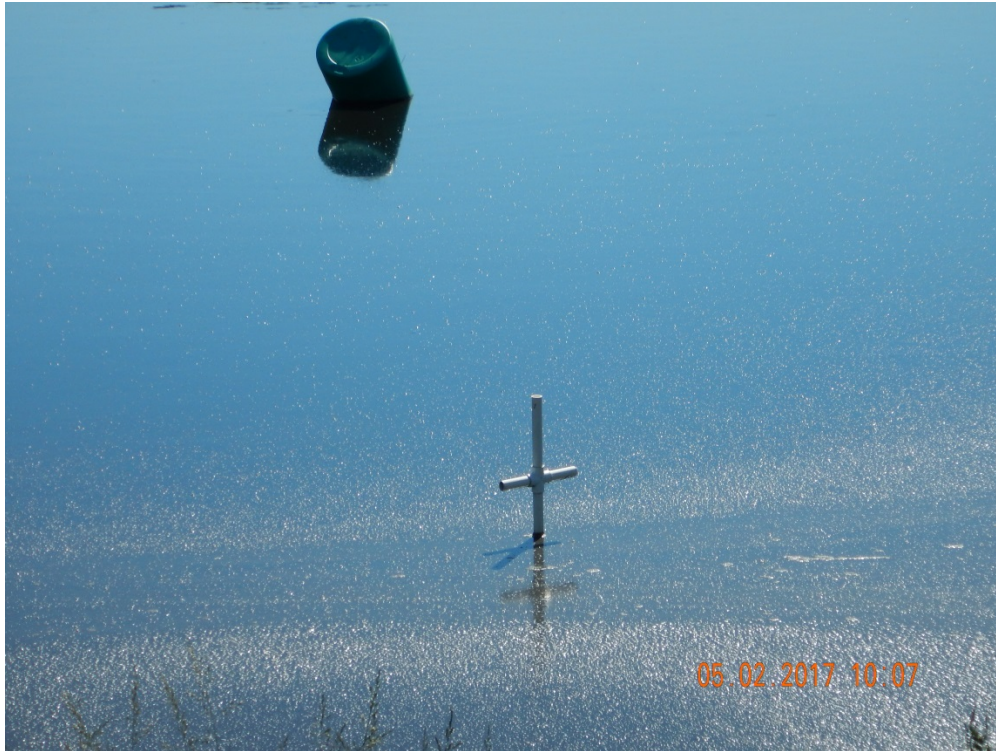
Location:	C&H Hog Farms, Inc.				
Photographer:	Jason Bolenbaugh	Date:	5/2/2017	Time:	10:07
Witness:				Photo #:	9
Description:	Must Pumpdown Level in Pond #2. Approximately 3-6 inches above Must Pumpdown mark.

On May 2, 2017 I conducted an investigation of C&H Hog Farms, Inc. due to the above referenced complaint. During the investigation water conditions at Big Creek and the unnamed tributary leading to Big Creek were observed. Water conditions were clear and had no evidence of receiving a discharge of wastewater from the facility. I walked around each wastewater pond and directly below to a monitoring station. There was no evidence wastewater had discharged from either pond, or that the ponds were leaking or compromised. Three pump trucks were removing wastewater from Pond 1 and according to Mr. Henson, the trucks were land applying the wastewater onto Field 15. From residue formed on the inside of Pond 1 the pond level had dropped 12-15 inches due to pumping activities. Pond 2 had approximately 2-3 feet of freeboard at the lowest point but was approximately 3-6 inches above the Must Pumpdown Mark. In a telephone conversation with Mr. Henson on May 10, 2017 he indicated Pond 2 is now approximately 12-18 inches below the Must Pumpdown Mark and will submit photodocumentation confirming Pond 2 is below the mark.
