I would like to go on record stating that the C&H Hog Farm draft permit 5264-W was improperly approved by ADEQ and should be denied. The information I am including in my comments, I feel are relevant to this permit process. It includes historical and current information about storage and land application of liquid waste from this swine facility.

**“PUBLIC NOTICE OF DRAFT NO-DISCHARGE PERMIT  
PERMIT NUMBER 5264-W  
AFIN 51-00164**

**This draft permit is for the storage and land application of liquid waste from a swine facility in accordance with Arkansas Pollution Control and Ecology Commission (APC&EC) Regulation 5.”**

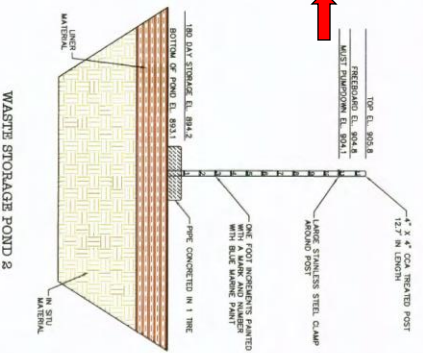
**Waste Storage Pond 2 Stage Storage Table**

Elevation	Stage	Area	Volume	Cum. Volume	Cum. Volume	Freeboard	Top	Bottom
(ft)	(ft)	(sq ft)	(ft <sup>3</sup> )	(ft <sup>3</sup> )	(acre-feet)	(ft)		
900.8	12.7	35,259	30,719	208,798	6.0	0.0

900.2	3.1	16,733	4,724	44,742	1.0			
900.2	2.6	15,976	4,250	36,779	0.9			
900.2	2.1	15,256	3,844	28,779	0.7			
900.7	1.6	14,475	3,478	21,365	0.5			160 Day Storage

900.7	1.1	13,729	3,064	17,078	0.4			
900.1	0.6	13,023	2,704	12,594	0.2			
900.1	0.0	12,282	0	0	0.0

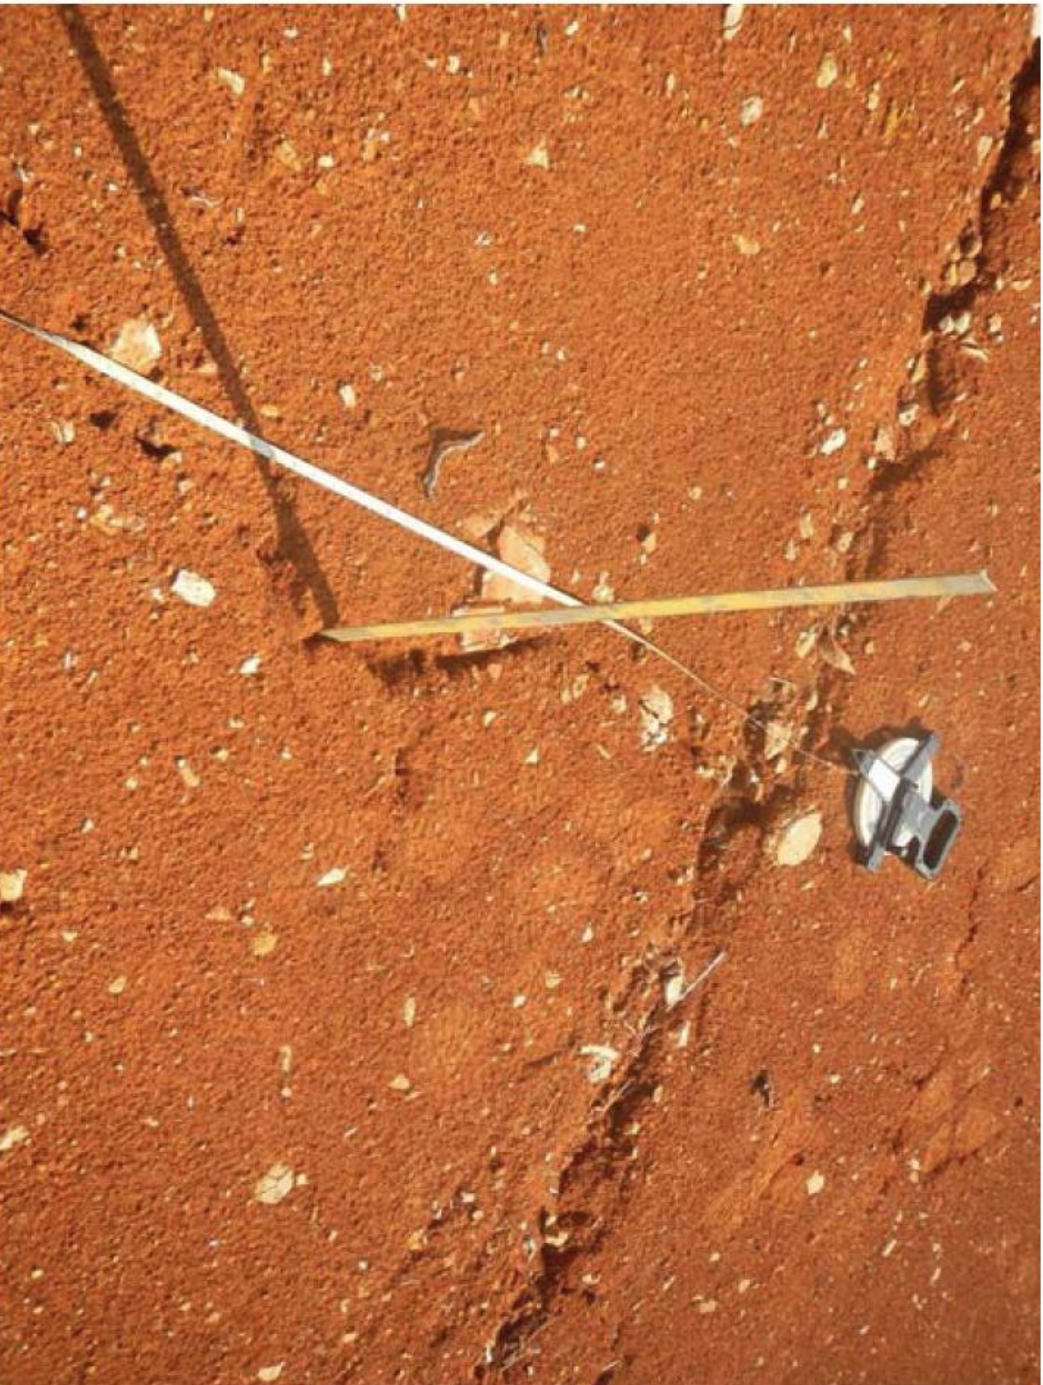
<b>Photographer:</b>	Tony Morris			<b>Witness:</b>	Phillip Campbell		
<b>Photo #</b>	6	<b>Of</b>	6	<b>Date:</b>	07/23/13	<b>Time:</b>	17:21
<b>Description:</b>	Rill erosion and desiccation cracks in Holding Pond liner due to extended exposure.

3.) Immediately after this issue was brought to our attention by the inspectors, we performed the necessary maintenance on the minor erosion rills and desiccation cracks on Pond 2 and will continue to monitor this pond for any further deterioration. C & H Hog Farms considers the immediate action item complete and will continue to perform routine maintenance.

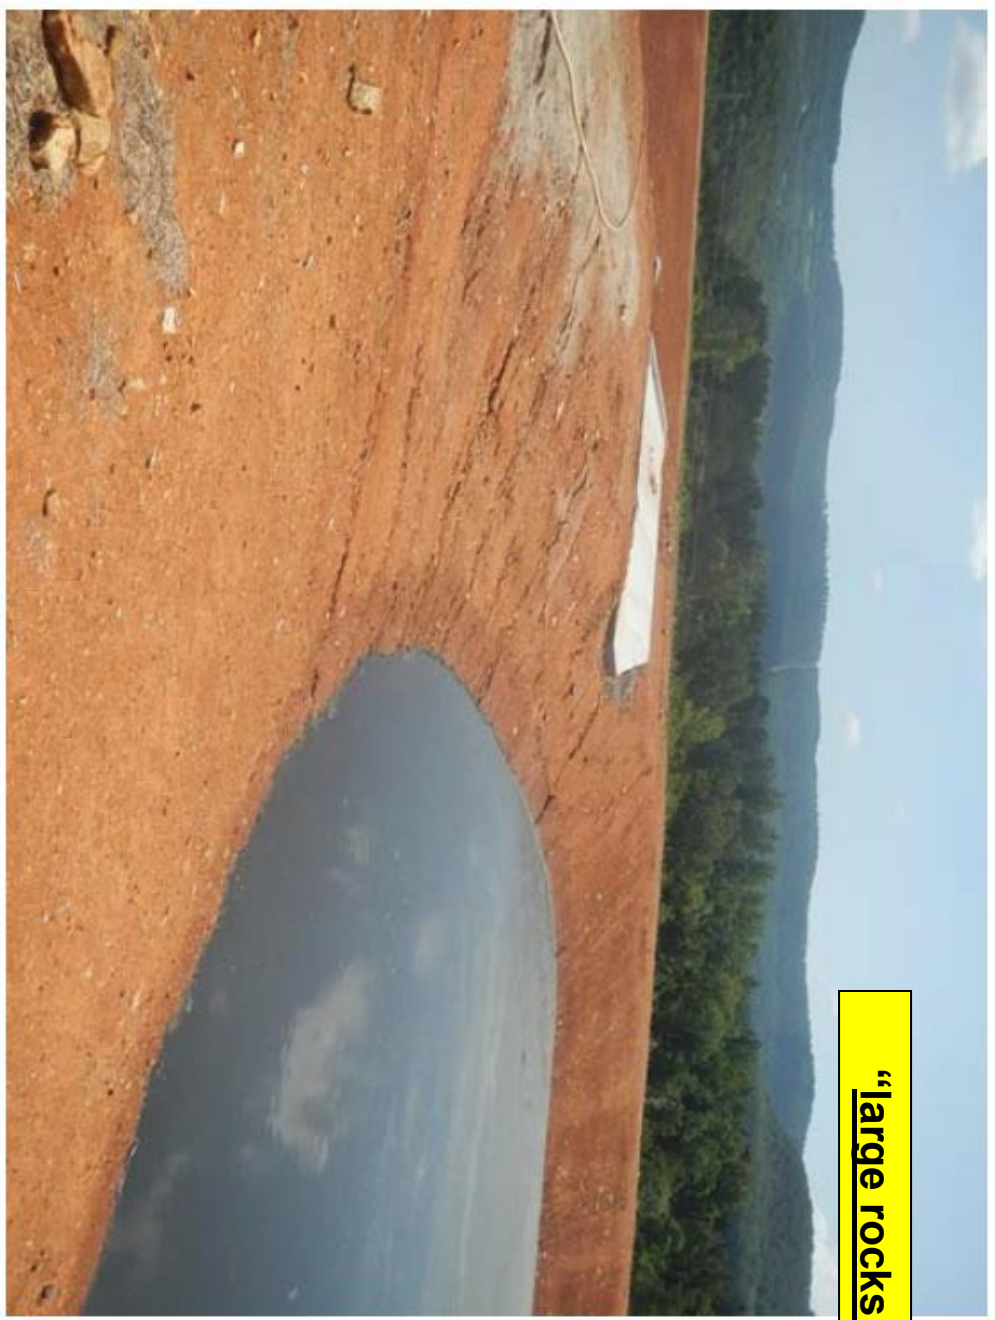
Description: Rill erosion in Settling Basin liner. Large rocks in liner. Signs of liner deterioration.

"large rocks in liner" ★

The wastewater pond liners were observed to have erosion rills, desiccation cracks and gravel to cobble-sized coarse content within the liner clay. If the liner is to be exposed for extended periods of time, it should be protected from deterioration by erosion and desiccation.

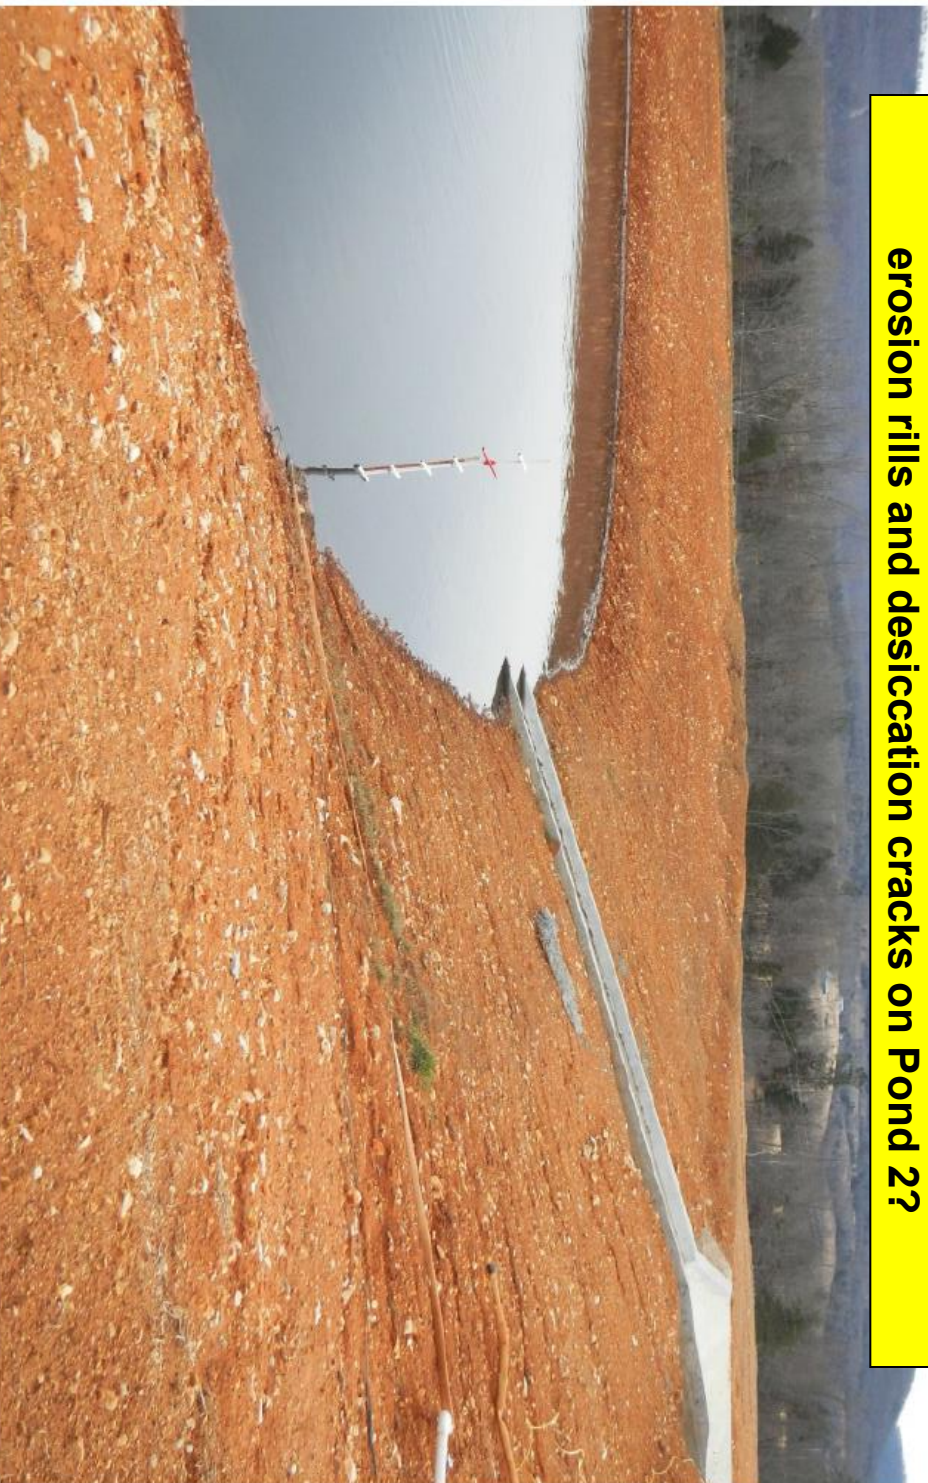
**Inside of Holding Pond 2. Note erosion rills and unstabilized banks. Holding Pond Must Pumpdown elevation is indicated in red on the Must Pumpdown gauge.**

**2<sup>nd</sup> Compliance Inspection and Report after correspondence by the department to C&H asking for "immediate action" and response by C&H that they immediately took care of erosion rills and desiccation cracks on Pond 2?**

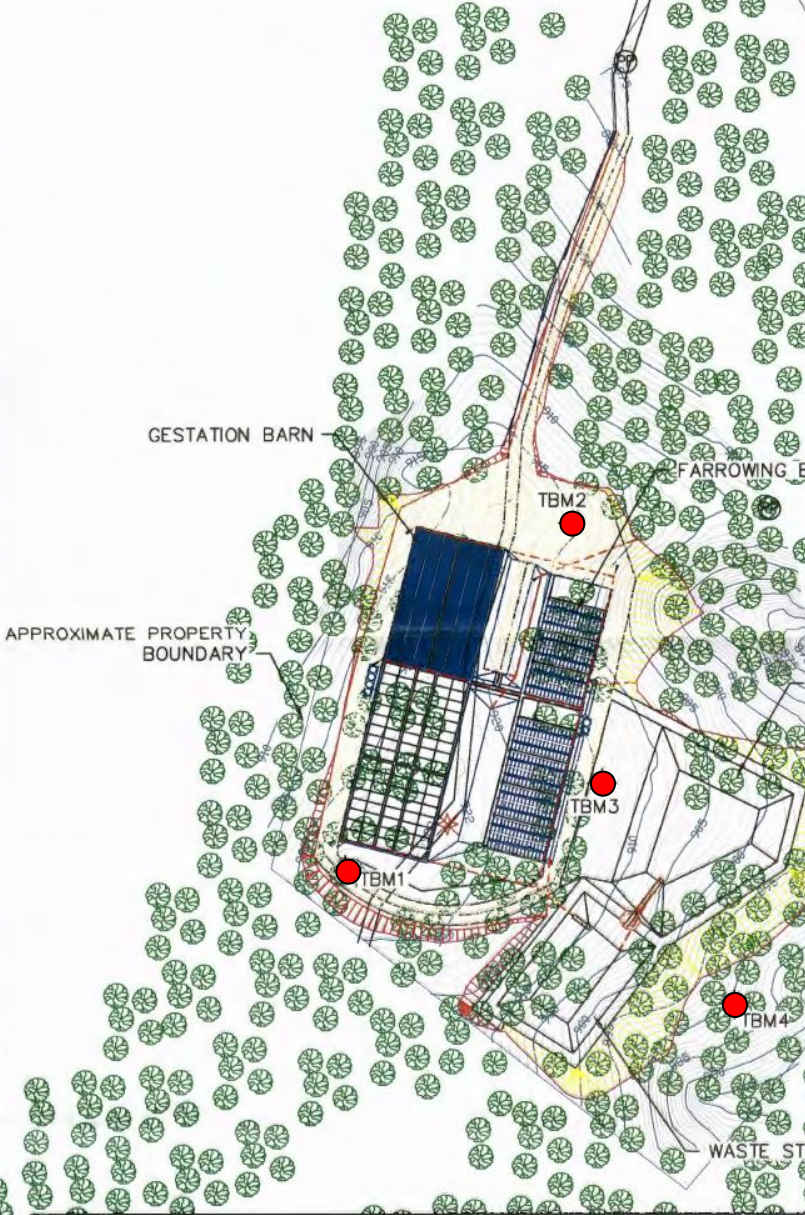
Reference Points the engineers used to plan this facility, reference points for the only other boreholes to aid in review of the lithology. These appear to be lower in elevation than the State of Arkansas Certified "Surveyed Boring Location" of 930.61' ?

Benchmarks				
TBM #	Northing	Easting	Elevation	Description
1	580,264.50	994,267.97	925.68	Elevation
2	580,715.06	994,563.20	915.64	Elevation
3	580,375.60	994,600.08	914.71	Elevation
4	580,090.02	994,770.77	889.80	Elevation

Datum or known reference point. From this certified "Elevation", notations contained within in the Final Report were noted in "Below Ground Surface or bgs). Important information including soil and rock core samples/log, epikarst zone, lost drilling fluid, geophysical data, etc. All of this is referenced from the surface elevation of 930.61' . ★

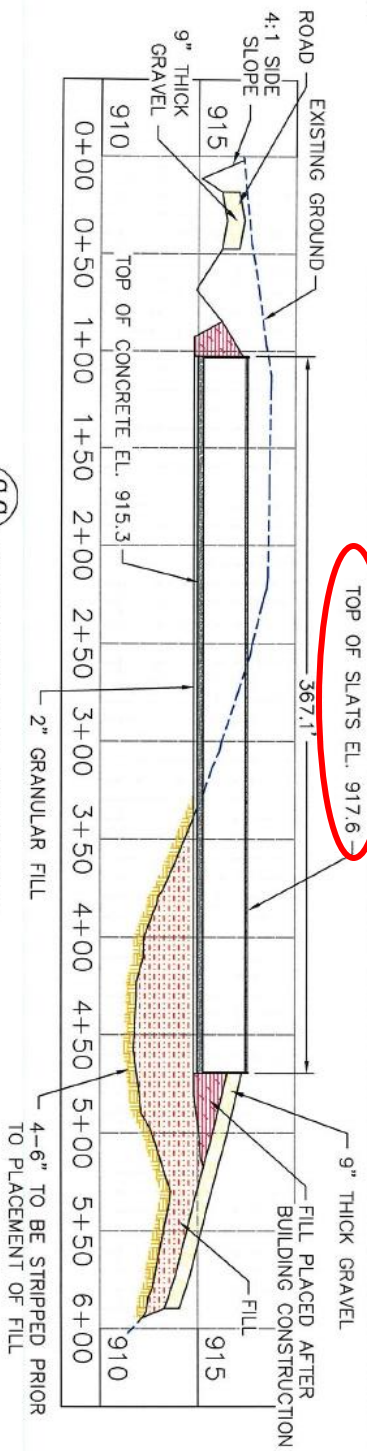
**BARN CROSS SECTION**

**Elevation for the Barn Slatted Floor = 917'**

SCALE:  
VERTICAL: 1"=6'  
HORIZONTAL: 1"=60'

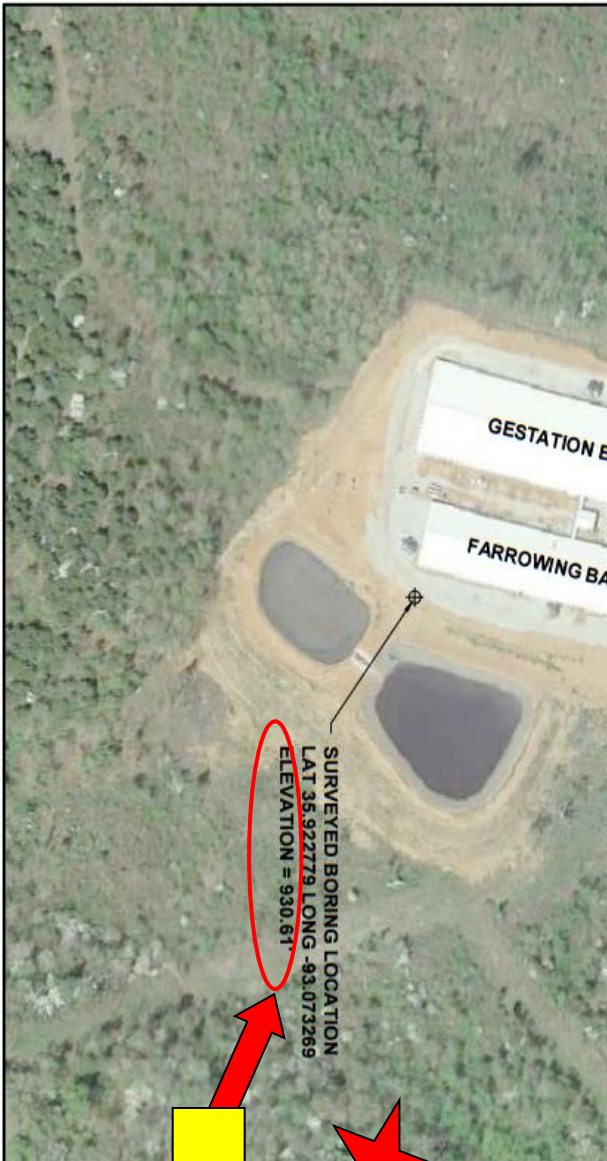
Included are Engineering Drawings from the NOI as well as the "As Built" drawings. Sheet 10 below shows "Top of Slats El. 917.6" for the barn. ★ "The Surveyed Boring Location" appears to be 10 to 15' higher in elevation than any elevations recorded on the Engineering Drawing(s) provided below.

**"Elevation 930.61'"** ★
