Surface-Water Quality in the Buffalo National River (1985-2011)

Sandi J. Formica, Executive Director
Watershed Conservation Resource Center

1st Annual Buffalo National River Science Symposium
Harrison, Arkansas
April 23, 2019

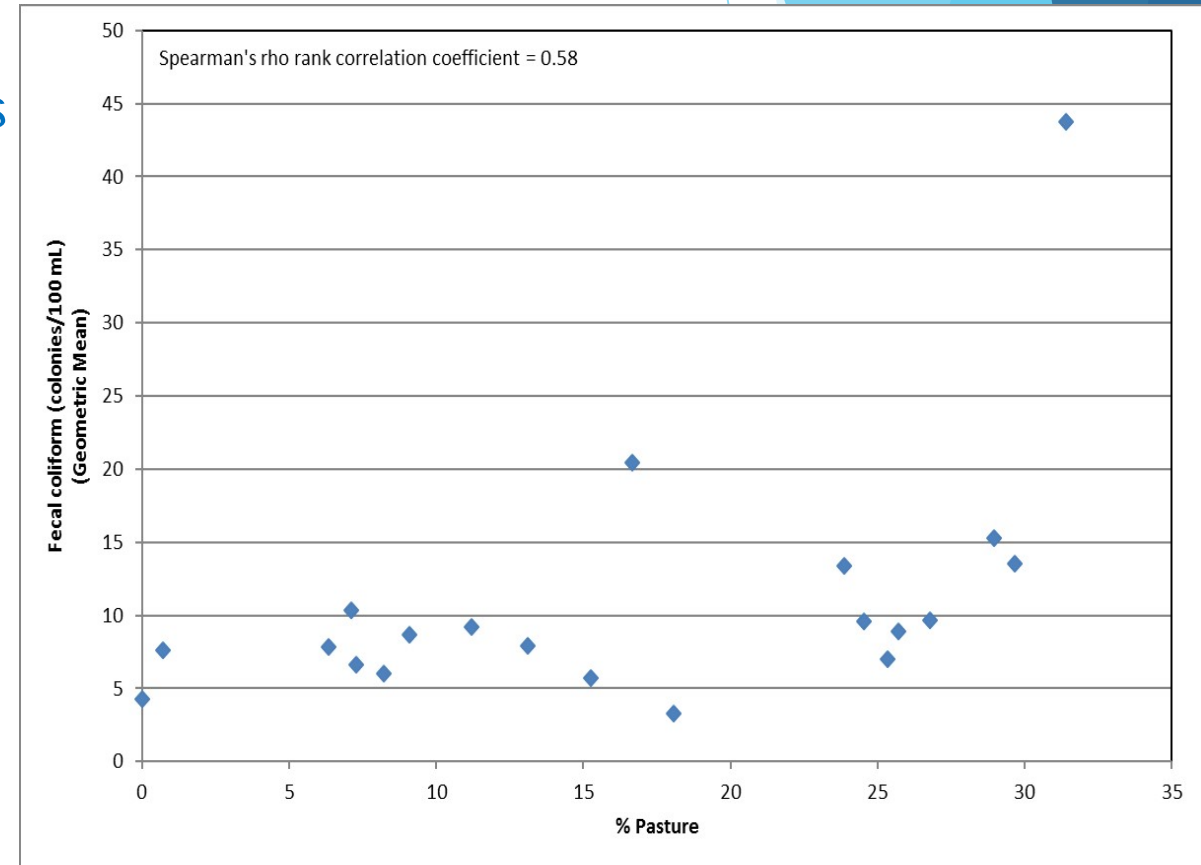
Figure 4.2.9 Relation between geometric mean fecal coliform bacteria concentrations and percent pasture of watersheds of Buffalo River tributary sites sampled between 1985-2011 during storm- flow and base-flow conditions.

- ▶ Fecal Coliform Bacteria Geometric Mean Verses Percent Pasture within Tributary Watershed (using Spearman's rank correlation)
- ▶ A general upward trend was noted

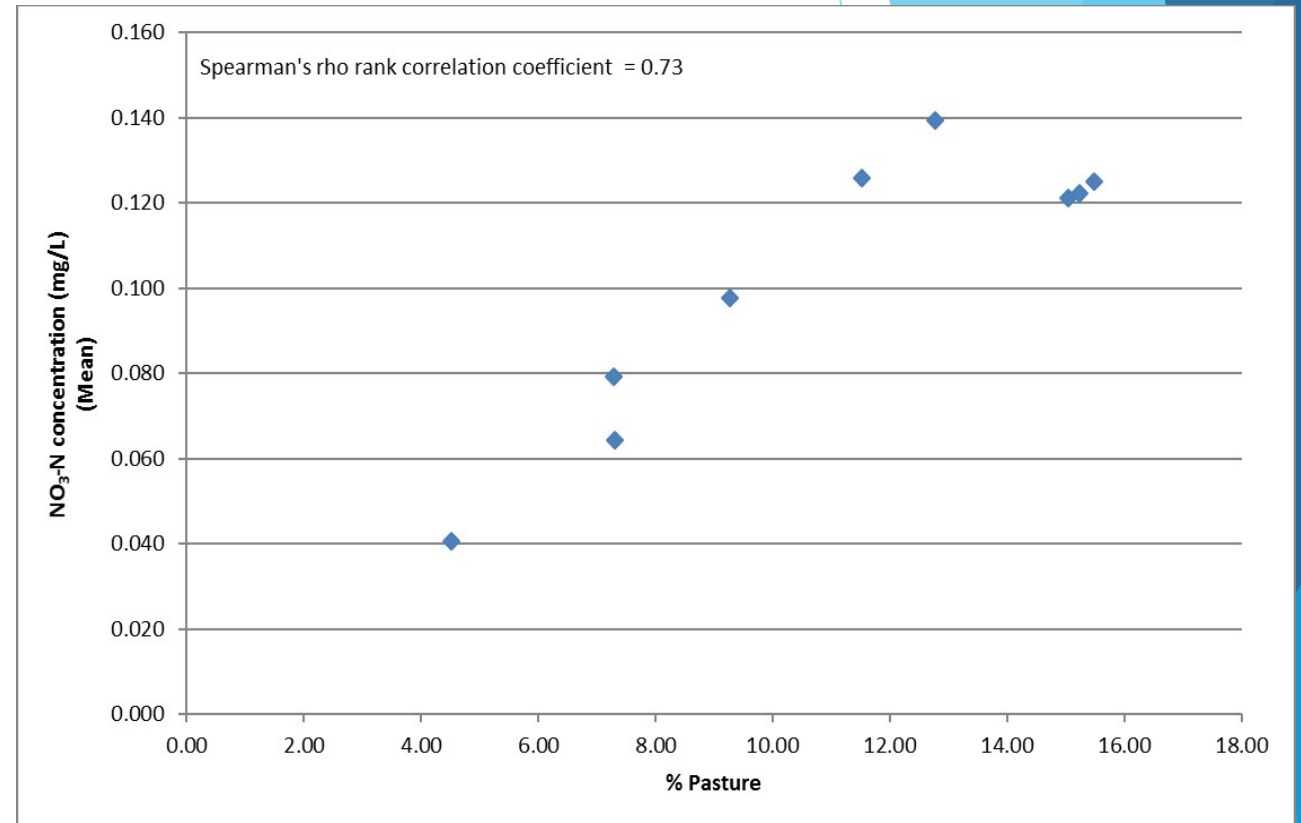
- ▶ Mean Nitrate Concentrations verses Percent Pasture of Upstream Watershed Area (using Spearman's rank correlation)
- ▶ Generally an upward trend

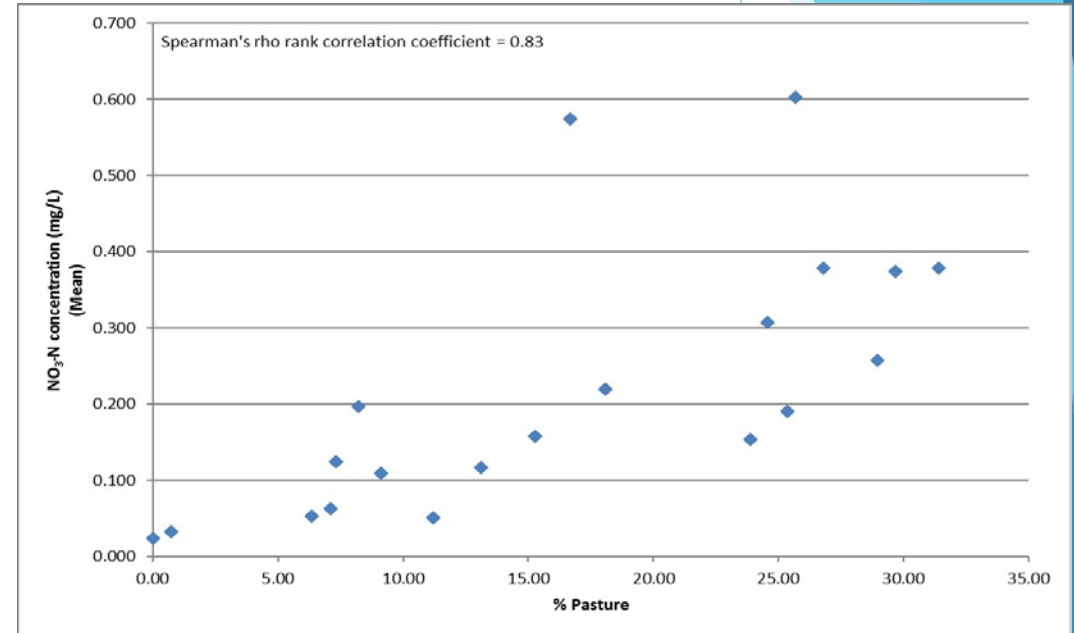
- ▶ Mean Nitrate Concentration versus Percent Pasture (using Spearman's rank correlation)
- ▶ A general upward trend was noted
